## D/DRC Case

1703 Wayne Street

**DESIGN/DEVELOPMENT REVIEW COMMISSION**  
**DESIGN REVIEW DISTRICT**  
**CONSENT AGENDA**  
**EVALUATION SHEET**  
**Case # 4**

**NATURE OF REQUEST:** Request for preliminary approval for the Bailey Bill

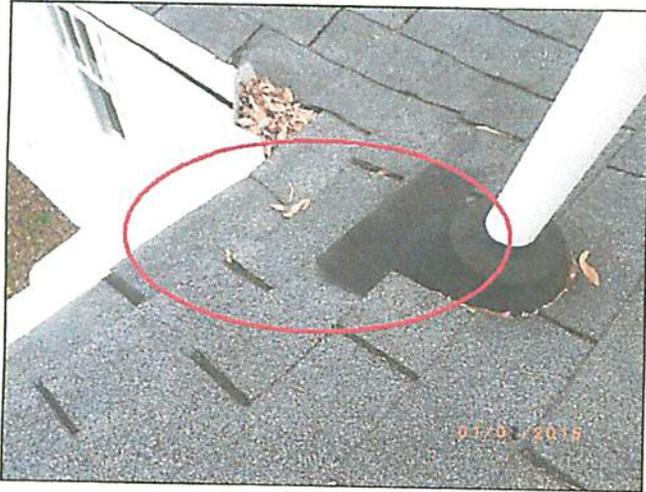
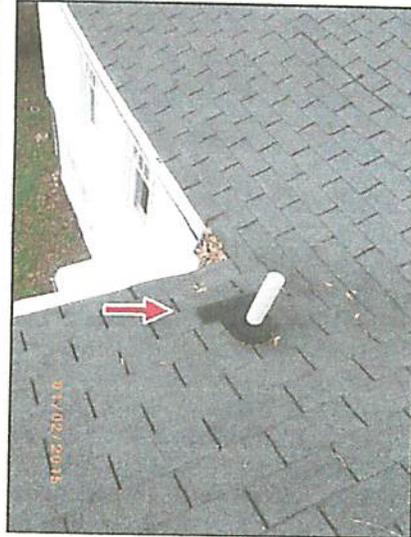
1.1 Item 1(Picture)

1.1 (1) ROOF REAR EDGE - SAG: The roof noticeably sags at the area below the plumbing roof vent (stack). Found damaged plywood sheathing visible in the Attic.

**Recommend replacing all damaged plywood sheathing (wood rot) in affected area.**

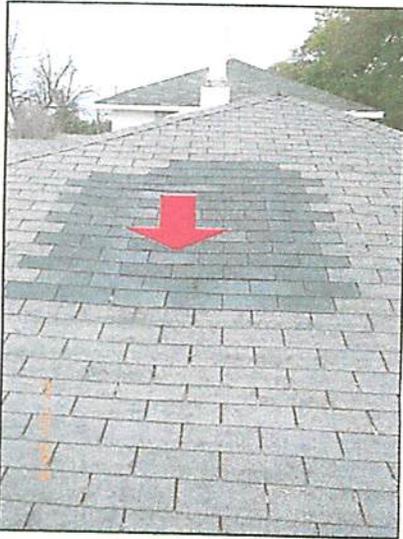
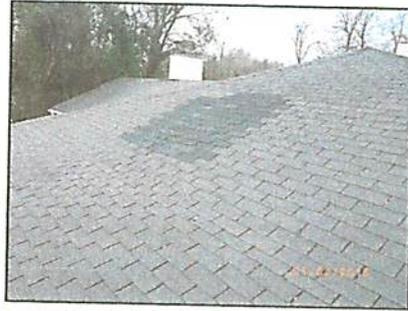
1.1 Item 3(Picture) LEFT SIDE  
HIP SECTION

(2) LEFT SIDE HIP SECTION: There is a noticeable sway/sag in between the joists. The shingles have been replaced (new color).

*Note: Roof structure has been re-framed and sheathed at where chimney has been removed.*

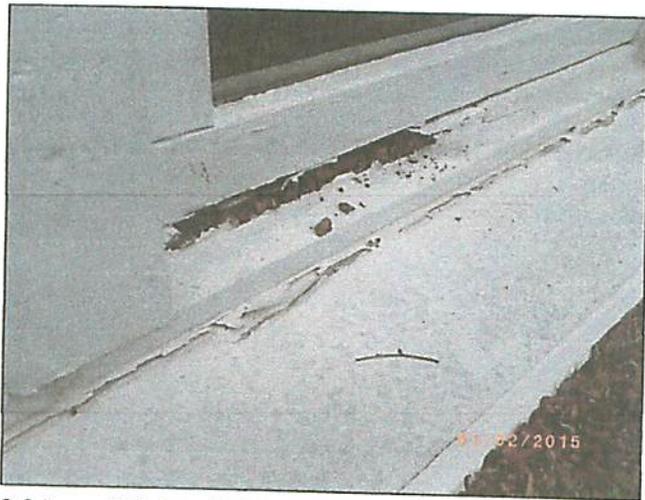
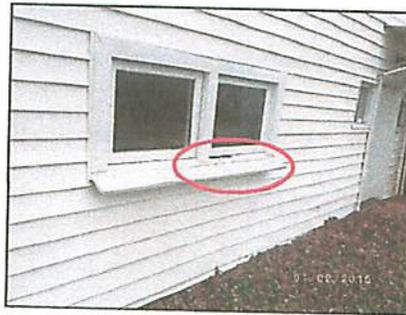
2.0 Item 1(Picture) LEFT SIDE WINDOW

2.0 LEFT SIDE WINDOW (apartment) - WOOD ROT- Found wood rot/deterioration in the window sill.  
**Recommend replacing all rotten wood.**

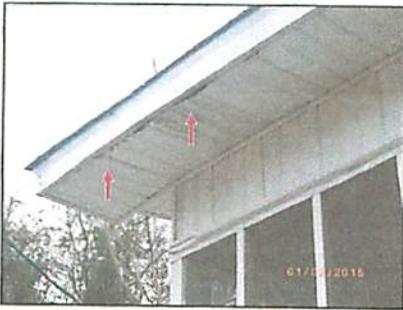
3.0 Item 1(Picture)

3.0 LEFT SIDE - PORCH SOFFIT: The vinyl soffit material is loose/gapped.  
**Recommend securing soffit.**

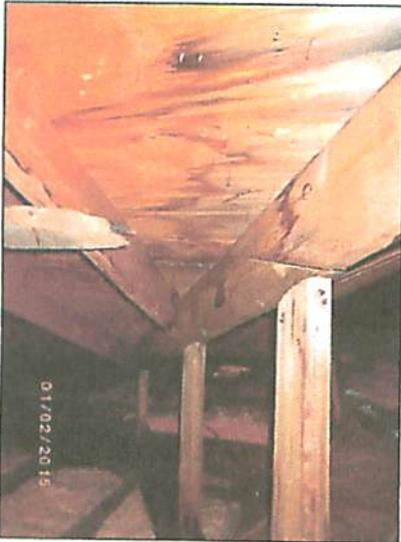
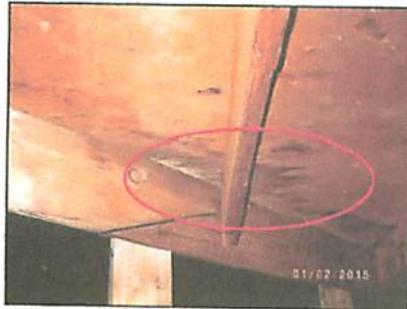
6.1 Item 1(Picture) PLYWOOD STAINED

**6.1 ATTIC - PLYWOOD STAINED:** Found water stains/discoloration in the plywood sheathing at in the valleys at the left side and various locations.

*Note: Plywood was dry at the time of inspection during dry weather. Note: No significant damage found.*

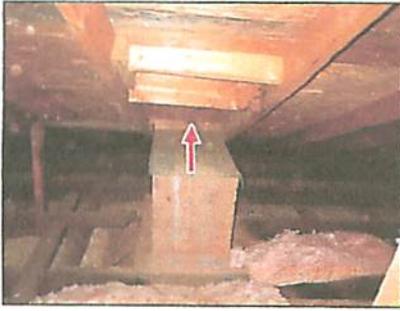
6.3 Item 1(Picture)

6.3 ATTIC - LEFT SIDE: Roof framing has been added where the brick chimney has been removed.

Note: See Item 1.1 (sag in roof).

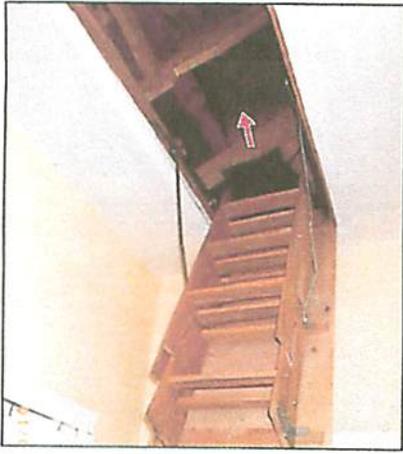
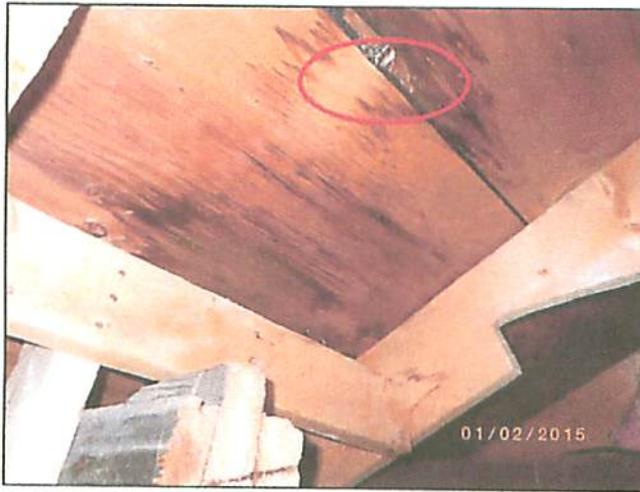
6.4 Item 2(Picture) HOLE IN ROOF

6.4 HOLE IN ROOF - ABOVE ACCESS: Found visible light through-the-roof sheathing (stained) above the drop-down ladder.

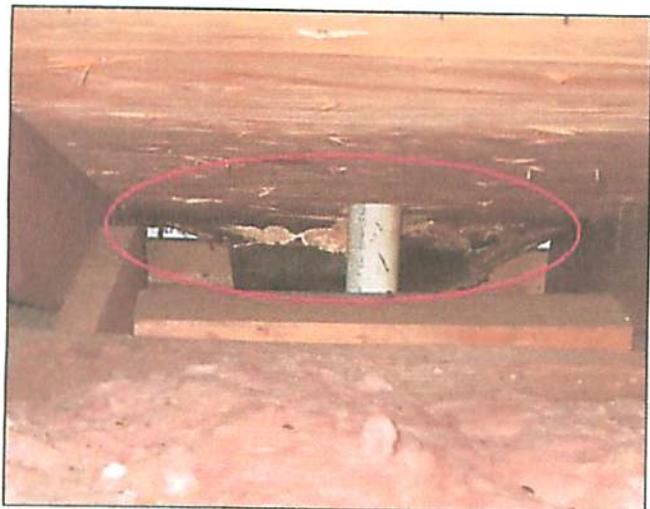
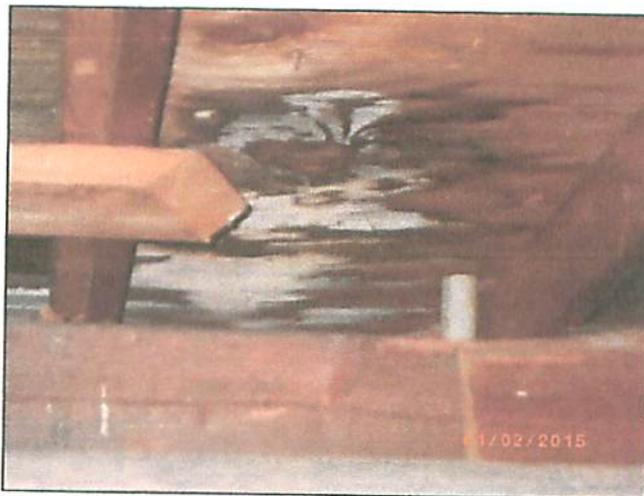
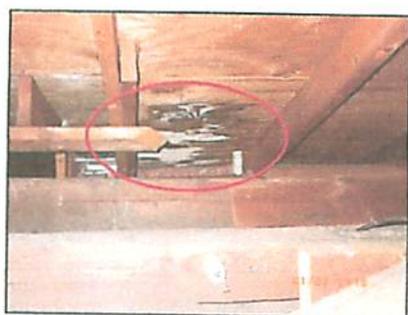
6.5 Item 2(Picture) MOISTURE DAMAGE

6.5 ATTIC - LEFT SIDE: Found wood rot/deterioration in the plywood from moisture damage at the plumbing vent stacks. **Recommend repairs by a qualified building or roofing pro.**

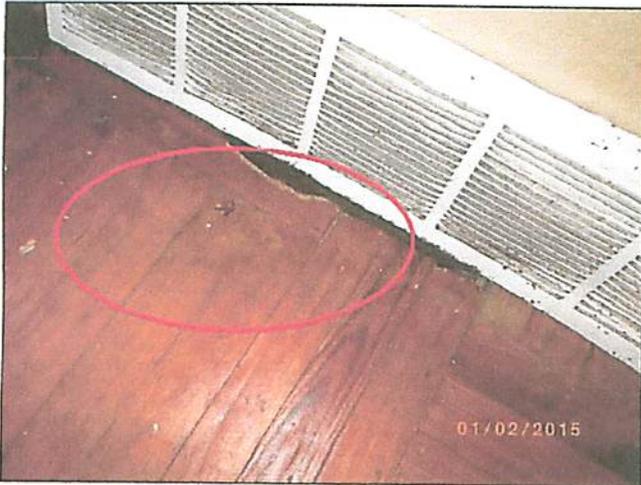
12.2.A Item 3(Picture)

(2) LIVING ROOM - NEAR ENTRY - FLOOR GAPPED: Found a gap in the wood flooring near the air vent (outlet).  
**Recommend adding filler strip or sealing (all) gaps at floor vents.**

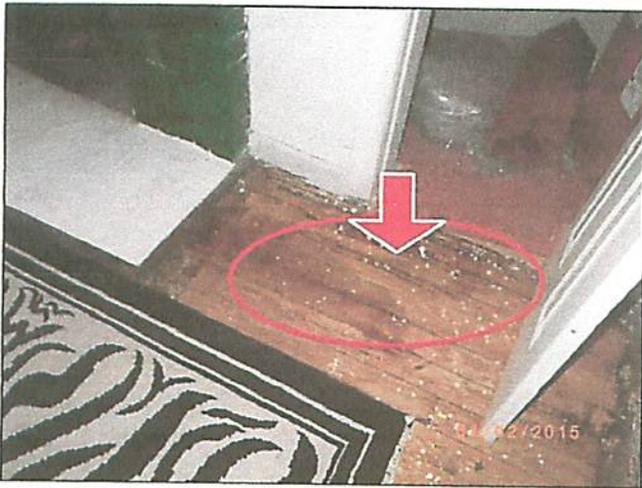
12.2.A Item 4(Picture) FLOOR SPONGY

(3) MIDDLE RIGHT BEDROOM - FLOOR SPONGY: The wood flooring is soft/spongy near the closet.  
**Recommend repairing (reinforcing) area.**

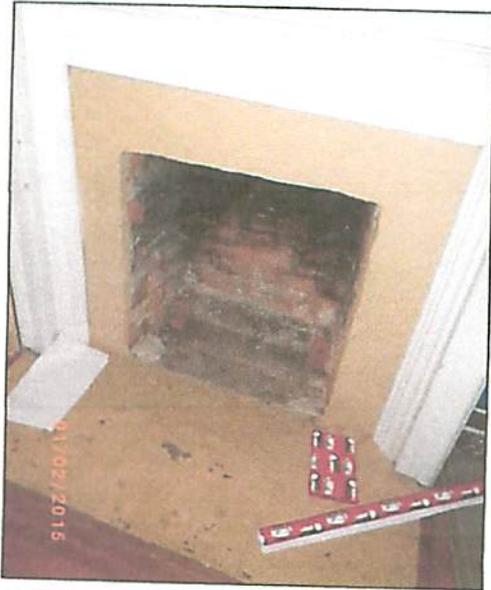
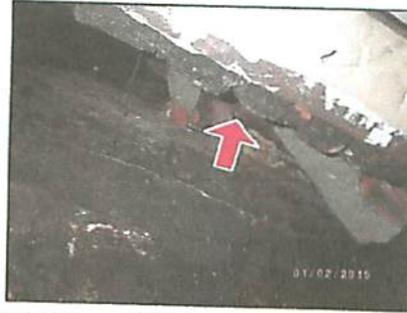
15.0 Item 1(Picture)

15.0 FIREPLACES: The fireplaces in the building have shallow firebox. These type of fireplaces generally were intended for burning coal. Typically there are no flue liners as installed in wood burning fireplaces.

*Note: Fireplaces have been blocked off or partially sealed. Do not attempt to use with combustible materials.*

**Recommend a qualified chimney sweep or fireplace specialist inspect all fireplaces further before use for safety concerns.**
