# SMITH BRANCH WATERSHED ASSESSMENT

MAY 20, 2016

CITY OF COLUMBIA  
UTILITY AND ENGINEERING DEPARTMENT  
1136 WASHINGTON STREET, 7TH FLOOR  
COLUMBIA, SOUTH CAROLINA 29201

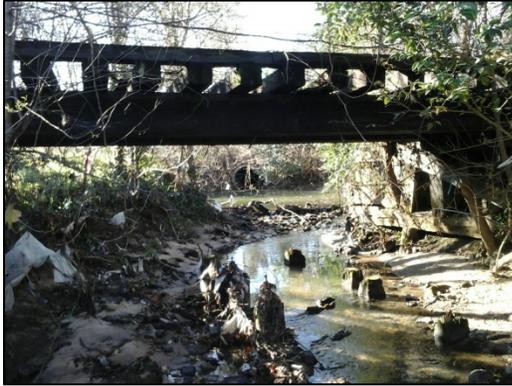
**Channel Conditions:**

SW-F drains to a segment of open stream channel extending along the SW-H and SW-G boundary to the west. The upstream limit of open channel originates from a 52 inch concrete outfall under the railroad behind Andrews Auto Service (west of Harden Street and north of Calhoun Street). Expansion scour has likely contributed to widening and there is a large scour pool downstream of the outfall. Downstream, an abandoned degraded railroad bridge constricts the channel, and creates a pinch point. Stream banks are approximately 7-feet tall and are vegetated and stable.

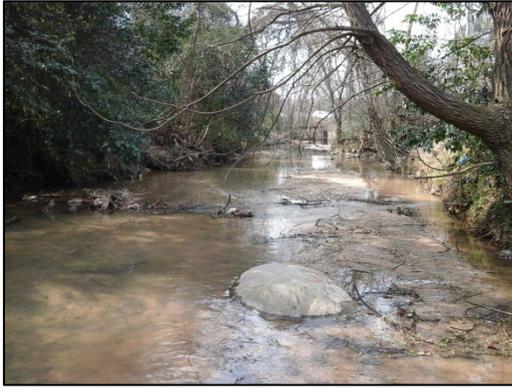
### Channel Conditions:

Within SW-I, the upstream extent of the mainstem of Smith Branch flows from a 10 foot wide by 10 foot tall double box culvert beneath Colonial Drive. There is a 30 inch baseflow water surface drop off at the end of the culvert apron and a deep scour pool immediately downstream. The floodplain and top of bank is heavily vegetated with thick underbrush and the 12-foot banks are relatively stable, with isolated areas of erosion. A beaver dam creates a significant backwater 650 feet downstream of the Colonial Drive culvert. Downstream of the beaver dam, the stream is shallow, with depositional midchannel and point bars. Substrate within this segment of stream is predominantly sand, with gravel, cobble, and boulder along the riffles. Riprap stabilizes the right bank and thick vegetation covers the left bank face as Smith Branch approaches the Harden Street Extension.

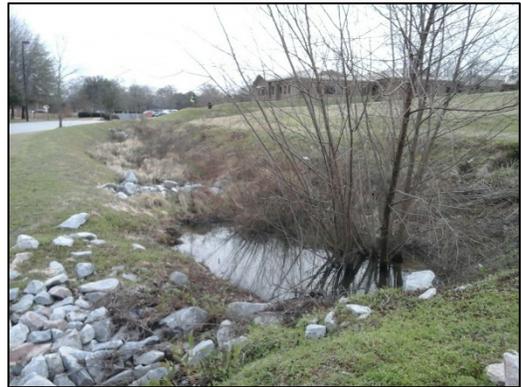
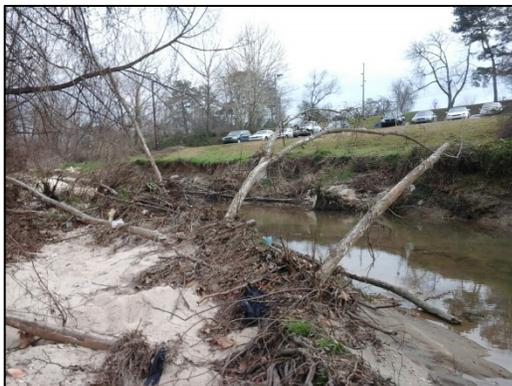
The Smith Branch mainstem flows west through the double box culvert underneath the Harden Street Extension. Infrastructure encroachment, excessive sediment deposition, and poor buffer management practices (mowed to top of bank) have resulted in bank instability and observed block failures extending 150 feet along the left bank, downstream (north) of the Harden Street Extension. Downstream, the banks are more heavily vegetated and stable. Two small tributaries contribute flow into this mainstem segment. The upstream tributary runs parallel to the Harden

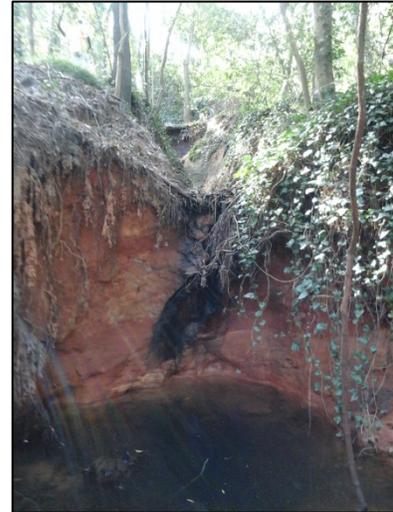
Downstream of SC-277, the Smith Branch mainstem flows through a forested parcel, with vegetated, stable banks and large points bars. Bay Branch joins the mainstem 260 feet downstream of the SC-277 culvert. Bank erosion and lateral migration threatens a utility right of way and manhole stack upstream of Main Street. The stream then flows through a 12 foot tall, 16 foot wide culvert under Main Street. Downstream of Main Street, Smith Branch enters Earlewood Park and is confined within brick and mortar walls for 70 feet, extending to the downstream side of the Parkside Drive bridge. The downstream boundary of SW-I crosses the mainstem at this point and Smith Branch continues to flow downstream through SW-J.

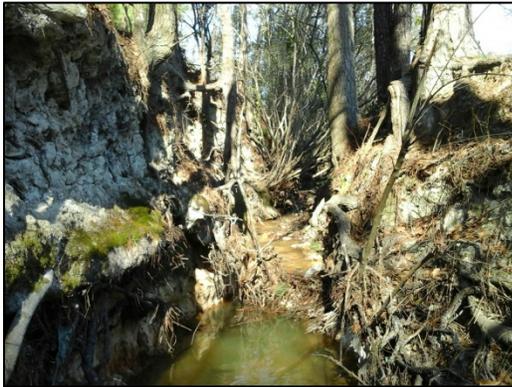
## Channel Conditions:

The upstream extent of the open channel network in SW-B begins north of the Truman and Scurry Street intersection. Channel bed substrate is primarily sand and silt. The right bank is near vertical and is much taller than the left bank. Both banks are vegetated yet show evidence of the channel downcutting and widening. The right bank has been heavily armored with riprap at the Burton-Pack Elementary School stormwater pond outfall and erosion on the left bank has begun to encroach upon adjacent properties. Near the northern end of Hammond Avenue, the stream channel becomes more highly incised, with bank stability decreasing and sedimentation increasing; erosion threatens adjacent residential properties, slope failures have exposed bedrock, and land clearing on the right bank has likely contributed to observed slumping.

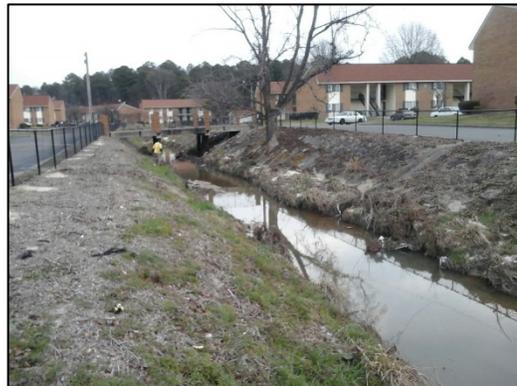
The stream then becomes channelized with concrete bed and banks, flowing parallel to Ripplemeyer Avenue. Channel conditions along this segment show signs of severe degradation of the concrete channel; soil slump has caused the right bank to fracture and sag. Downstream of the concrete channel, the stream returns to a natural state with earthen bed and banks. Debris caught in understory brush and saturated soils provides evidence of possible flooding. Stream banks are sparsely vegetated with herbaceous material and contain areas of instability. The stream then flows through an 8-foot wide, 6-foot high twin box culvert crossing westerly under Lester Drive. Large sand bars define the channel upon the streams emergence. The stream flows approximately 100 feet before being conveyed through a culvert beneath SC-277 and beyond the SW-B boundary.

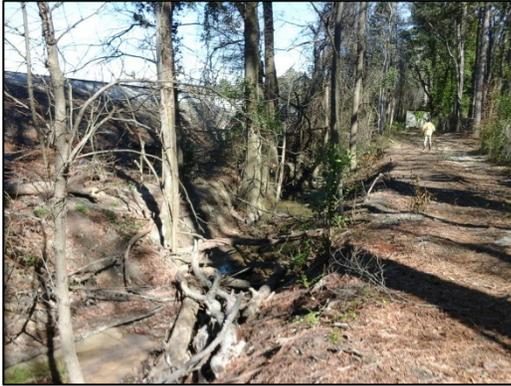
### Channel Conditions:

The easternmost open channel segment in SW-G is located between the railroad and C.A. Johnson High School. Flow initiates from two 36 inch RCPs that were submerged and backwatered at baseflow. Downstream, the channel is incised, pinched between the railroad embankment and residential properties along Dart Street. Woody bank vegetation adds stability through most of this segment and the channel bed material is primarily sand and silt. The main channel converges with two small tributaries before flowing east through a railroad culvert. The stream

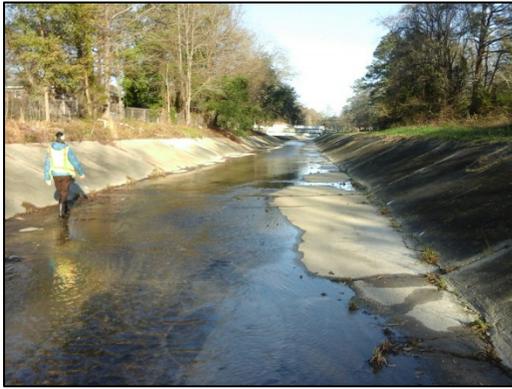
### Channel Conditions:

Within SW-D, the upstream extent of Bay Branch mainstem begins west of the culvert underneath SC-277. The stream flows west through a degraded trapezoidal cellular concrete channel. Large sand bars/benches are prevalent within the reach between SC-277 and Shaw Street. At Shaw Street, the condition of the channel changes, the concrete channel downstream of Shaw Street is smooth concrete, less degraded than the upstream reach, and with little to no deposition or vegetation present within the concrete margins. The channel becomes less degraded, with a

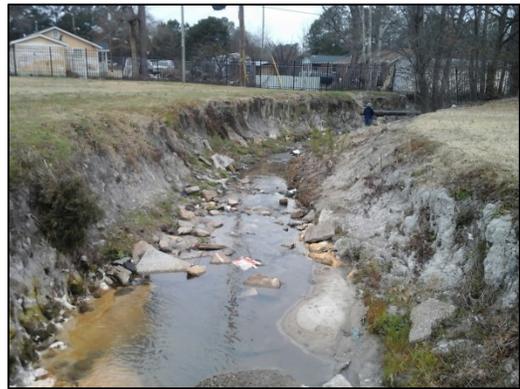
The second major tributary originates from south of SC-277 and west of Farrow Road. Open stream channel originates from a 36 inch RCP southwest of the intersection of Water Street and Adams Street. The tributary is then piped north under SC-277. Another segment of open channel originates from 52 inch RCP west of Water Street between Chappelle Street and Lorick Avenue. A third of the banks within this segment are actively eroding where the channel is tightly confined between private residential properties. The stream is piped underneath Chappelle Street then emerges from a 48 inch RCP into the Bay Branch mainstem east of Colonial Drive.

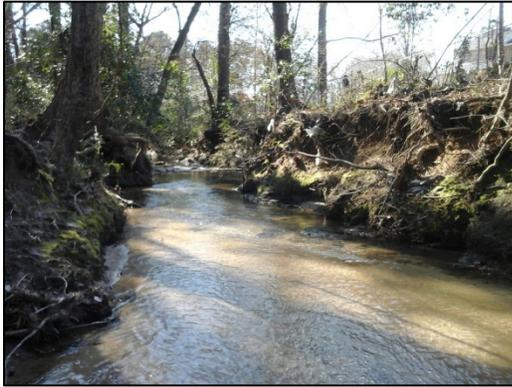
## Channel Conditions:

The upstream extent of the main channel (Bay Branch) in SW-E begins at the Lorick Avenue crossing. The channel bed and banks are initially concrete, changing to natural channel approximately 170 feet downstream of Lorick Avenue. Paralleling Lorick Circle and flowing in a south/southwest direction the channel is entrenched and straight. The cross-sectional area through this reach is significantly smaller than the concrete channel immediately upstream, combined with the increased roughness within the natural channel segment, a backwater condition would be anticipated

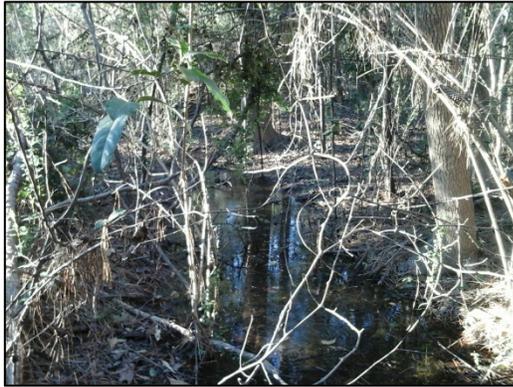
**Channel Conditions:**

There are four open channel segments in SW-C. The upstream segment begins at an outfall on the south side of Koon Road and flows through a densely vegetated area before entering a pipe at Ames Road. Channel substrate is comprised of mostly sand and silt. Stream banks are very low, there are various locations of split flow and points where the channel takes on wetland like characteristics with shallow low velocity flow and subtly defined bank margins dense with vegetation.

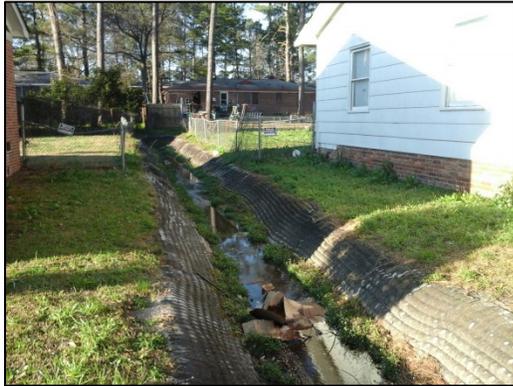
The upstream and northern extent of open stream channel within SW-A begins at an outfall emerging from underneath SC-277. The main outfall channel converges with a concrete flume extending along the northern shoulder of Oscar Street. The concrete flume is ephemeral, conveying roadway drainage during storm events. Erosion and flanking along the southern bank of the concrete channel has exposed the base of a fire hydrant. The stream extends downstream through a culvert beneath Oscar Street and opens into a natural stream bed within a forested parcel. Channel substrate consists primarily of sand, with some gravel and cobble present primarily in riffles. Banks are low, stable and well vegetated. The stream flows approximately 260 feet before it is channelized, with concrete bed and banks. The stream takes multiple abrupt turns, while confined between single-family, detached homes. The concrete channel extends downstream, continuing south of the Webb Court culvert before being piped through a 36-inch RCP north of the entrance road of Burton-Pack Elementary School.

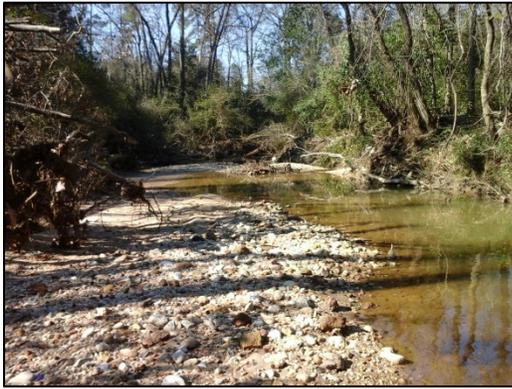
Within SW-K, the upstream extent of the Smith Branch mainstem channel begins southwest of the Sunset Drive and Summerlea Drive intersection. Smith Branch passes through a 9.8 foot wide by 9 foot high double box culvert under Sunset Drive and enters a forested floodplain parcel between residential communities. There are indications (lateral scour and fine sediment deposition) that suggest a severe meander bend immediately downstream of the Sunset Drive creates a backwater during storm events. This area (specifically the right bank downstream of Sunset

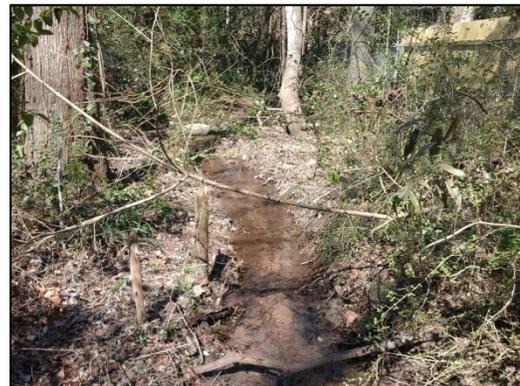
The second tributary begins southeast of the Makeway Drive and Sunset Drive intersection. Multiple headcuts have formed throughout the segmented channel network. At the upstream end, south of Sunset Drive, a 15-foot tall headcut is nearing the foundation of a single family home. The stream is then piped under Sunset Drive and Falling Springs Road. Downstream of Falling Springs Road, the channel has downcut and undermined the culvert and an additional

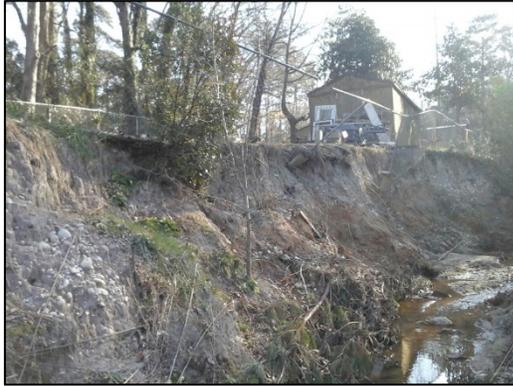
Upstream limits of the open channel network within SW-L begin between Steadham and Wildwood Avenue, west of Palmetto Avenue. Banks are low, stable, and well vegetated. Channel substrate is primarily sand, with gravel and cobble along riffles. The left bank is stabilized with a brick wall upstream of the Abingdon Road crossing. After the stream extends under Abingdon Road, the channel becomes deeply incised extending within a cleared utility right of way; raw vertical banks threaten infrastructure and private property on both sides. Bedrock intrusion

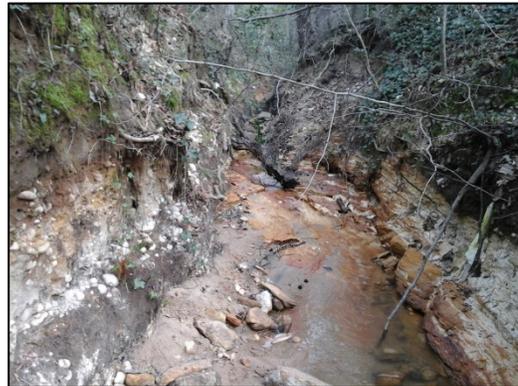
Downstream of the confluence of the two tributaries previously described, the channel incision continues, with 6 to 8 foot banks. Downtcutting into bedrock has created a series of steep cascades with large scour pools downstream. Substrate in this segment is mainly bedrock with sand in the pools and gravel and cobble along the riffles. The stream then extends through a 42 inch road culvert under Woodridge Drive.

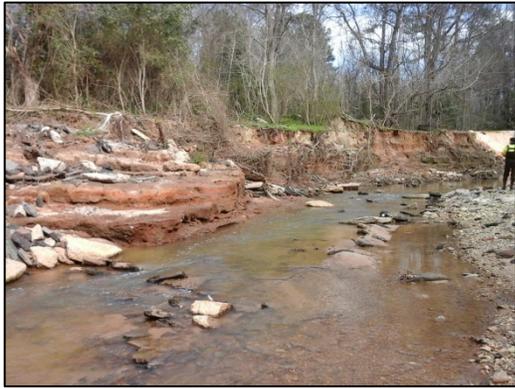
Within SW-M, the Smith Branch mainstem begins at the subwatershed's eastern most boundary from a bridge crossing at Clement Road. Riprap and gabion baskets have been placed on the right bank to mitigate severe bank erosion that has endangered Mountain Drive. Downstream of the riprap, the right bank is severely eroded, slumping into the bed and migrating towards Mountain Drive. A large coarse point bar has formed on the left bank. Downstream, a large debris jam at the confluence with the major tributary from SW-L has obstructed flow, resulting in flanking and scour around the obstruction on the left bank. Substrate consists of mostly sand, with significant quantities of cobble and gravel along the riffles and point bars. Erosional activity continues downstream, impacting the outside of bends. Large depositional bars have formed on the inside of bends. A small tributary originating from a pond outfall contributes flow from the left bank. As the channel approaches Williamsburg Drive, another significant debris jam obstructs flow, storing large amounts of fine sediment upstream of the obstruction. Downstream of the debris jam, the 40-foot tall left bank becomes raw, with no vegetation on the bank face or at the top of the bank. As the channel moves away from Williamsburg Drive, banks stabilize. Cobble and gravel quantities diminish within the bed. A significant tributary that runs roughly parallel to Mountain Drive joins the Smith Branch mainstem north of Williamsburg Drive. The channel then passes under a railroad, turning sharply south where it is confined between the railroad trestle on the left and an access road on the right. Backwater from the Broad River and associated dam influences the channel from this point to the confluence with the Broad River.
