D/DRC Case

15 Gibbes Court

DESIGN/DEVELOPMENT REVIEW COMMISSION
DESIGN REVIEW DISTRICT
CONSENT AGENDA
EVALUATION SHEET
Case # 3

Summary
Structural Evaluation
of
15 Gibbes Court
Columbia, SC

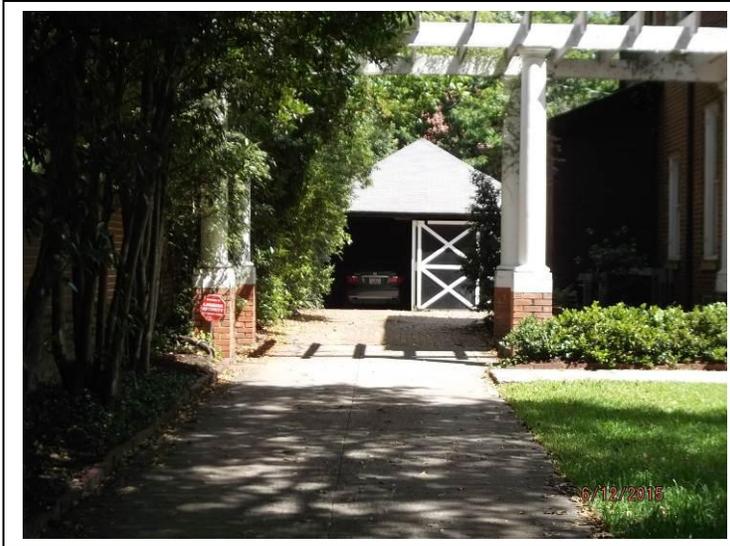
This is a c.1912 single-family home with what appears to be a c.1940s garage that is in disrepair. The proposal is to demolish the existing one-story garage and construct a two-story garage/apartment/studio in the same location. This new building is not highly visible to the public right of way as it is located at the rear of a lot that is partially hidden from view by a tall garden wall along the front of the property.

Garage to be demolished and replaced.

Staff recommends granting approval for the demolition of the garage based on Section 17-674(e) of the City Ordinance as it does not appear to have historic or architectural significance, it is not important to the ambience of the district, and the proposed reuse of the property will not have a negative effect on the district.

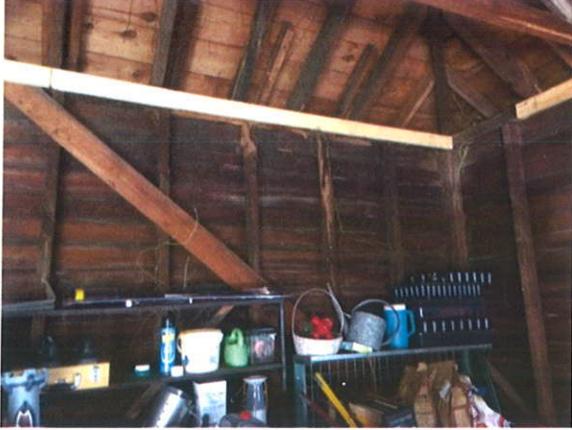
1. Numerous areas of termite damage were noted. Those locations are noted to be but not limited to the stud wall at the right rear (See photos 1 and 2), the top front corner of the window at the left side (See photo 3), the top front corner of the window at the right side (See photo 4) and at the top of the window at the right side. (See photo 5).

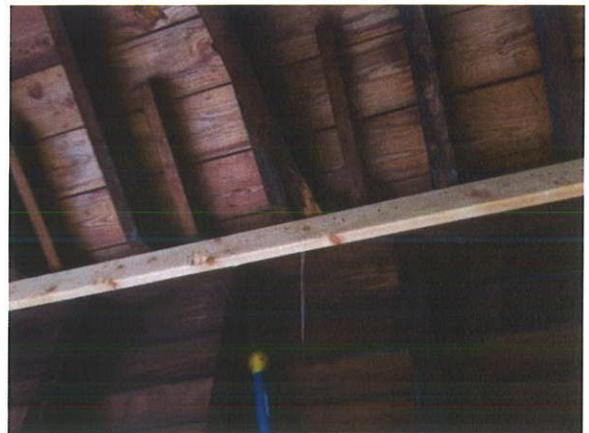
2. There were no collar ties noted on the existing roof rafters. There are a few rafter tie members noted, however, some of them were not connected properly to the existing rafters. Numerous roof rafters were noted to not have the required rafter and collar tie connections (See photos 6 and 7).

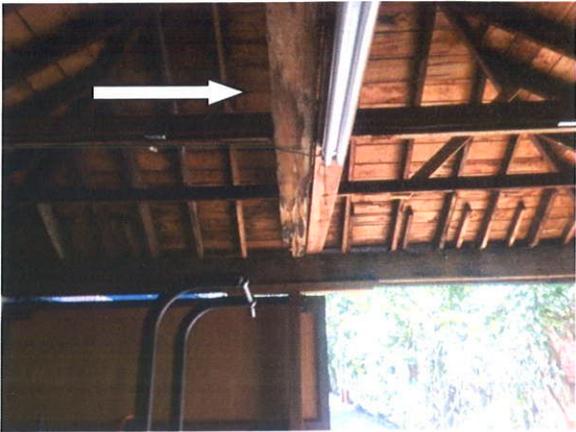
10

4. (2) Wooden beams, which were noted lying on their flat face, were used to shore the existing roof rafters. (See photos 9 and 10). Severe sagging/deflection was noted at the shoring locations along the flat beam (See photo 11).

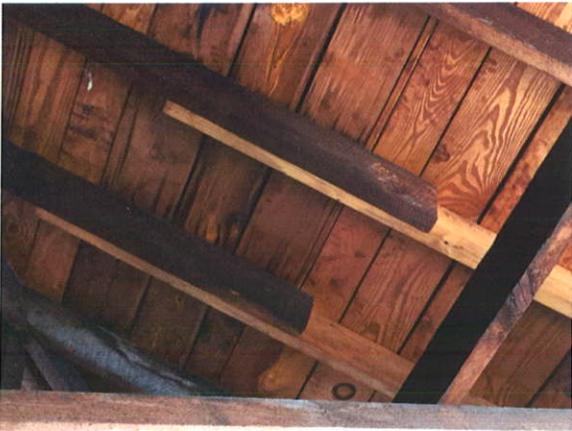
8

3. The existing roof rafters at the front of the hip were noted to have new pieces of timber scabbed to the sides of the original rafters to be an extension. It appears that the original rafter may have had problems in the past, which required a scab repair and extension (See photo 8).

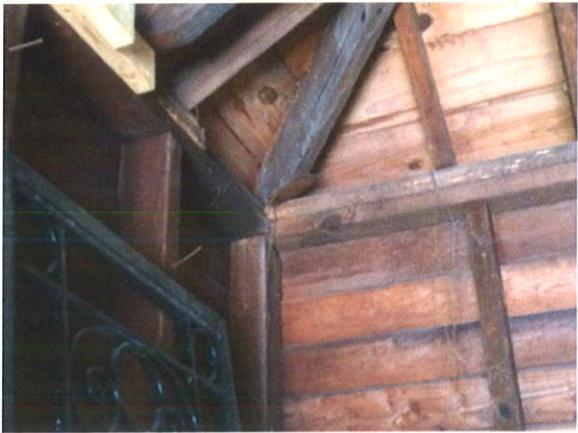
5. No hold downs or hurricane ties were noted. (See photos 12 – 15)
6. Numerous holes were noted in the existing wood siding. These locations were noted but not limited to the middle bottom of the left wall (See photos 16 and 17), the middle of the rear wall (See photo 18), the left rear corner (See photo 19), the right rear corner (See photo 20), the middle of the right wall (See photo 21) and the front right corner (See photo 22).

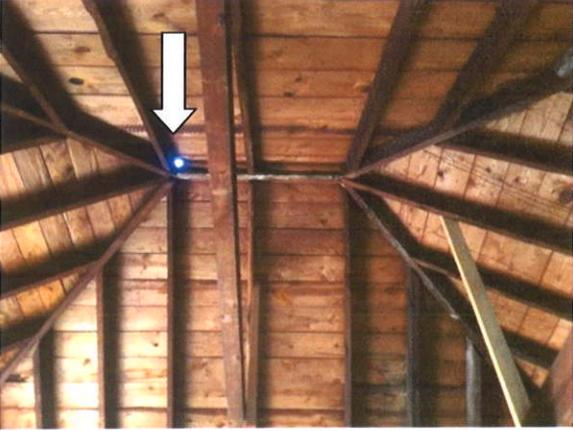
7. A hole was noted in the roof at the front of the ridge. (See photos 23 and 24)
8. A large hole was noted at the overhang at the right rear of the garage. It was reported by the owner that a tree grew through the roof and was previously removed. (See photo 25)

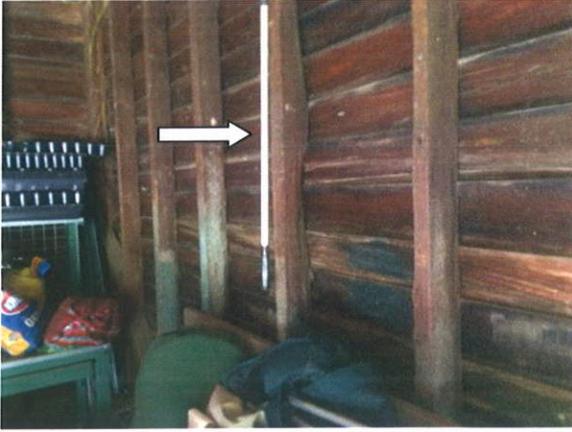
28

9. The window at the right side of the garage was noted to have multiple gaps around the frame. (See photos 26 and 27)
10. A warped 3x stud was noted at the rear area of the right wall. (See photo 28)
