D/DRC Case

601-603 Saluda Avenue

Wales Garden Architectural Conservation District

Summary
Structural Evaluation
of
601-603 Saluda Ave
Columbia, SC

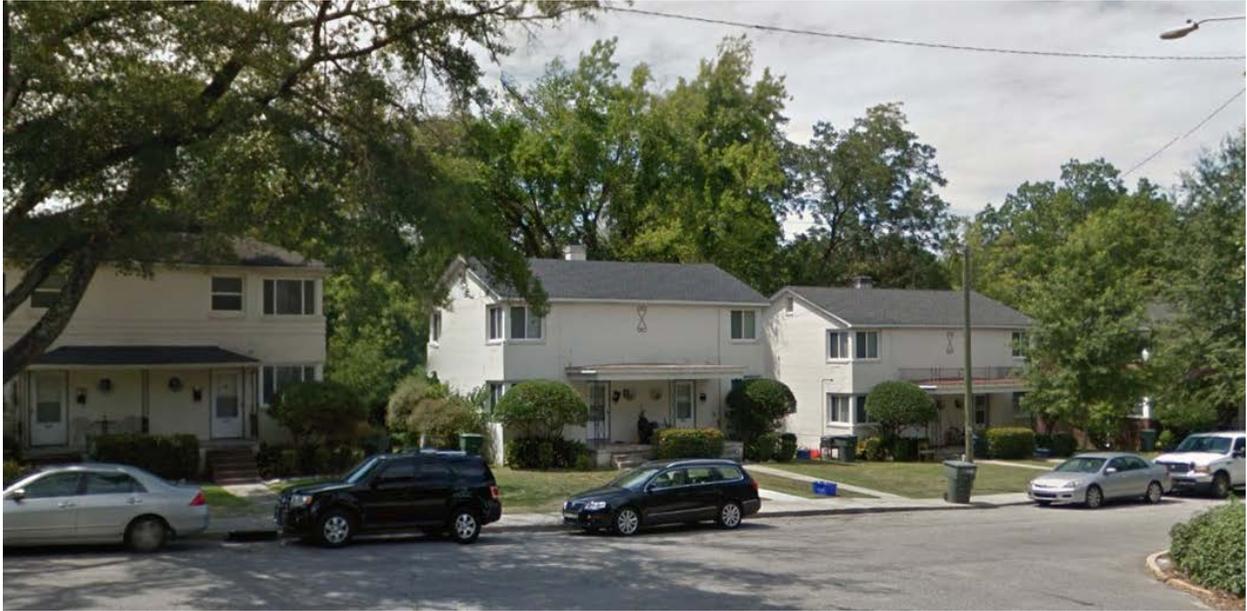
601-603 Saluda Avenue (center)

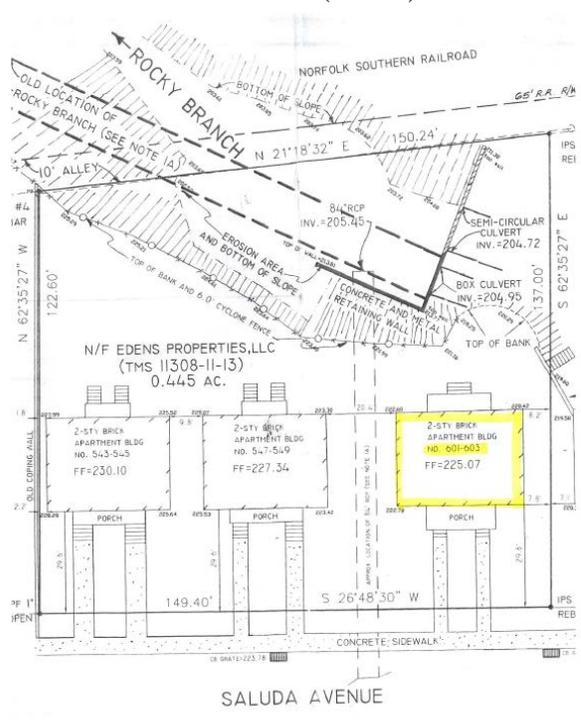
Location of duplex relative to drainage/repair area

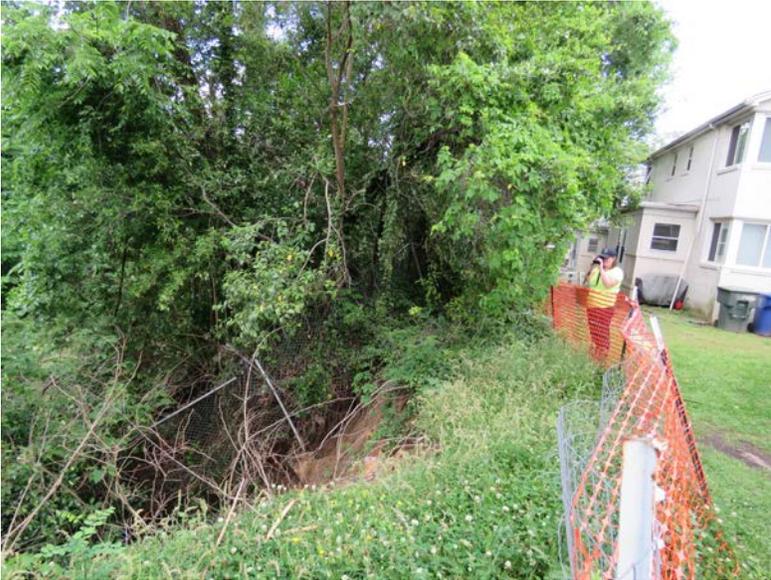
Erosion at the rear of the properties

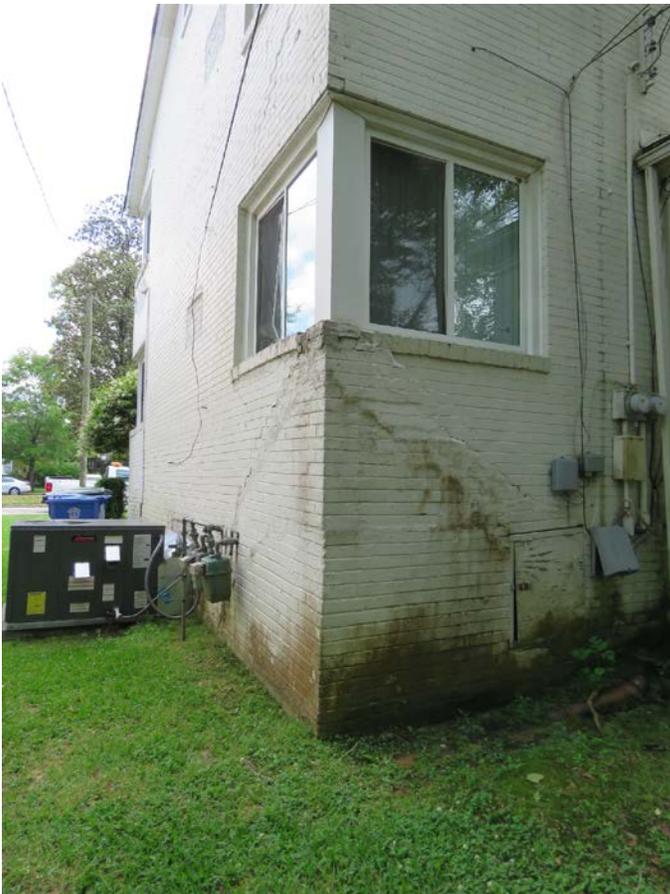
The conditions are summarized in the attached report but condense down to a) the building has settled; and b) there are issues either with the original construction or added pressure or overloading from the settling. The right rear of the building has severe settlement, bowing out about 2", and the engineering report recommends a new structural system, new masonry pier, and new brick veneer here. A series of helical piers are recommended to support all corners of the building, among other recommendations. Other stepping-stone cracks are visible on every elevation of the building. The interior of the building has been pretty well maintained, but the structural issues are becoming more evident inside. While some of these can be dismissed as minor, others are indications of the larger problems in the building.

Right rear of building (other issues addressed in attached report)

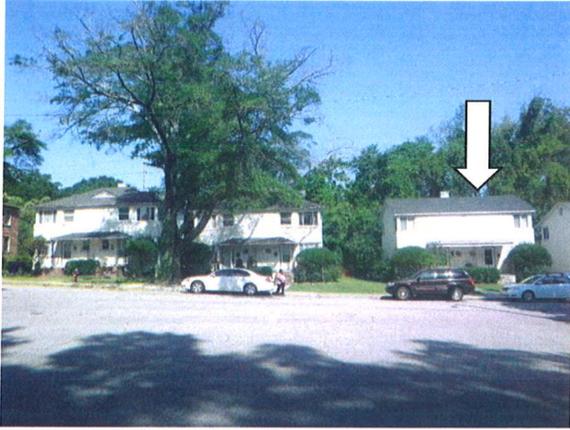
1

1. Upon arrival at the property, it was noted that the house is part of a series of three homes with similar construction/ architectural appearance (see photo 1).

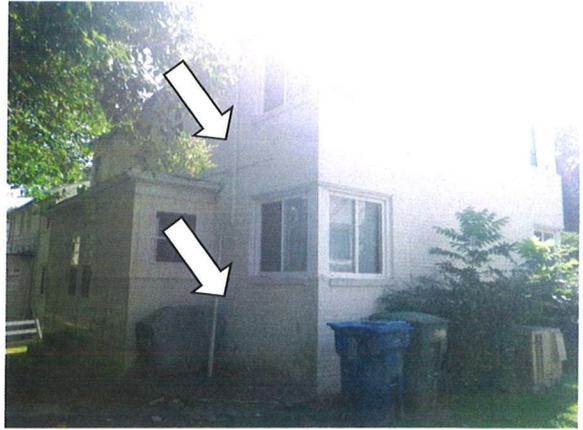
4

2. Multiple stair-step cracks were noted at approximately the front right corner of the house (see photos 2): stair-steps crack under each corner window on the right front side and a stair-step crack under the corner window of the front right window. Multiple stair-step cracks were noted at approximately the rear right corner of the house (see photos 3): stair-step cracks under each corner window on the right rear side as well as stair-step cracks under the corner window of the rear right window. The rear right corner of the house was noted to be leaning out significantly (about 2"). Stair-step cracks were noted at the rear left corner of the house under each of the corner windows (see photos 4). The crack openings at the right rear corner ranged from approximately 1" max gap to hairline in width. The crack openings at the remaining corners previously mentioned, ranged from approximately 1/2" max gap to hairline in width. None of these window openings appear to have a lintel to support the opening.

Considering the stair-step cracks noted at the front right, rear left, and rear right corners of the house, the noted sagging of the interior corners at the front right, rear left, and rear right corners of the house, the noted general sloping of the rear floors towards the rear of the house, and the orientation of the floor framing at the rear of the house, it is our opinion that the house has sustained severe localized settlement at the front right and rear corners of the house, as well as severe global settlement at the rear portion of the house. It is recommended to support the corners of the house as well as the rear portion of the house with either push-piles or helical piers as required. The quantity and spacing of the piers shall be determined by a licensed professional engineer or a competent foundation specialist. The steel lintels are recommended to be placed at all the corner widow openings along with placing a structural column at the corner of window to support the end of the lintels. In regards to the right rear corner of the house, due to the severity of the settlement/ leaning out of the veneer, and the apparent settlement/ leaning of the masonry pier at this location, it is recommended to remove the brick veneer and masonry pier, and provide new structural system as required (install new footing, pier, and brick veneer wall) at this location.

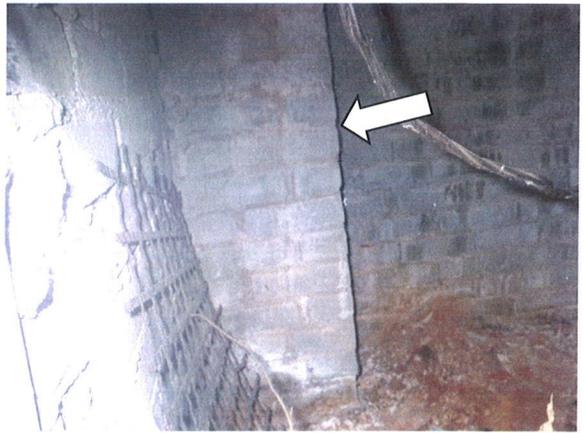
5

3. The brick masonry pier located within the crawlspace on the right rear side appeared to be leaning outwards (see photo 5).
4. From observation within the house, the front right corner of the house on the first and second-story, appeared to be dropped/sagging downwards (see photo 6 and 7).

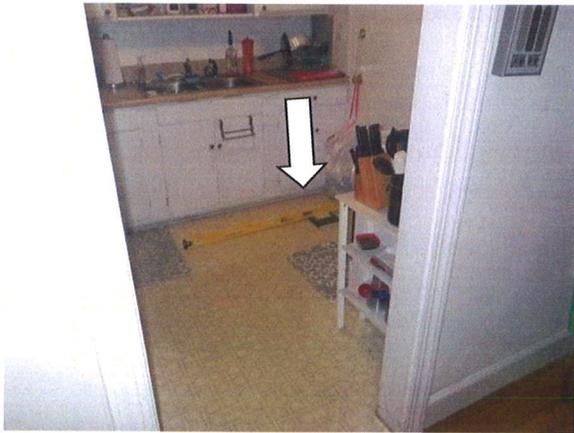
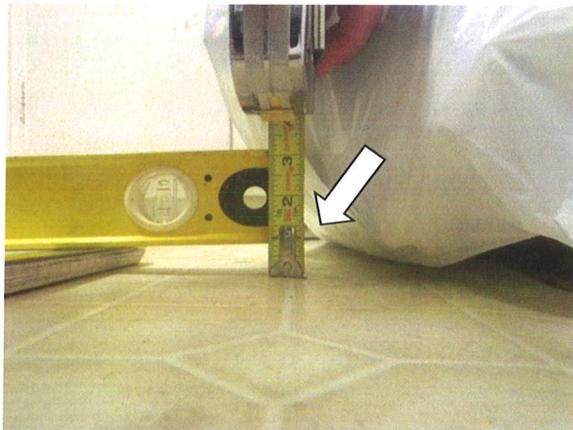
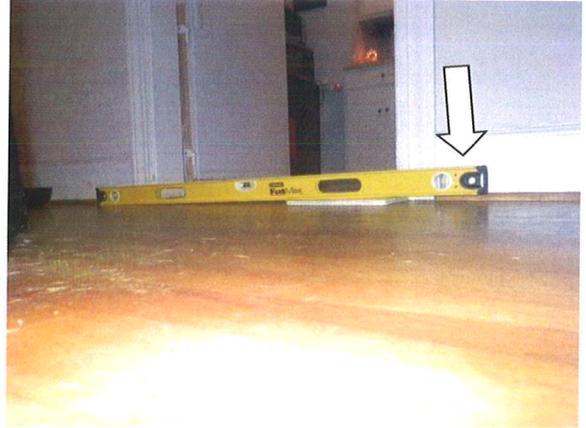
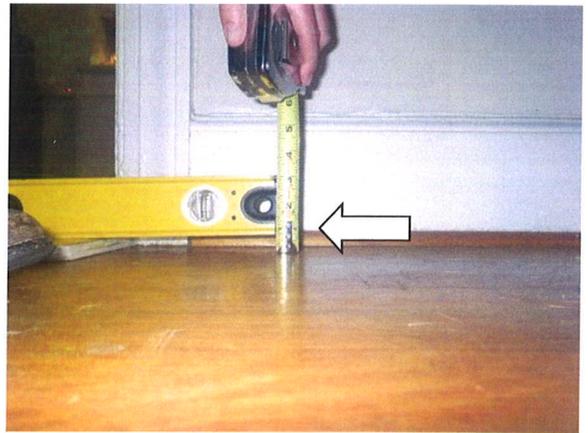
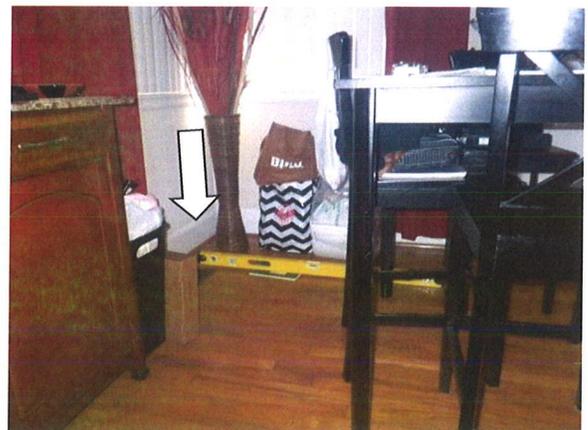
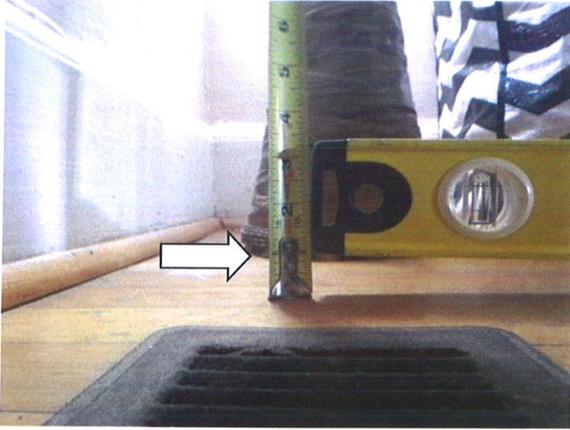
5. The floors at the kitchen and dining room were noted to be sloping significantly downward towards the back of the house. The sloping was measured to be approximately 3/4" to 1" over 4' level respectively (see photos 8-13). From observation within the crawlspace, it was noted that the first-story framing at the rear of the house spanned left to right (see photos 14 and 15). It was also noted that no visible sign of moisture was present within the crawlspace at the time of observation (see photo 16).

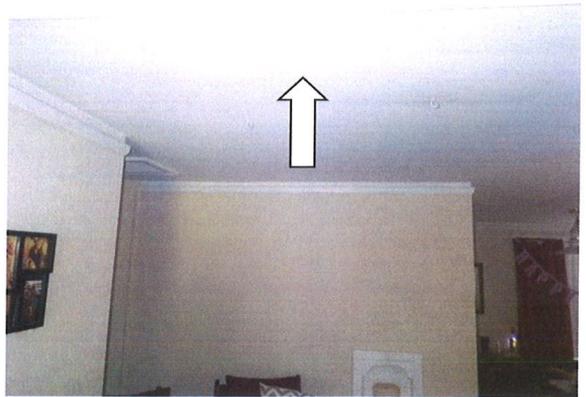
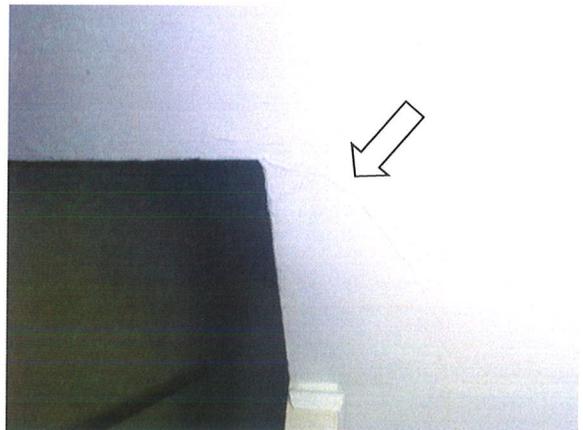
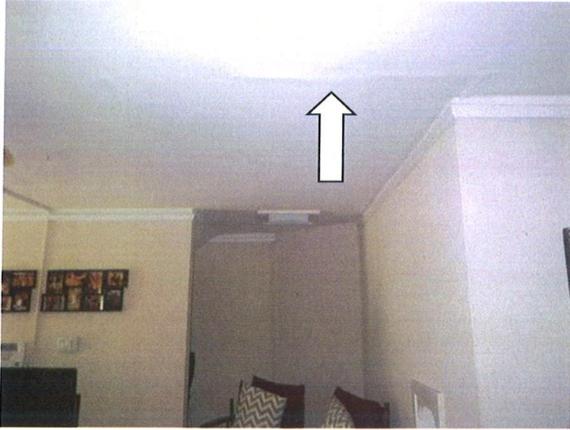
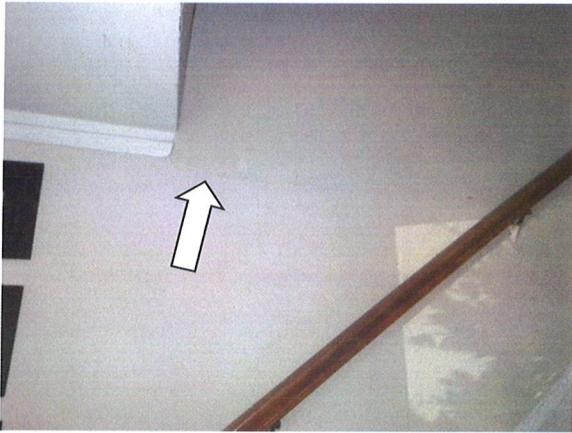
6. Cracks were noted generally throughout the house located on the walls and ceilings (see photos 17-20). These cracks measured approximately hairline in width. The cracks on the ceilings are mostly from left to right.

In regards to the general ceiling and wall cracks located throughout the house, it is our opinion that these cracks are likely caused by either settlement, deflection of structural members, or a combination of both. Due to the age of the house, these cracks throughout the house are likely not a structural concern at the present. It is recommended to properly repair the cracks with flexible tape, mud, and paint to match the existing colors as well as monitoring the condition for further reference.

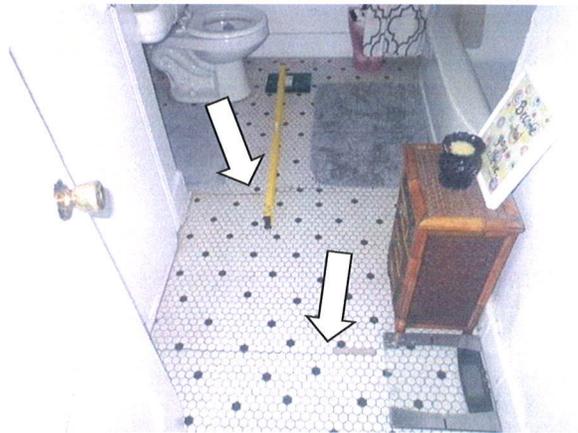
23

8. The floor of the second-story bathroom, located at approximately the rear end of the house, was noted to be sloped towards the rear of the house (see photo 23). The slope was measured to be approximately 5/8" over a 4' level (see photo 24). The floor of the bathroom was also noted to have a hump with a crack in the tile floor covering located at approximately the humped area (see photo 23). The floor was further noted to have dipped downwards at the front and also at the rear of the humped area (see photo 25). The dip measured approximately 3/16".

In regards to the tile cracks in the bathroom floors, based on the general sloping of the floors towards the rear of the house and the tub surround crack in Unit 603, it is most like due to settlement at the rear of the house. Providing additional helical piers at the rear of the house, as mentioned previously, will most likely adequately support the framing at this area. It is recommended to repaint/replace the tile flooring at these locations after the installation of the helical piers, and to monitor the condition for future reference.

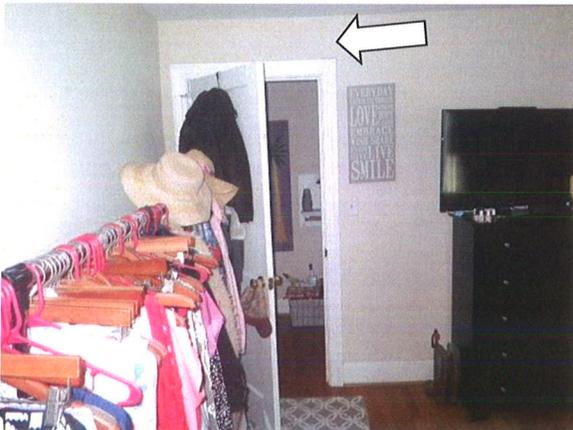
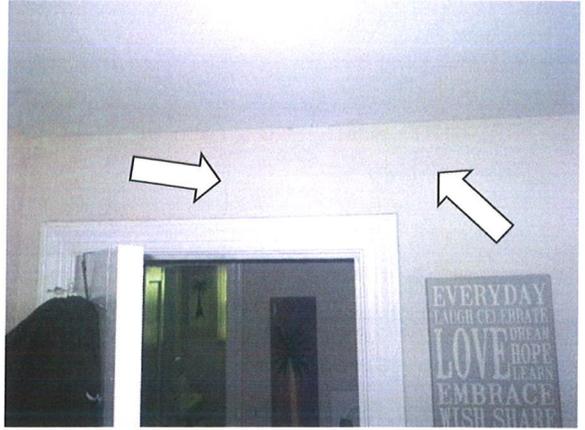
7. The jamb of the entry door to the front bedroom located on the second-story was noted to have settled with wall cracks located just on top of the door opening (see photos 21 and 22). The floor at this area was noted to be sloped towards the opening. The cracks noted above the doorway were noted to be approximately hairline in width. This is a common occurrence on all the door openings and window openings.

The noted door jamb settlement in the second-story bedroom of Unit 601 and 603 are most likely caused by inadequate structural support members beneath. The door jambs have concentrated load due to door opening and it often were placed between floor joists which were only supported by the floor sheathing. It is recommended to remove the first-story ceiling beneath this area and provide additional supporting framing members for the door jamb area or install a blocking in-between the floor joists to support the jamb. It is also recommended to properly repair the cracks with flexible tape, mud, and paint to match the existing colors as well as monitoring the condition for further reference.

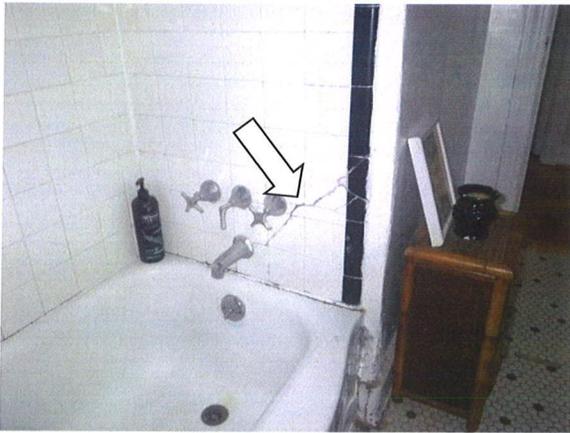
26

9. The tub surround located above the second-story bathroom tub was noted to have a diagonal crack (see photo 26).

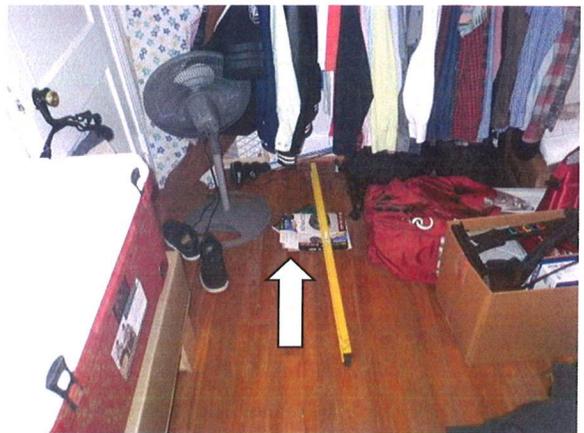
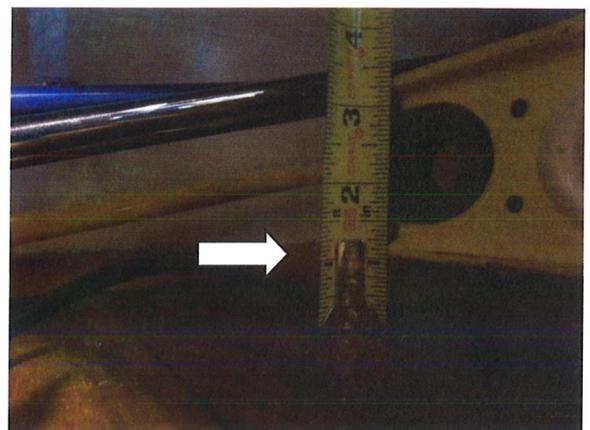
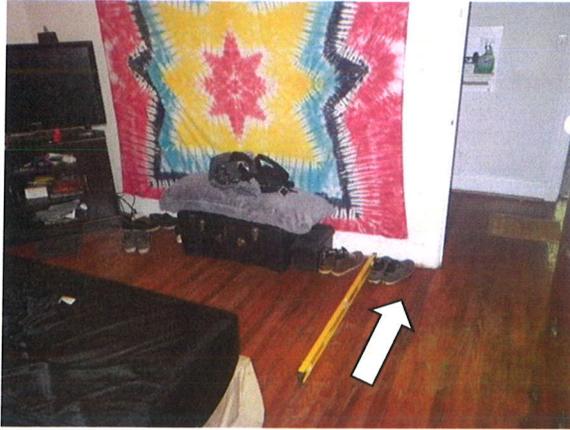
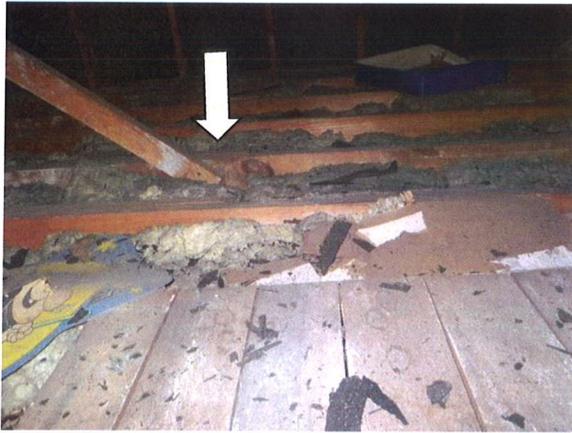
2. The floor of the rear second-story bedroom was noted to be sloped toward the front common wall located between the two second-story bedrooms (see photos 29 and 30). The sloping was noted to be approximately 1" over a 4' level. The floor of the front second-story bedroom was noted to be sloped toward the common wall located between the two second-story bedrooms (see photo 31). The sloping was noted to be approximately 1" over a 4' level. The floor of this bedroom was also noted to have a hump approximately 4' in front of the common wall of the bedrooms, which spanned across the room traveling left and right. From observation within the attic, it was noted that the second-story ceiling framing was bearing directly onto this common wall (see photo 32). Kickers supporting the roof load were also noted to be bearing onto this common wall.

As for the sloping of the bedroom floors as well as the humps in the second-story bedrooms located in Unit 601, considering that the roof and ceiling framing is supported by the common wall between the bedrooms, most likely the sloping of the floor and humps in the floor are due to severe deflection of the supporting member for the load bearing common wall. This supporting framing member is most likely not adequately sized and/or damaged to carry the imposed roof/ceiling load. It is recommended to open the ceiling of the first-story approximately beneath this area to verify the orientation of the joist surrounding this wall supporting beam. After verification of the orientation of the joist at this location, one of the two following repair recommendation can be used: If the floor joists are spanning parallel to the wall supporting beam, the repair option would be to provide an additional beam scabbed directly to the side of the existing beam. If the ceiling joists are spanning perpendicular to the wall supporting beam, the repair option would be to place an additional beam under the existing beam (spanning the full span of the room) supported with a column on each side. A pier in the crawl space is required to support the column.

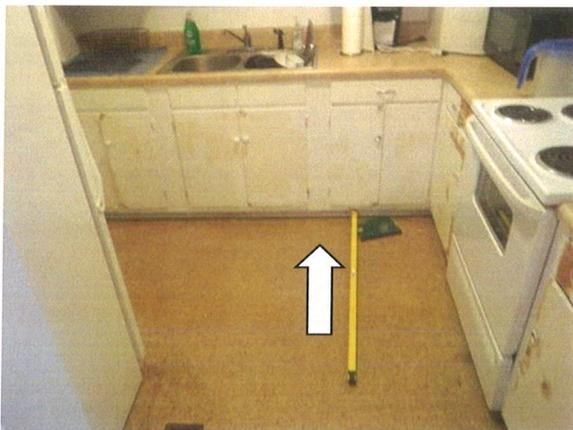
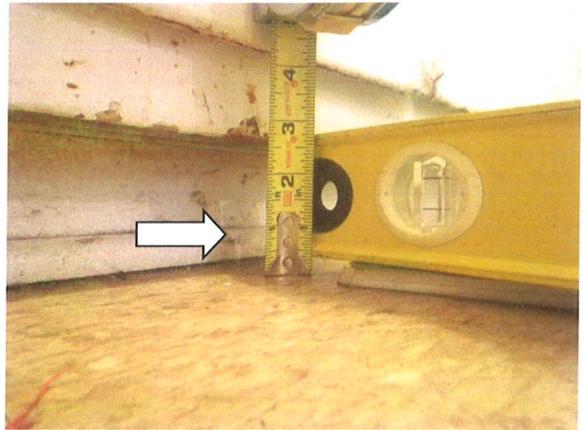
1. The kitchen floor located in the rear middle portion of the house was noted to be slopped towards what appears to be the common wall shared by the two apartments, and a load bearing wall (see photo 27 and 28). The slope of the floor was measured to be approximately 5/8" over 4' level.

In regards to the sloping of the floor in the kitchen of Unit 601 towards the apparent common/load bearing wall, the causation is likely the same as with the common/load bearing wall between the two bedrooms on the second-story mentioned previously (the supporting framing members beneath this wall have experienced severe deflection as well). Considering that the floor joists at this location span perpendicular to this wall's supporting beam, it is recommended to provide additional piers beneath this wall's supporting beam for added support. In regards to the separations noted at the ceiling to wall interfaces, please see repair recommendations mentioned previously for general cracks after the foundation repair is completed.

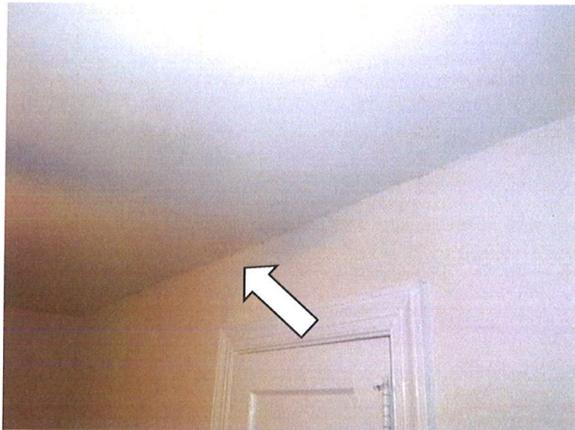
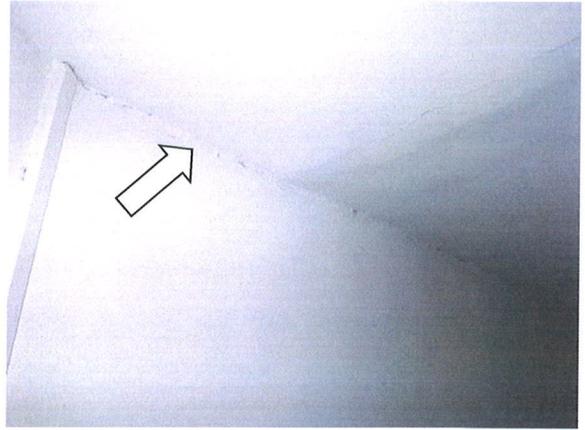
3. A separation was noted at the interface between the ceiling and the right wall of the second-story rear bedroom (see photo 33). This separation was noted to be approximately hairline to 1/16" in width. A separation was noted at the interface between the ceiling and the right wall of the staircase (see photo 34). This separation was noted to be approximately hairline to 1/16" in width. A separation was noted at the interface of the overhead walls of the staircase at the front left corner of the staircase (see photo 35). This separation was noted to be approximately hairline to 1/16" in width.
