DESIGN/DEVELOPMENT REVIEW COMMISSION
DESIGN REVIEW DISTRICT
HISTORIC AGENDA
EVALUATION SHEET
Case # 10

ADDRESS: 1721 Gadsden Street

NATURE OF REQUEST: Request Certificate of Design Approval for exterior changes and Preliminary Certification for the Bailey Bill

1721 Gadsden Street Renovation

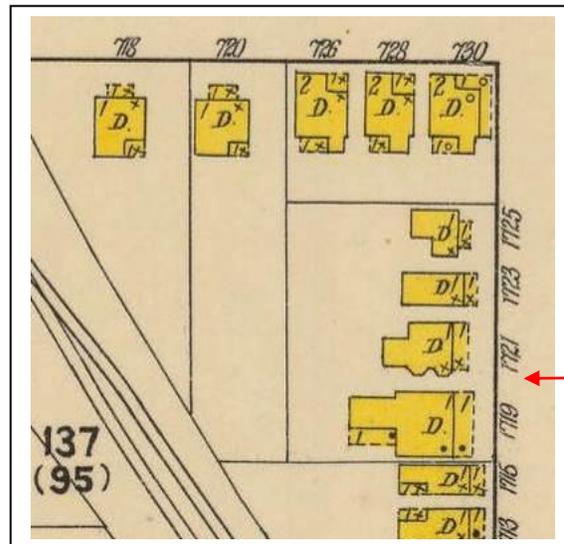
It appears that of the two bays on the left side, the front bay was likely a later addition; its foundation and windows are different from the rest of the house, however its appearance in a 1919 Sanborn map proves it was extant on the house almost 100 years ago. It is to be retained in this proposal.

The unique double bays on the south side show up in this 1919 Sanborn map.

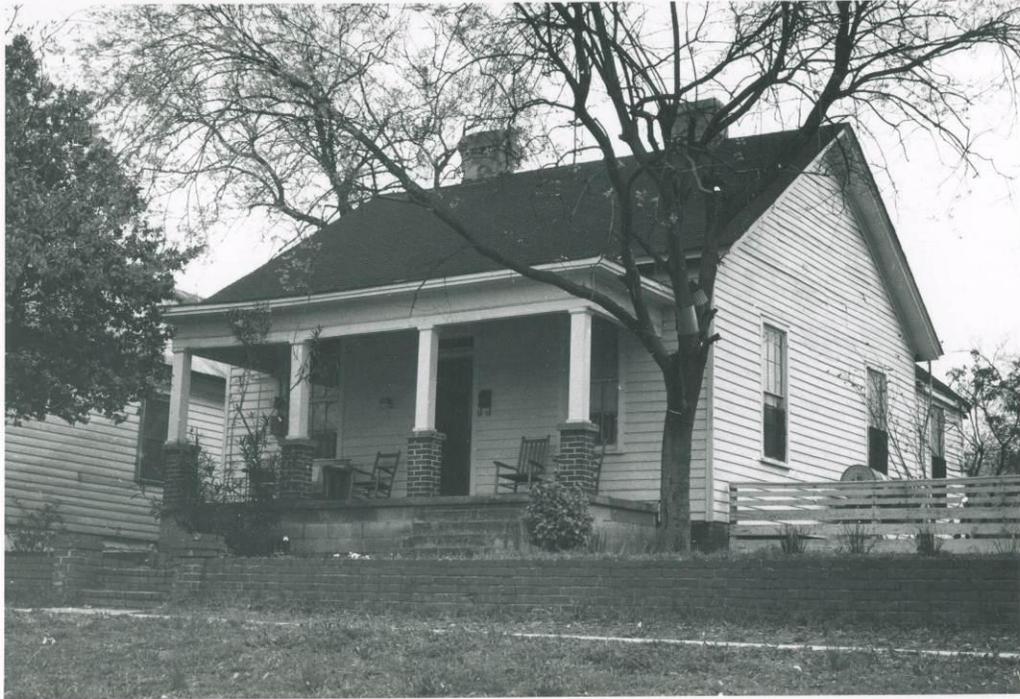
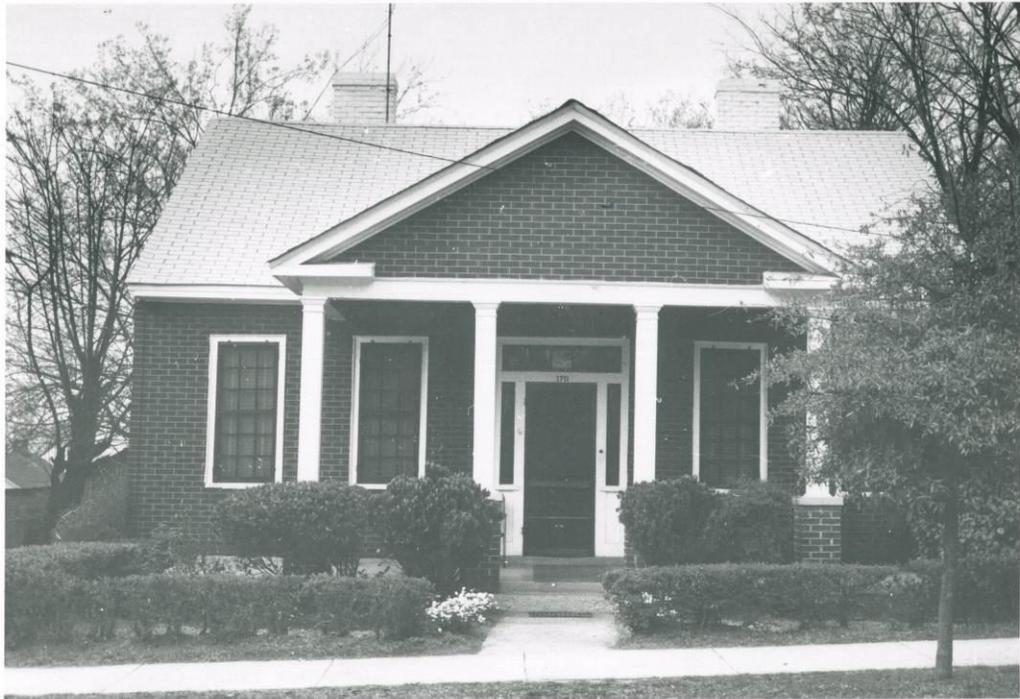
1964 images of similar cottages one block to the west on Wayne Street. Note the single windows and volume of wall space around them, as well as the transoms and sidelights

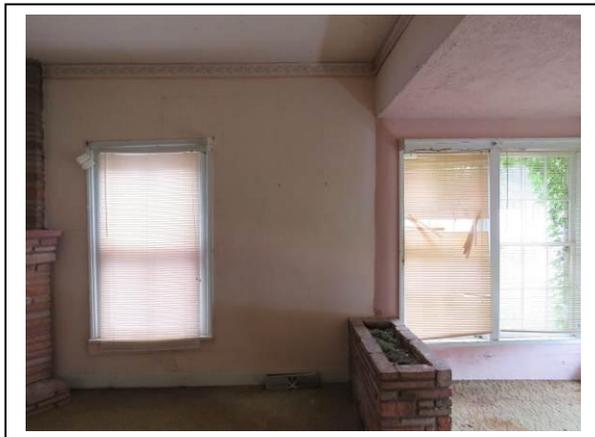
Planter where front wall stood

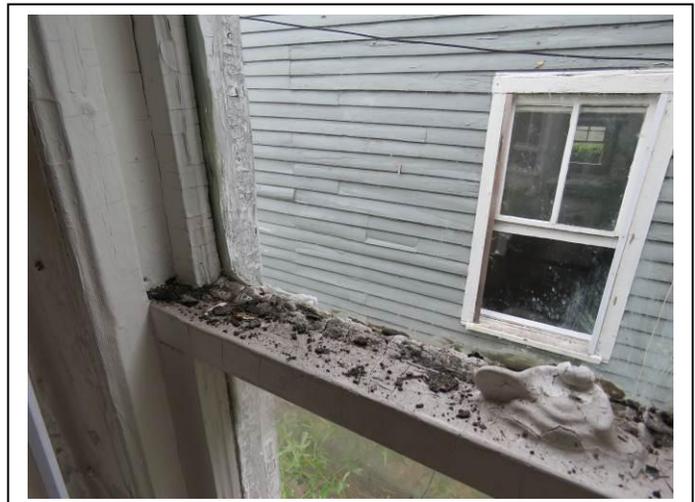
The windows have some deterioration in a number of locations, but most commonly along the bottom rail. These rails will likely need to be repaired or replaced on several sashes in order for them to be restored to working condition. Some missing, replaced, or severely deteriorated windows, after review by staff, could be replaced by wood windows to match the original configuration. Some replacement of non-original windows is indicated in the architect's renderings, and indicates at least one opening being opened back up to its original large size. Staff has also reviewed most of the windows and recommendations are included at the end of the evaluation. For the front bay, for instance, which has a shorter top sash than the bottom sash, only 3 of the 6 sashes found here appear to be historic, and they are in disrepair. For the front and side window, the only ones visible, the best of the sashes can be used or, if severely deteriorated, replaced with windows of the same unusual configuration, as this is part of the evidence that the bay was an addition.

Some issues evident with one window

- That the new porch columns be reduced to an 8 inch width maximum, but could be 6 inches
- That any original windows be repaired, but if beyond repair as determined by staff, that they be replaced in kind with wood windows matching the profiles of the original

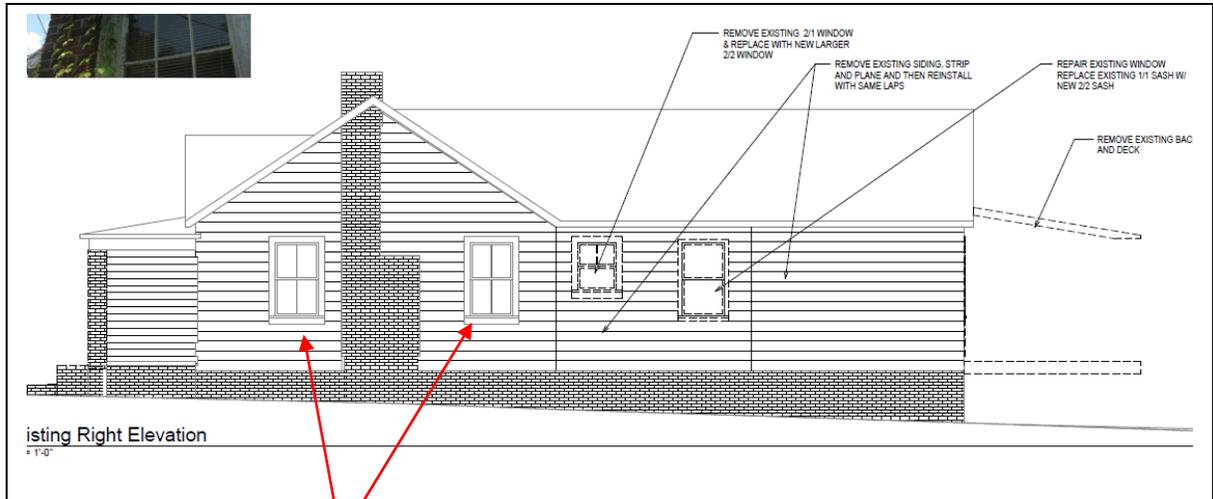
Only original windows left on this elevation

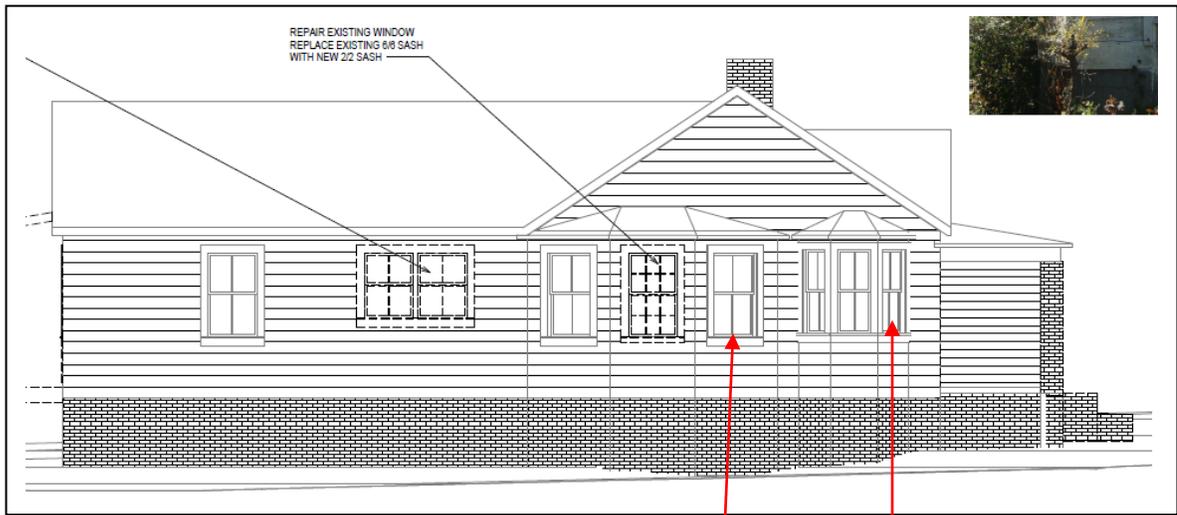
Only original windows left on this elevation

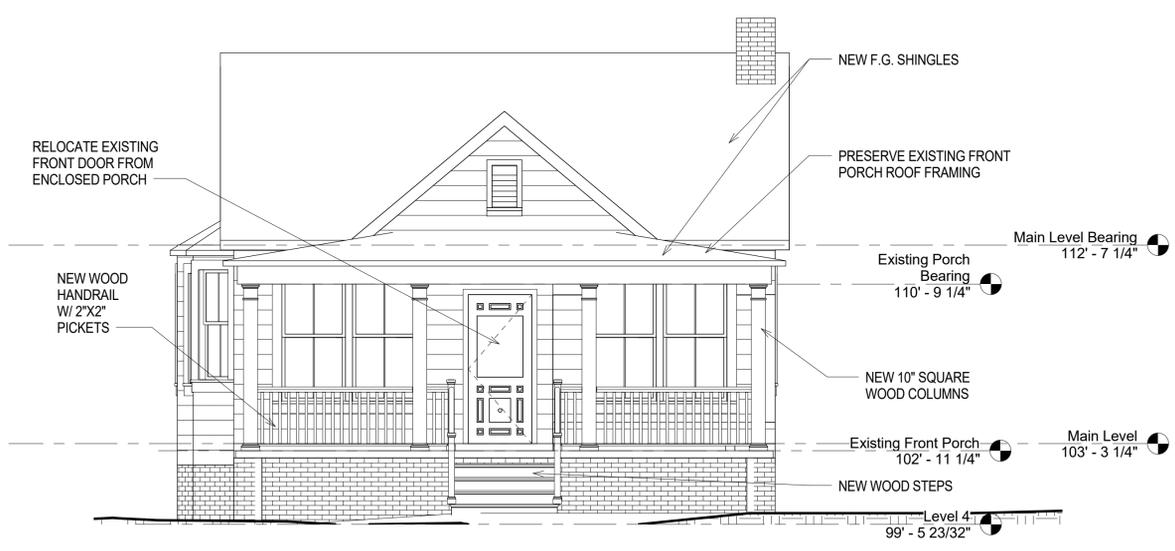
1 Proposed Front Elevation
A-2.01 1/4" = 1'-0"

What is proposed are two sets of paired windows flanking the central door. Unfortunately, they appear overly large individually in comparison to the original windows in the building, and are disproportionate to the façade and rhythm of openings on the side elevations when paired together. There are no other paired windows on the building. Other small historic homes similar to this in the area either had single windows or two single windows separated by wall space. Using the age and architectural cues from this building it would seem that the façade should have single windows symmetrically flanking a central door. Paired windows appear to be somewhat conjectural.

- That the proposed paired windows on the façade be reduced to single windows, compatible in size with the historic windows on the building
- That any additional transom or sidelight detail for the front door be worked out with staff

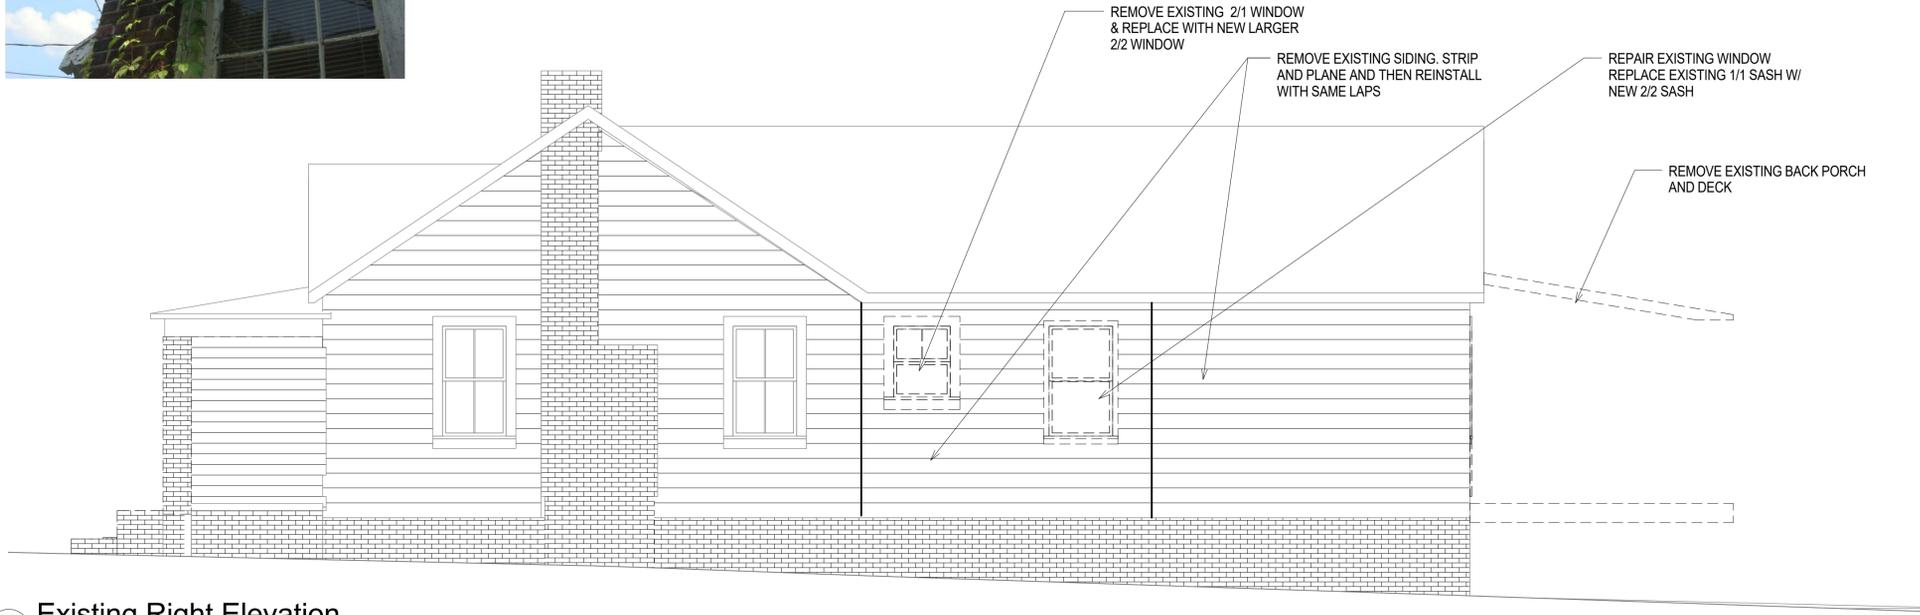
2 Existing Right Elevation
 A-2.02 1/4" = 1'-0"

The treatment for the wood siding as proposed is to remove all of the siding, strip the paint and plane where necessary to smooth out imperfections and then re-install the siding. This is a fairly aggressive process that has the potential to damage siding during removal so the

utmost care should be taken. Stripping may sufficient without the added step of planing. Fortunately the oldest siding on the front half of the building is exceptionally thick so it may handle the removal better than thinner wood siding. Given the massive paint failure occurring on the oldest siding it will require a great deal of effort to get back to a wood surface, but removal efforts should not damage the original siding. For the “newer” siding on the rear addition of the building, which may not have as extensive of paint failure, scraping and sanding in place may produce favorable results.

NOTE EXTENSIVE SIDING REPLACEMENT AND PATCHING HAS OCCURRED ON BACK HALF OF RIGHT SIDE
 REMOVE EXISTING SIDING, STRIP AND PLANE AND THEN REINSTALL WITH CONSISTENT LAPS

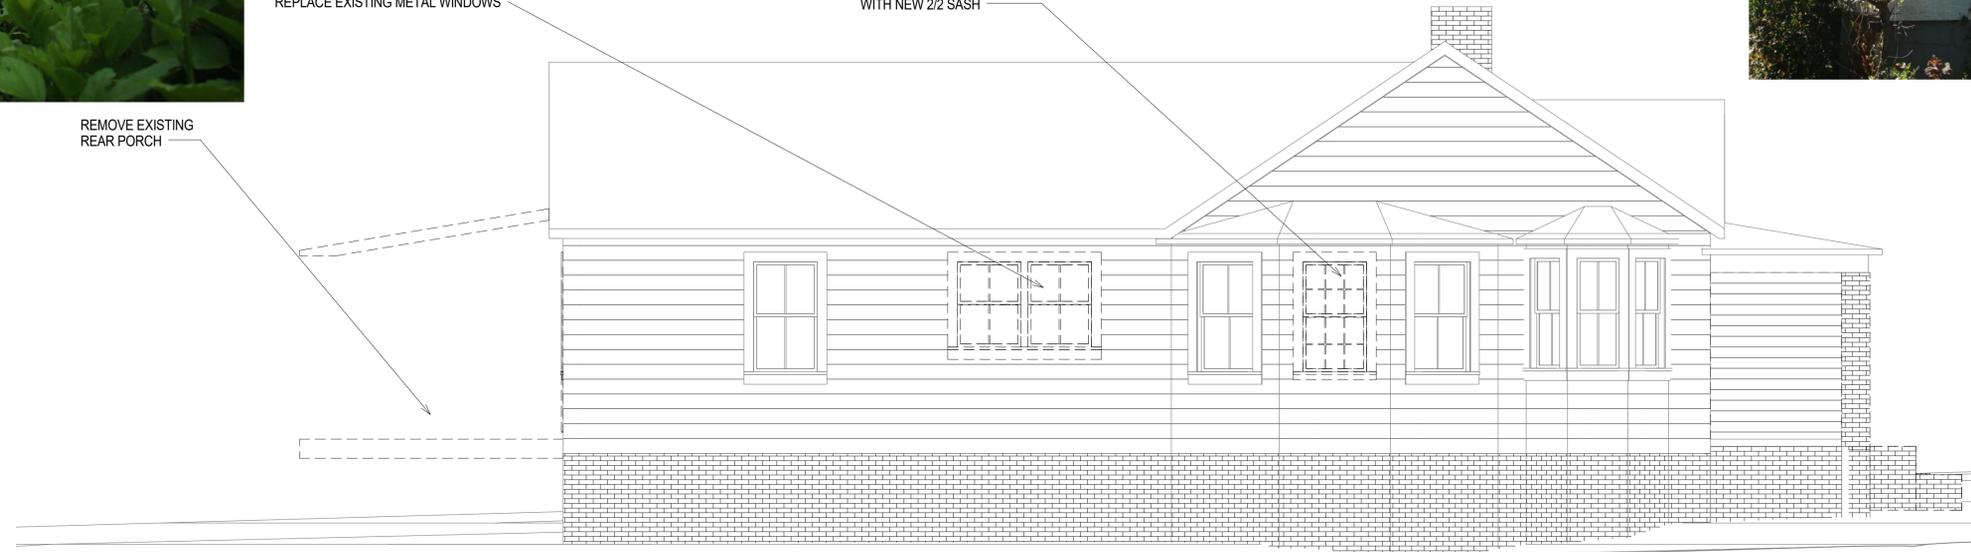
2 Existing Left Elevation
A-2.03 1/4" = 1'-0"

The only item that is proposed that suggests “removal” of a historic characteristic of the property is a note on the architectural plans to repair a part of the brick foundation and then to “paint or parge.” The unpainted brick foundation that is visible on the front and sides should remain as brick and not be covered with a mortar or stucco system, nor should it gain a coat of paint as that would not retain and preserve a historic feature. For the foundation under the front bay, which appears to be either parged or to have concrete block, brick veneer or paint added to this feature may help it to blend in to the rest of the building, but would also leave the original foundation intact.

REPAIR EXISTING WINDOW
REPLACE EXISTING 6/6 SASH
WITH NEW 2/2 SASH

REPLACE EXISTING METAL WINDOWS

REMOVE EXISTING SIDING, STRIP
AND PLANE AND THEN REINSTALL
WITH SAME LAPS

PATCH & REPAIR EXISTING
FOUNDATION WALL & PAINT OR PARGE

- That the foundation not gain any paint or parge coat on non-coated brick, but that the foundation under the non-original bay may be painted or veneered as it has already been painted
