D/DRC Case

142 Edisto Avenue

Wales Garden Architectural Conservation District

DESIGN/DEVELOPMENT REVIEW COMMISSION
DESIGN REVIEW DISTRICT
CONSENT AGENDA
EVALUATION SHEET
Case # 1

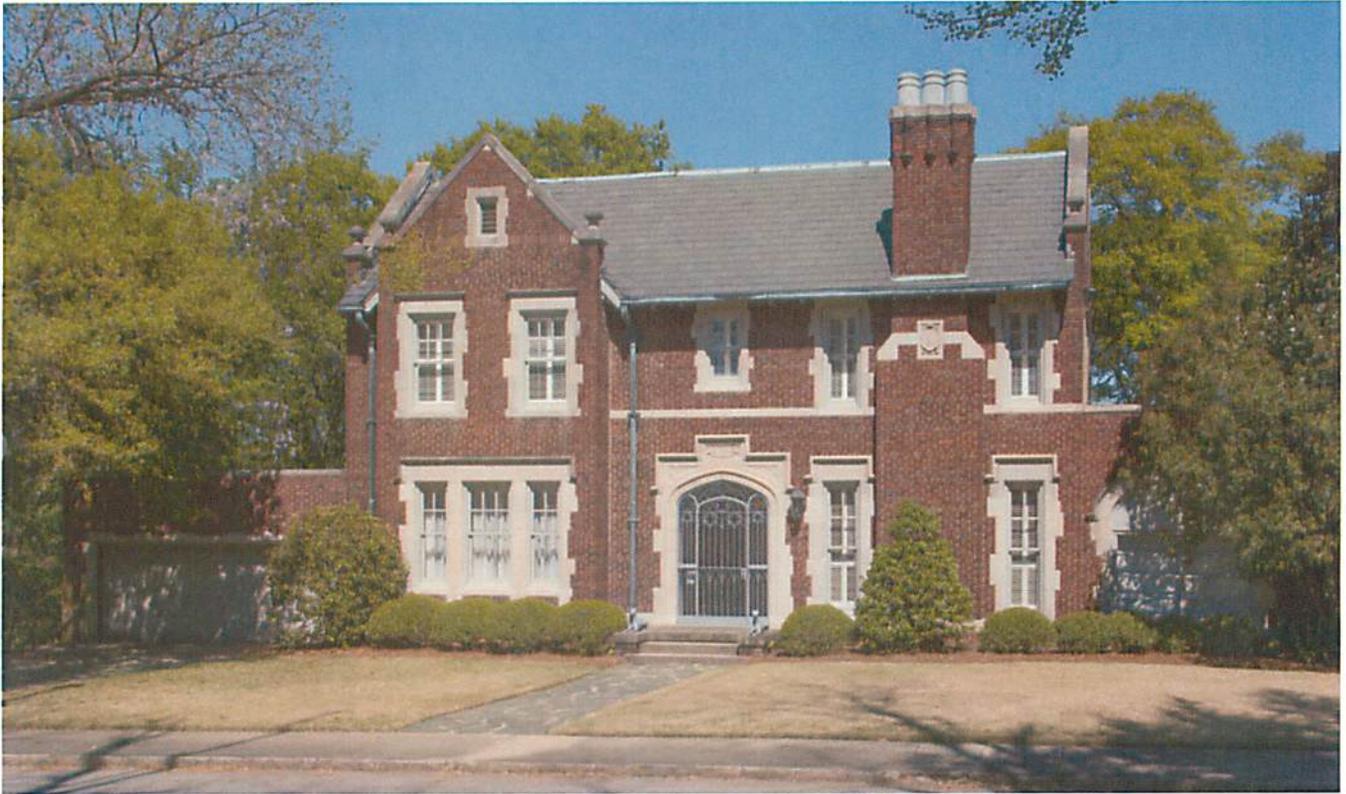
1. West facade

<p>Architectural feature: Exterior Façade of Home Approximate date of feature: 1927</p> <p>Goal is to stabilize and maintain all key features of this 1920's American Tudor Revival House designed by J. Carroll Johnson.</p> <p>Photographs 1-3</p>	<p>Describe work and impact on feature:</p> <p>Repair all rotten window sashes and sills, where necessary, replace with like kind materials.</p> <p>All wood surfaces will be sanded and painted to match existing trim color.</p> <p>Replaced louvered windows in sun room with architecturally appropriate windows, with mullions in keeping with other windows on front façade.</p> <p>Sand and repaint ornamental front gate.</p>
<p>Architectural feature: Roof Approximate date of feature: 1927</p> <p>Original slate roof leaks substantially and needs significant repair.</p> <p>Photographs 1, 2</p>	<p>Describe work and impact on feature:</p> <p>Palmetto State Roof has been contracted to do the following work:</p> <p>All Slate Being Removed, new 50-year+ underlayment being installed.</p> <p>New matching slate to replace broken or worn slate. Original slate to be used on most visible portions of roof.</p> <p>New 16 and 20-pound copper flashing being installed at all peaks and joints.</p> <p>20-year membrane roof installed on flat surfaces of main roof.</p> <p>Wood repairs to any water damaged sub-structures.</p>

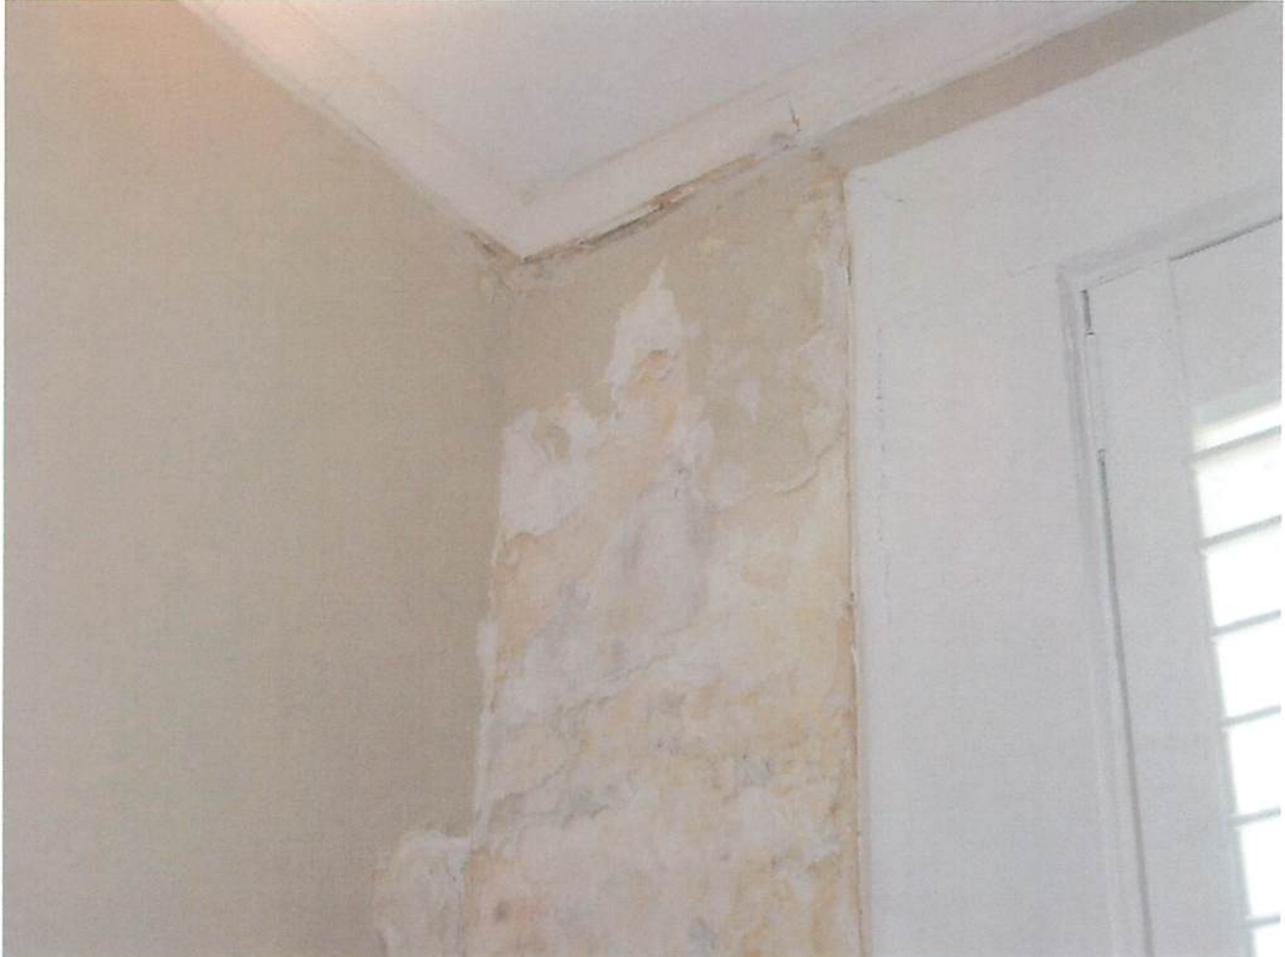
12. Example of Plaster Water Damage

<p>Photographs 4,5,6,7,8,9,11,12</p>	<p>New subfloor to repair underlying water damage and ceramic tile and/or natural stone floor in all bathrooms</p> <p>Wallpaper removal and subsequent plaster restoration</p> <p>Where water damage exists, dig out old plaster and replaster.</p> <p>Repair water and settling damaged plaster crown molding</p> <p>Sand and paint all trim, doors, and walls, repair hardware</p>
<p>Architectural feature: Master Bathroom, Guest Bath, Powder Room, Laundry Room, and Kitchen Approximate date of feature: 1927</p> <p>All bathrooms, kitchen, and laundry room have not seen significant improvement since the 1970's, some since the 1950's.</p> <p>Photographs 8 and 10</p>	<p>Replace all fixtures, plumbing, and appliances. Upgrade electrical for safety, to support modern appliances, add adequate grounding. All new flooring, cabinetry, and decorative finishes.</p>
