D/DRC Case

923-925 Gervais Street

DESIGN/DEVELOPMENT REVIEW COMMISSION
DESIGN REVIEW DISTRICT
CONSENT AGENDA
EVALUATION SHEET
Case # 3

NATURE OF REQUEST: Request for a Certificate of Design Approval for exterior changes and for preliminary certification for the Bailey Bill

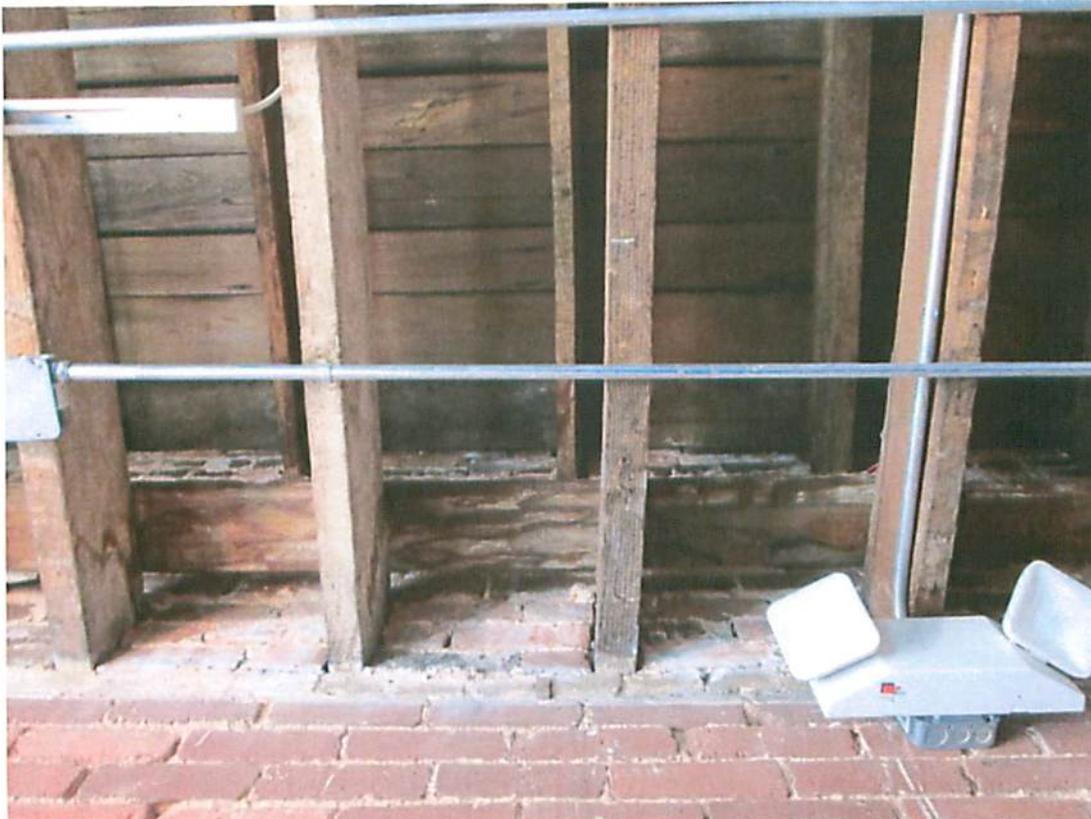
1. Ceiling/Roof Framing

<p>Architectural feature <u>Roof/Hazardous Material Abatement</u> Approximate date of feature <u>Unknown</u> Describe feature and its condition Visible water damage on roof/ceiling joists. Asbestos present.</p> <p>Photograph No. <u>1</u> Drawing No. _____</p>	<p>Describe work and impact on feature Replace roof to make watertight, as well as remove asbestos.</p>
<p>Architectural feature <u>Skylights</u> Approximate date of feature <u>Unknown</u> Describe feature and its condition Existing, but not original, skylights have become damaged, cause glare and have been covered from inside.</p> <p>Photograph No. <u>2-3</u> Drawing No. _____</p>	<p>Describe work and impact on feature Remove or repair damaged skylights with replaced roof. Replace all water damaged material.</p>
<p>Architectural feature <u>HVAC</u> Approximate date of feature <u>Unknown</u> Describe feature and its condition Existing HVAC units outdated.</p> <p>Photograph No. _____ Drawing No. _____</p>	<p>Describe work and impact on feature Rework existing HVAC distribution to meet future tenant requirements and to meet IMC and IECC requirements.</p>

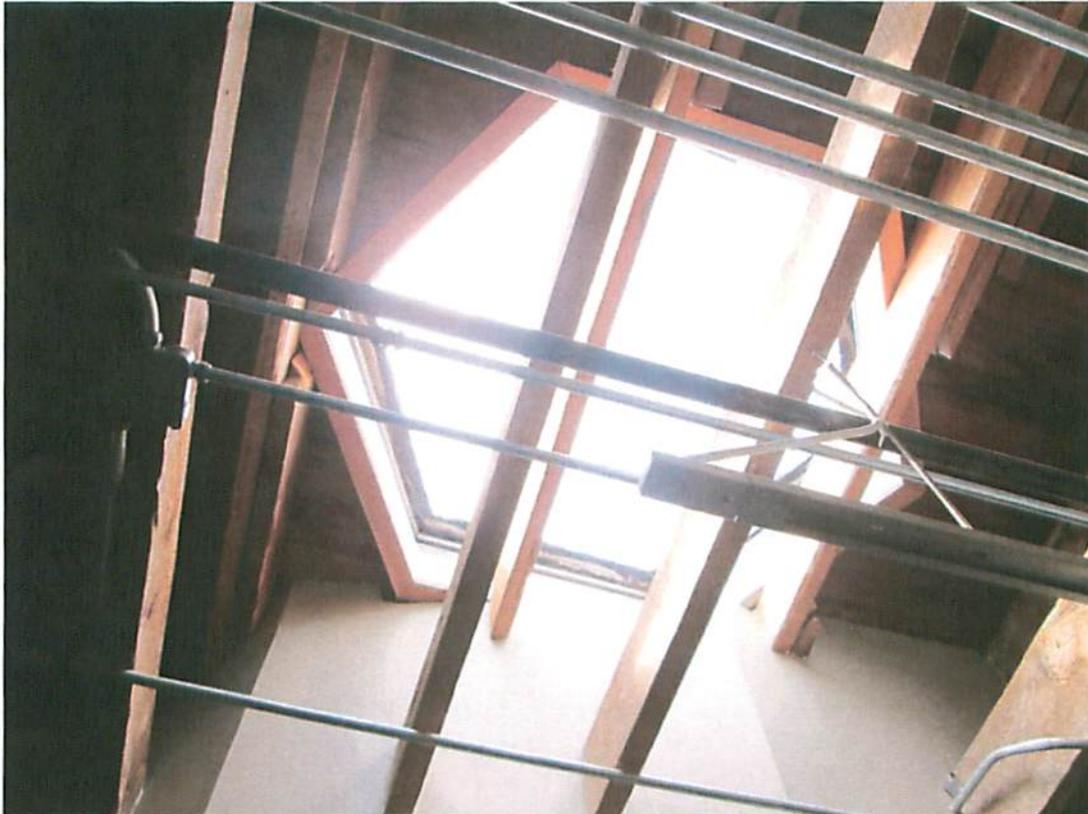
2. Skylight

Most of the proposed work would follow more of a maintenance and rehabilitation scope with an emphasis on repair instead of wholesale replacement of historic materials. The proposal includes roof replacement, repairing or removing the non-historic skylights, and updating the HVAC and electrical systems. The applicant also proposes to replace the second story windows, which are not original to the structure and will work with staff on the appropriate configuration. The applicant estimates that qualified rehabilitation expenses for this project will meet or exceed the 20% minimum investment threshold needed to make the project eligible.

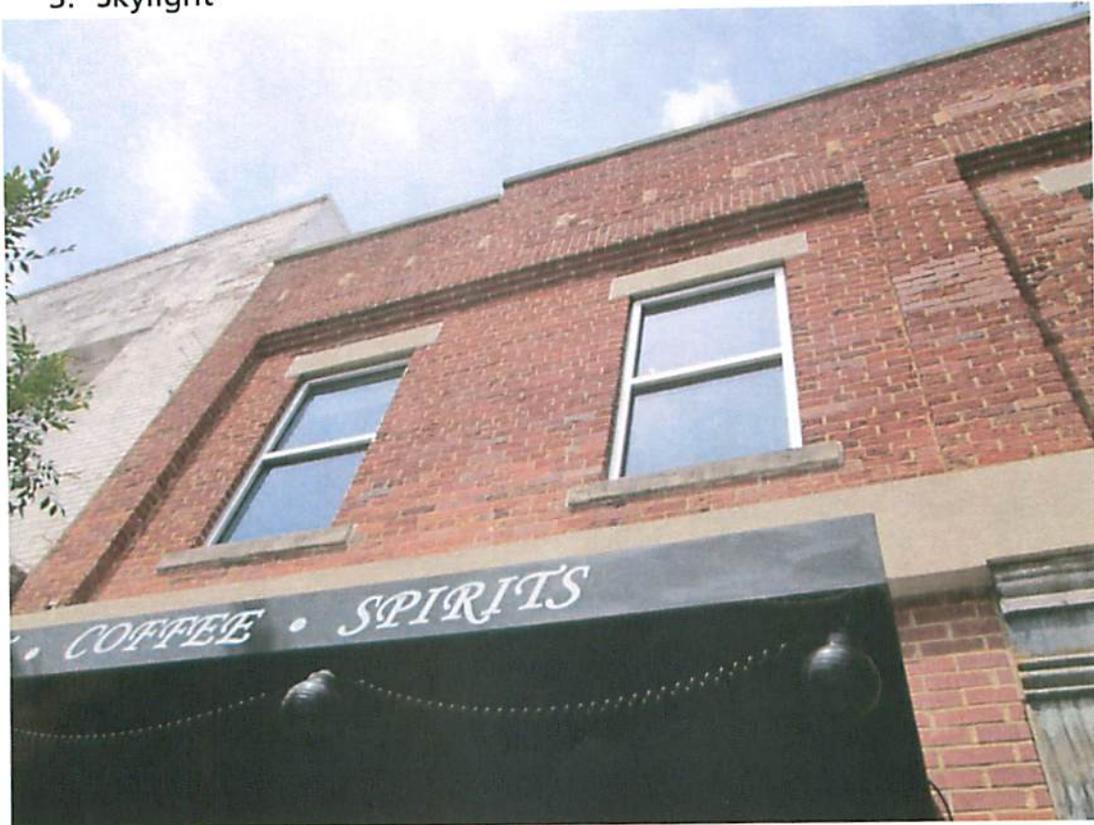
4. Second Floor Windows

<p>Architectural feature <u>Second floor windows</u> Approximate date of feature <u>1980s/90s</u> Describe feature and its condition Existing second floor windows not original to building, tinted, restricting natural sunlight into space.</p> <p>Photograph No. <u>4</u> Drawing No. _____</p>	<p>Describe work and impact on feature Replacing with DDRC-approved window units, to match IECC requirements.</p>

- Staff will continue to work with the applicant to find appropriate windows for the second floor of the building.
- All details deferred to staff.

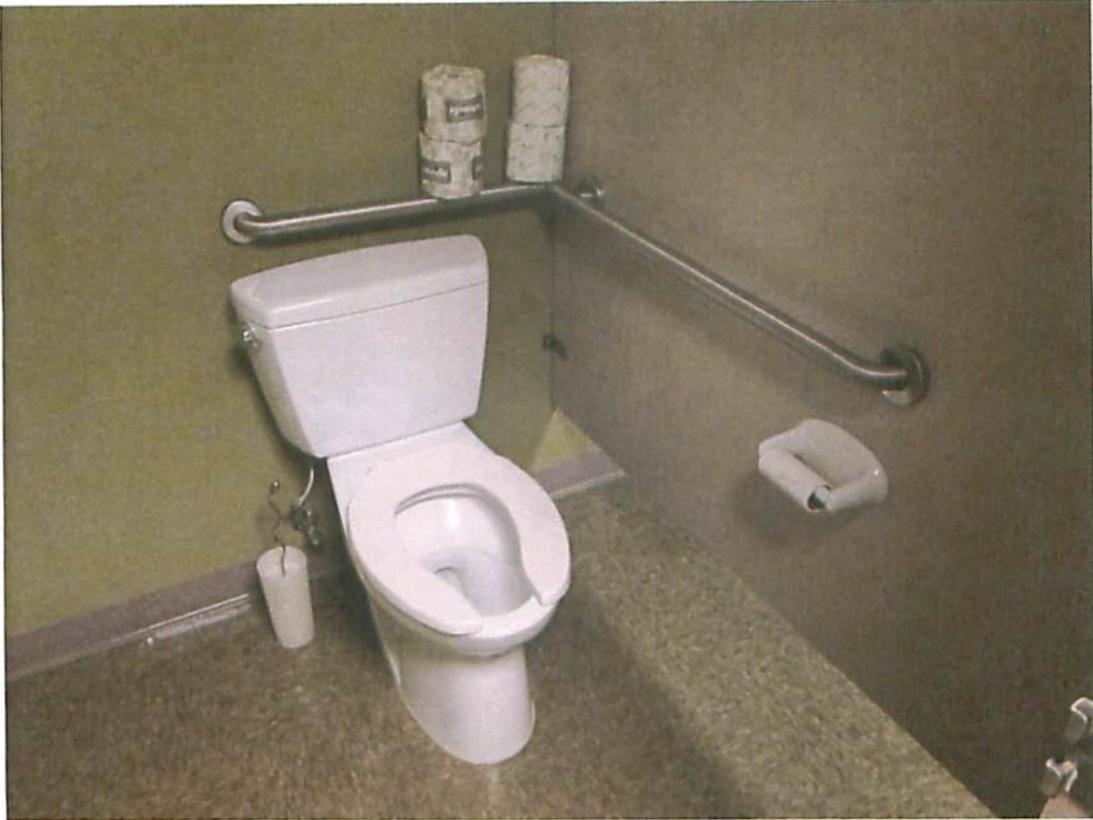
5. Restroom

Architectural feature <u>Accessibility</u> Approximate date of feature _____ Describe feature and its condition Existing second floor plumbing facilities do not meet current accessibility requirements. Floor steps with no accessible routes. Photograph No. <u>5</u> Drawing No. _____	Describe work and impact on feature Pending tenant requirements, plumbing layout and floor elevations to be modified and renovated/replaced to meet current IBC/ANSI/ADA requirements. Accessible steps/stairs to be provided for floor elevation changes.
Architectural feature <u>General</u> Approximate date of feature _____ Describe feature and its condition Design fees associated with renovations. Photograph No. _____ Drawing No. _____	Describe work and impact on feature Architectural and engineering fees.
Architectural feature <u>Demolition</u> Approximate date of feature _____ Describe feature and its condition Interior elements unoriginal to building removed for future tenants. Photograph No. _____ Drawing No. _____	Describe work and impact on feature General demolition of non-original items from previous office tenants.

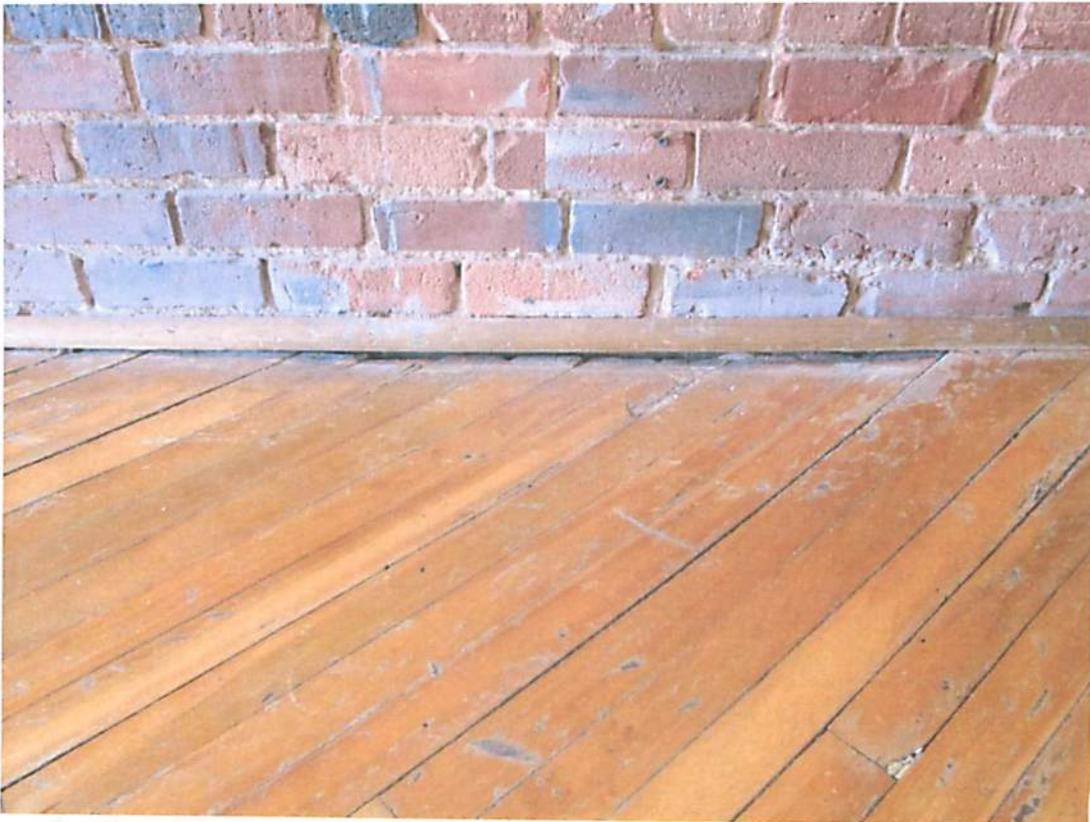
6. Flooring

Architectural feature <u>Flooring</u> Approximate date of feature <u>Unknown</u> Describe feature and its condition Existing flooring appears uneven, damaged. Photograph No. <u>6</u> Drawing No. _____	Describe work and impact on feature Repair existing, original flooring.
