D/DRC Case

DESIGN/DEVELOPMENT REVIEW COMMISSION
DESIGN REVIEW DISTRICT
CONSENT AGENDA
EVALUATION SHEET
Case # 5

ADDRESS: 1504-1508 Main Street, Kress Building

NATURE OF REQUEST: Request for Certificate of Design Approval for exterior changes and for preliminary certification for the Bailey Bill

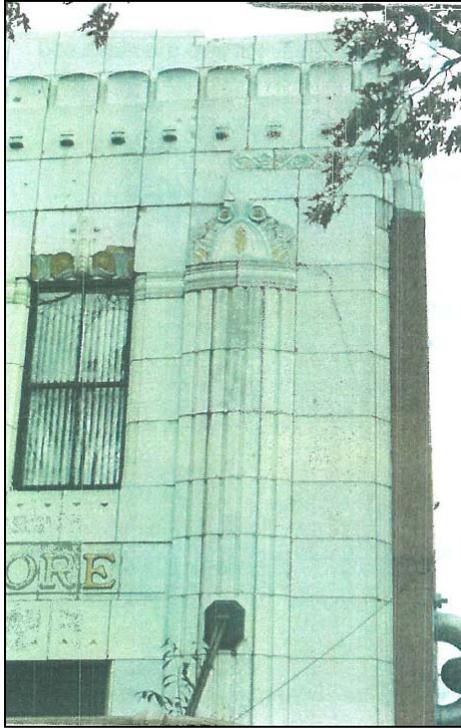
Terracotta façade details (images provided by applicant)

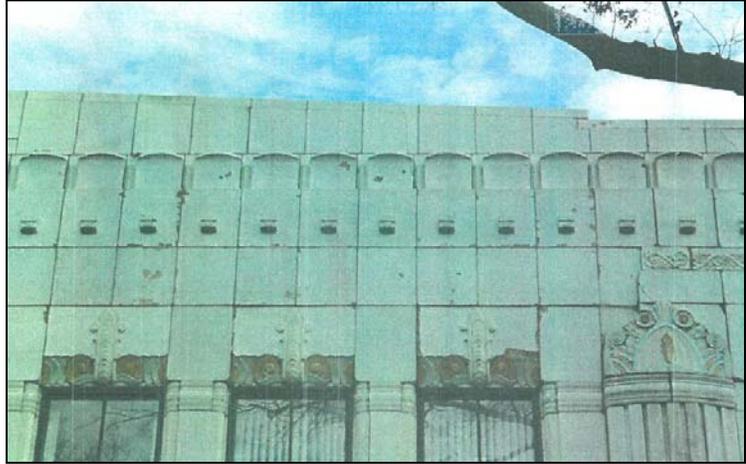
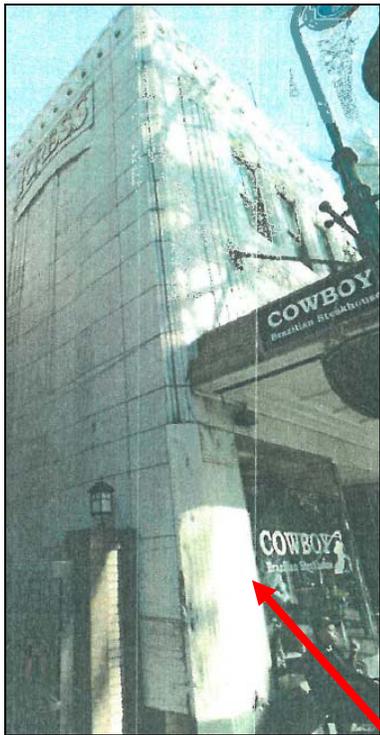
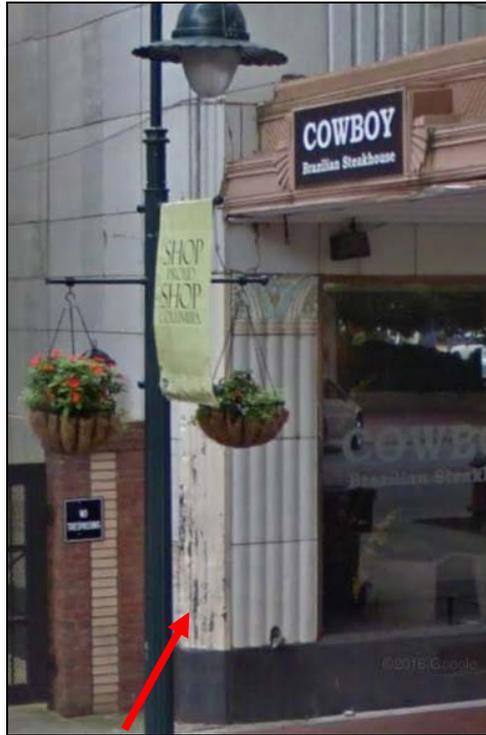
Northwest corner with metal replacement

<p>Architectural feature <u>NW CORNER DAMAGED TERRA COTTA</u> Approximate date of feature <u>1935</u> Describe feature and its condition <u>SOMETIME OVER THE LAST 50 YEARS A VEHICLE PULLING INTO THE FORMER ALLEY THAT RAN ALONG THE NORTH WALL DESTROYED THE LOWER TERRA COTTA CORNER PIECE. IT WAS REPLACED BY A FORMED METAL CORNER PIECE WHICH ALSO HAS UNDERGONE SUBSEQUENT DAMAGE OVER THE YEARS</u> Photograph No. <u>#4 & #8 IN WORK PLAN</u> Drawing No. <u></u></p>	<p>Describe work and impact on feature <u>WE WILL FABRICATE AND INSTALL A CORNER CLOSURE DETAIL TO REPLICATE THE ORIGINAL CORNER LOOK AND FINISH LOCATED AT OUTSIDE CORNER ON STREET SIDE WHERE NORTH WALL MEETS WEST WALL. WE WILL USE DETAILS FROM SOUTH WALL/WEST WALL CORNER AS A MODEL.</u> <u>⊗ SAMPLE OF FINISH WILL BE PROVIDED FOR CITY PERSONNEL APPROVAL BEFORE INSTALLATION.</u></p>
<p>Architectural feature <u>FLOORS</u> Approximate date of feature <u>1935</u> Describe feature and its condition <u>TERRAZZO FLOOR ON ENTIRE 1ST FLOOR LOBBY ARE IN EXCELLENT ORIGINAL CONDITION</u> <u>THE SECOND FLOOR LOBBY ORIGINALLY COVERED WITH TILE AND THEN CARPETED WHEN APTS PUT IN IN 2000 WILL BE REMOVED TO VANTILITE</u> Photograph No. <u>NA</u> Drawing No. <u>NA</u></p>	<p>Describe work and impact on feature <u>WILL BE CLEANED AND POLISHED TO RESTORE SHINE & LUSTER</u> <u>NEW LONG LASTING AND MORE DURABLE VINYL TILE ADDED</u></p>

The terracotta corner piece that will be added to the northwest corner will be a replica of the terracotta element that was in place originally. This replica will be fabricated to match the terracotta corner still intact on the southwest corner of the building. The replacement piece should be reviewed by staff prior to installation.

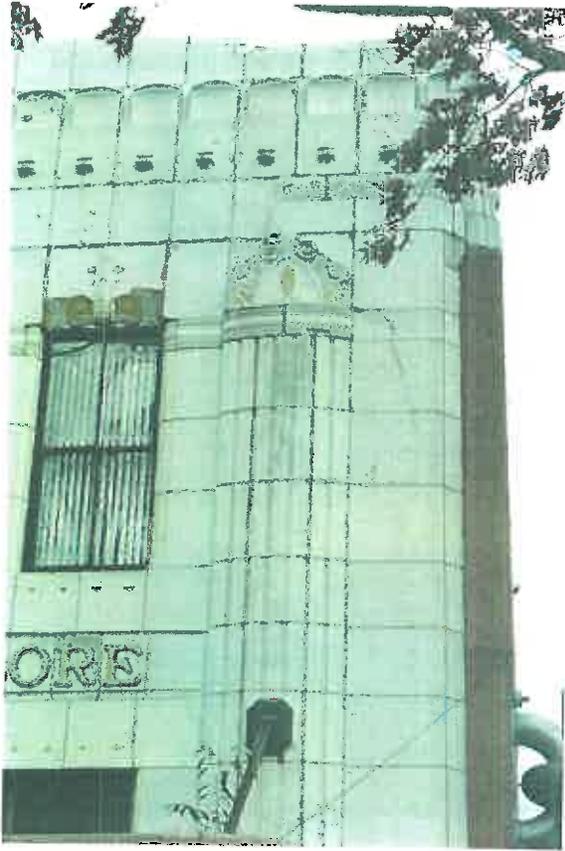
Image XI

Detail of cornice and of second-story façade. Note damage to terra cotta and organic growth in the form of a small tree emerging at the parapet (seen at top middle section of picture).

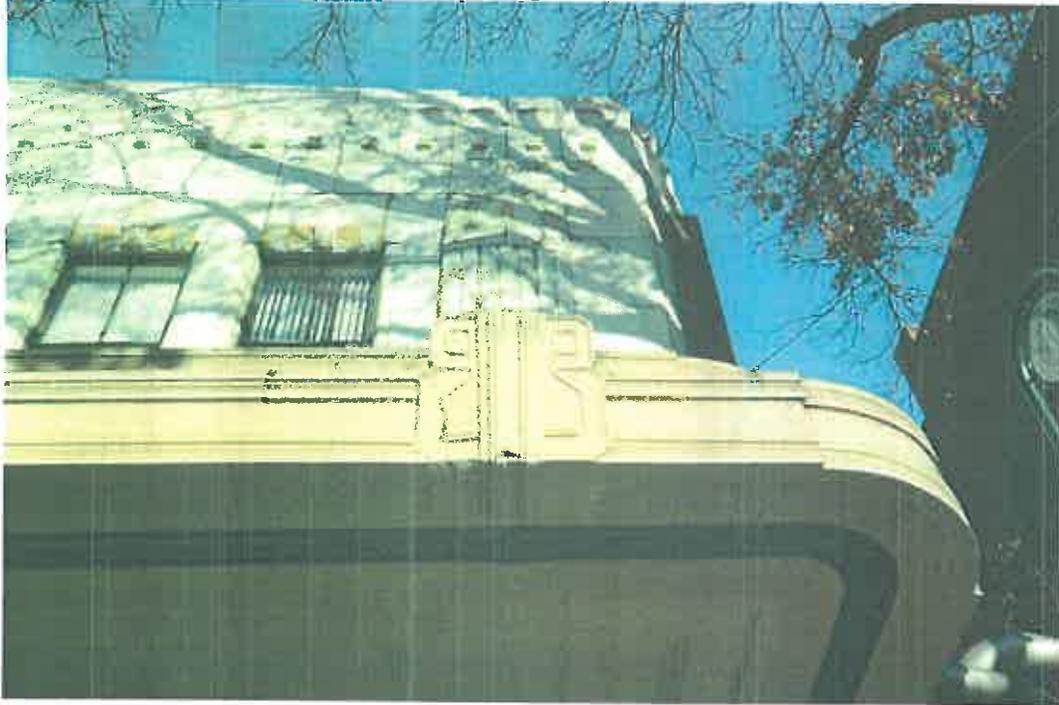
Image XIII

Detail of south corner of painted copper marquee showing Art Deco-style fluting. Note damage to and staining on finish.

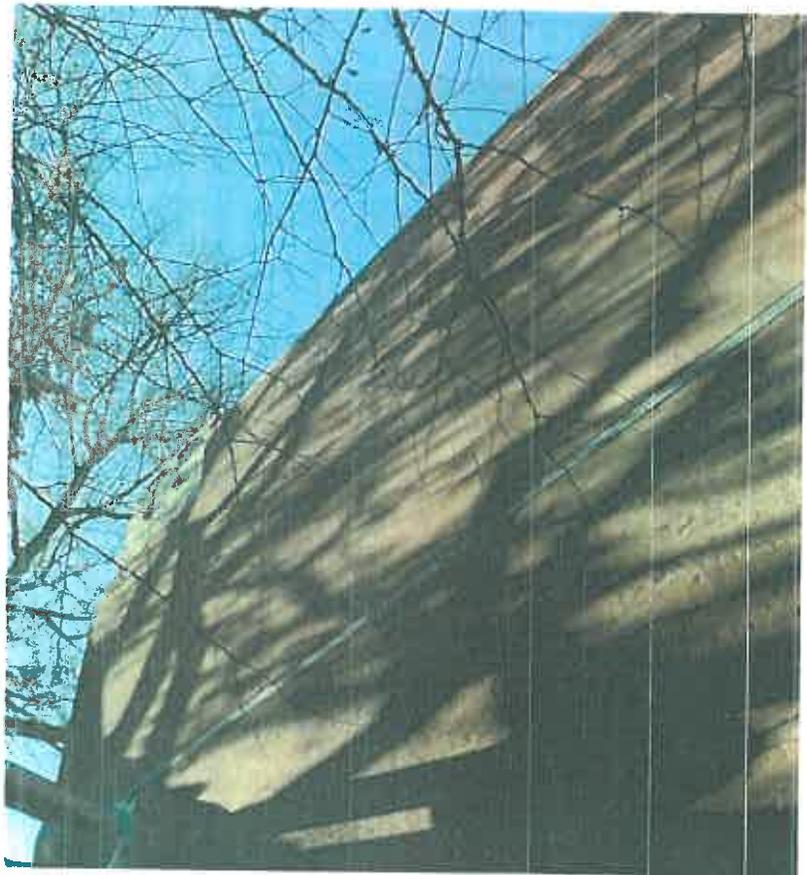
Image XV
Detail of upper section of wall
with finished stucco coat and
white terra cotta wrapping
around from the Main St
façade. Note the water stains.

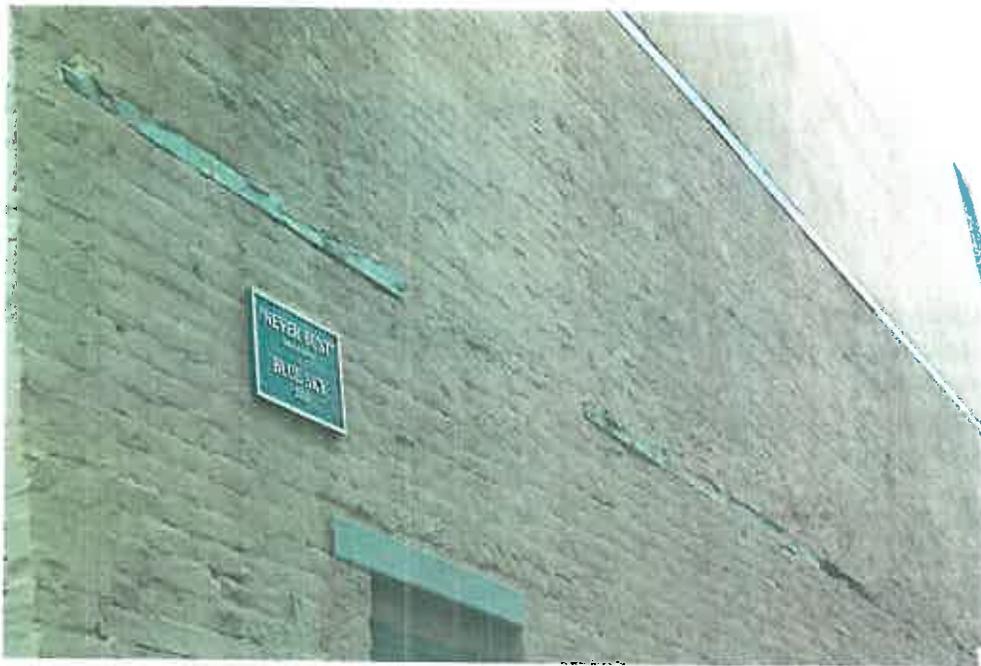
Image XVII

Detail image of wall showing deteriorated embedded wood nailer blocks and roofline of demolished building.
