D/DRC Case

1714 Enoree Avenue

Wales Garden Architectural Conservation District

DESIGN/DEVELOPMENT REVIEW COMMISSION
BAILEY BILL APPLICATION
CONSENT AGENDA
EVALUATION SHEET
Case #1

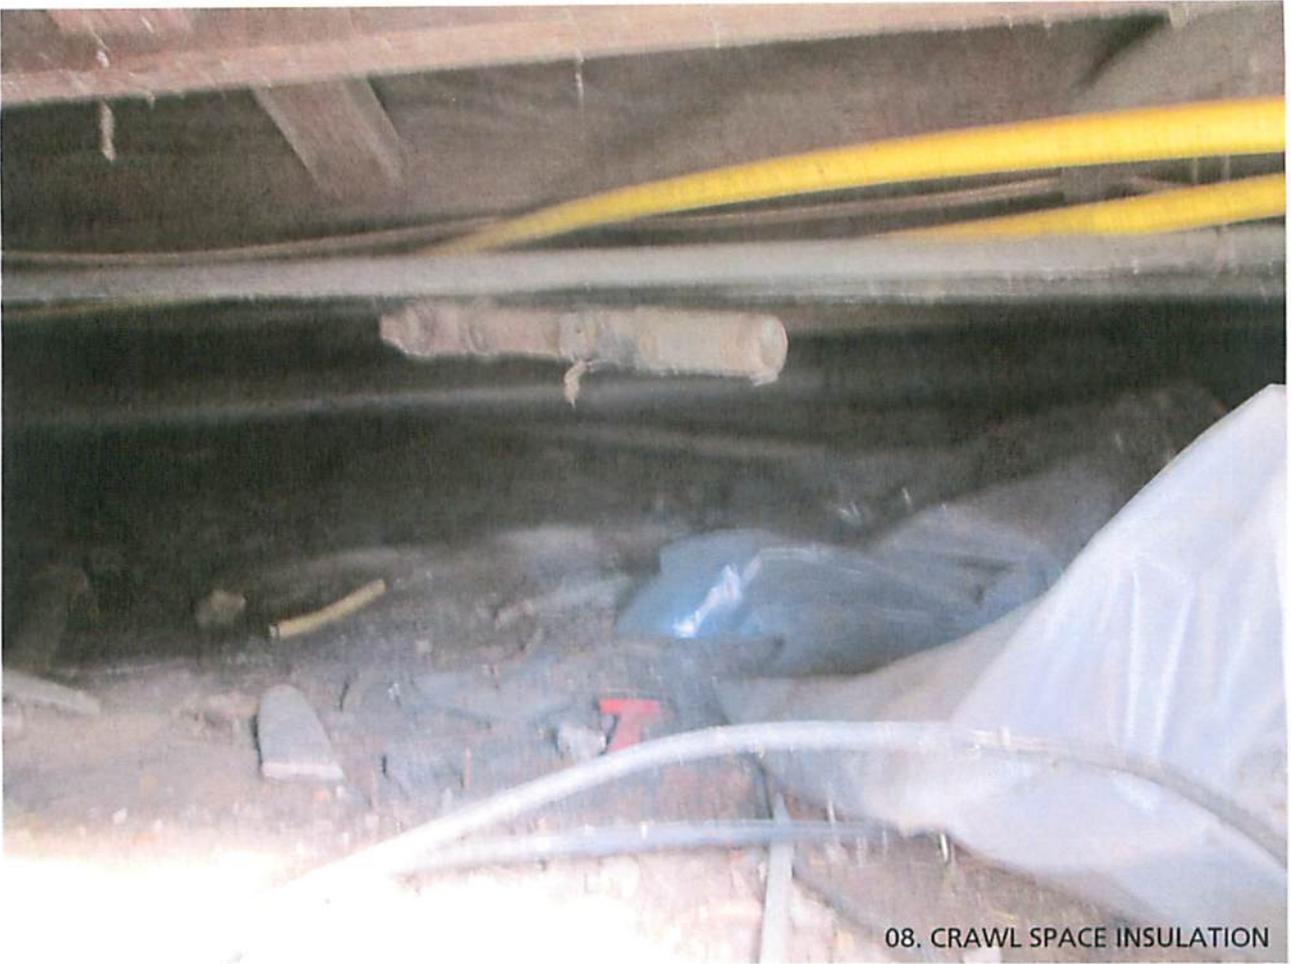
08. CRAWL SPACE INSULATION

<p>Architectural feature <u>Heating/Air Conditioning</u> Approximate date of feature <u>Unknown</u> Describe feature and its condition HVAC unit is outdated</p> <p>Photograph No. <u>12, 13</u> Drawing No. _____</p>	<p>Describe work and impact on feature New energy-efficient system to meet International Residential Code and International Energy Conservation Code</p>
<p>Architectural feature <u>Electrical</u> Approximate date of feature <u>Original/Unknown</u> Describe feature and its condition Existing system is outdated</p> <p>Photograph No. <u>10</u> Drawing No. _____</p>	<p>Describe work and impact on feature Upgrade to remove existing knob-and-tube system and replace with system to meet IRC and IECC</p>
<p>Architectural feature <u>Crawl Space and Attic Insulation</u> Approximate date of feature <u>Unknown</u> Describe feature and its condition Attic insulation old and missing in certain areas No insulation appears to be present in crawl space</p> <p>Photograph No. <u>6-8</u> Drawing No. _____</p>	<p>Describe work and impact on feature New insulation for crawl space and attic to meet IRC and IECC</p>

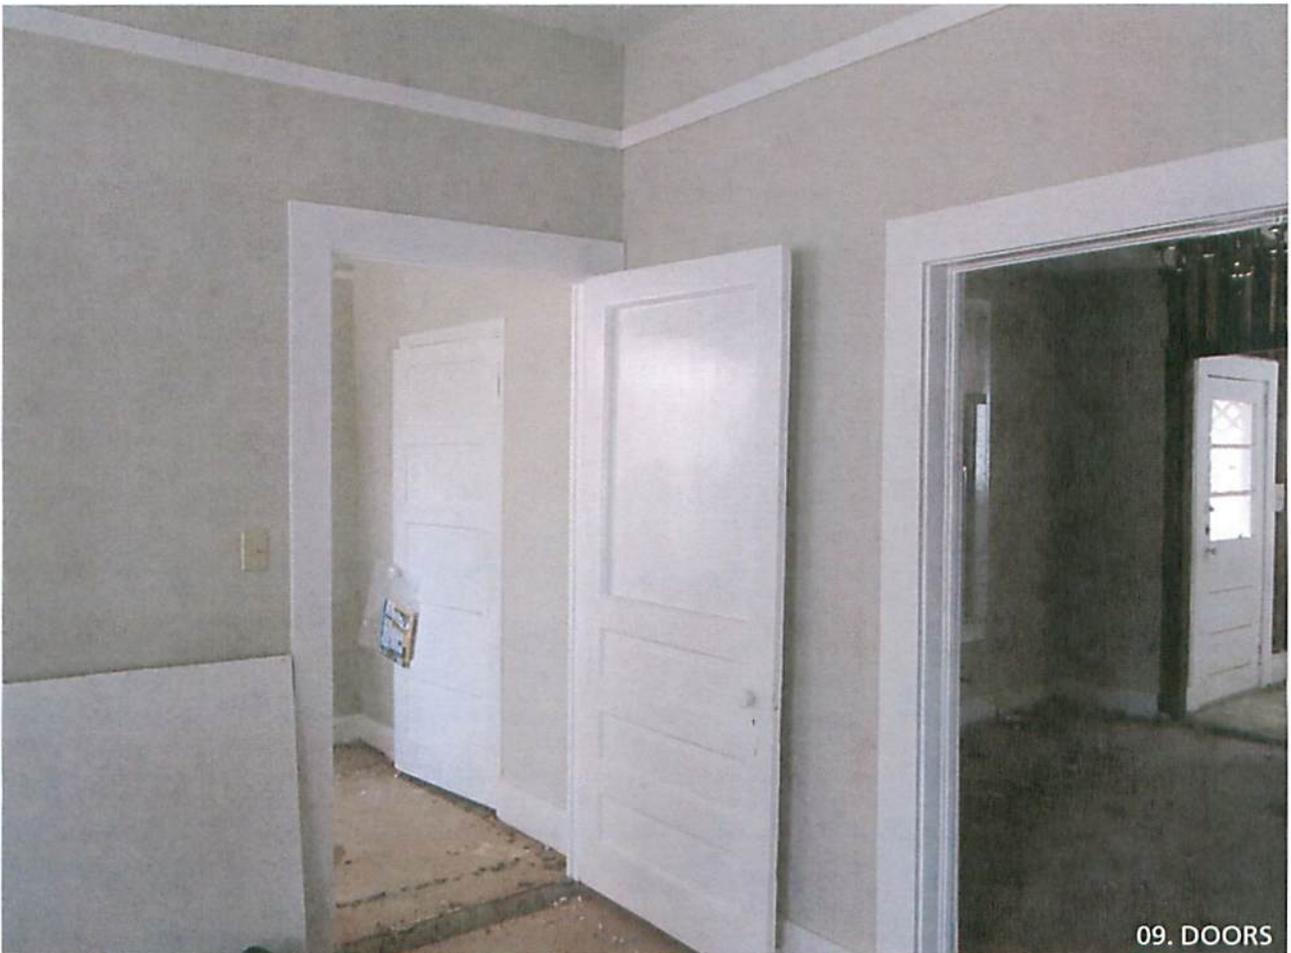
09. DOORS

Photograph No. <u>15</u> Drawing No. _____	
Architectural feature <u>Doors and Jambos</u> Approximate date of feature <u>unknown</u> Describe feature and its condition <p style="margin-left: 20px;">Existing doors not original to house</p>	Describe work and impact on feature <p style="margin-left: 20px;">Replacement of front and rear doors and jambos</p>
Photograph No. <u>9</u> Drawing No. _____

The house requires a good bit of repair work, including repairing termite damaged wood, repairing original windows, upgrading electrical and plumbing systems, replacing the roof, etc. The owners would like to replace the front door as well; staff will need to review this to ensure the front door is not original. Otherwise, all work meets the requirements of the Bailey Bill:

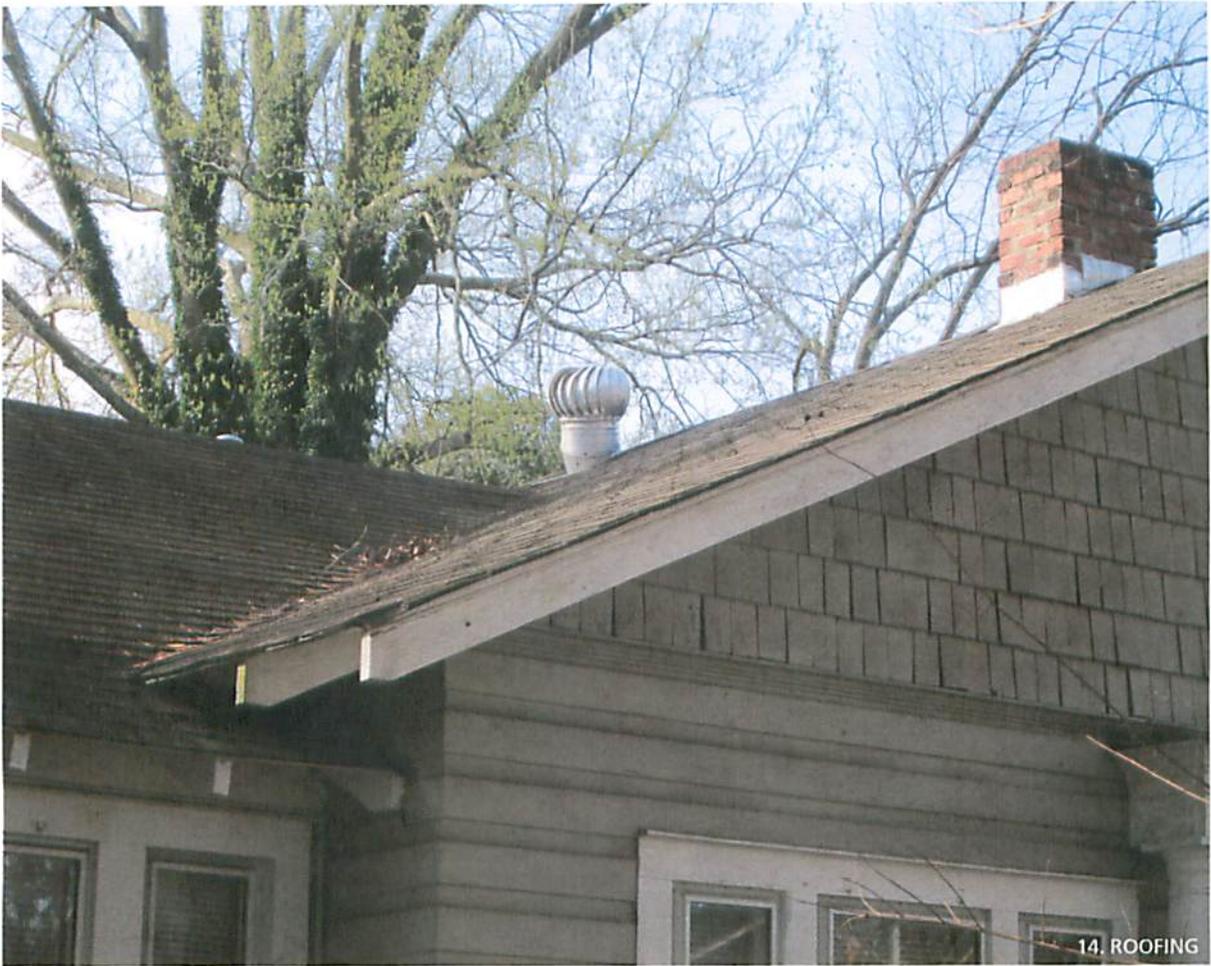
14. ROOFING

<p>Architectural feature <u>Roof</u> Approximate date of feature <u>Unknown</u> Describe feature and its condition</p> <p>Photograph No. <u>14</u> Drawing No. _____</p>	<p>Describe work and impact on feature Replace existing asphalt shingles with new architectural shingle roof</p>
