Cottontown Architectural Conservation District

DESIGN/DEVELOPMENT REVIEW COMMISSION
DESIGN REVIEW DISTRICT
CONSENT AGENDA
EVALUATION SHEET
Case # 2

ADDRESS: 2241 Marion Street

NATURE OF REQUEST: Request for a Certificate of Design Approval for exterior changes and for preliminary certification for the Bailey Bill

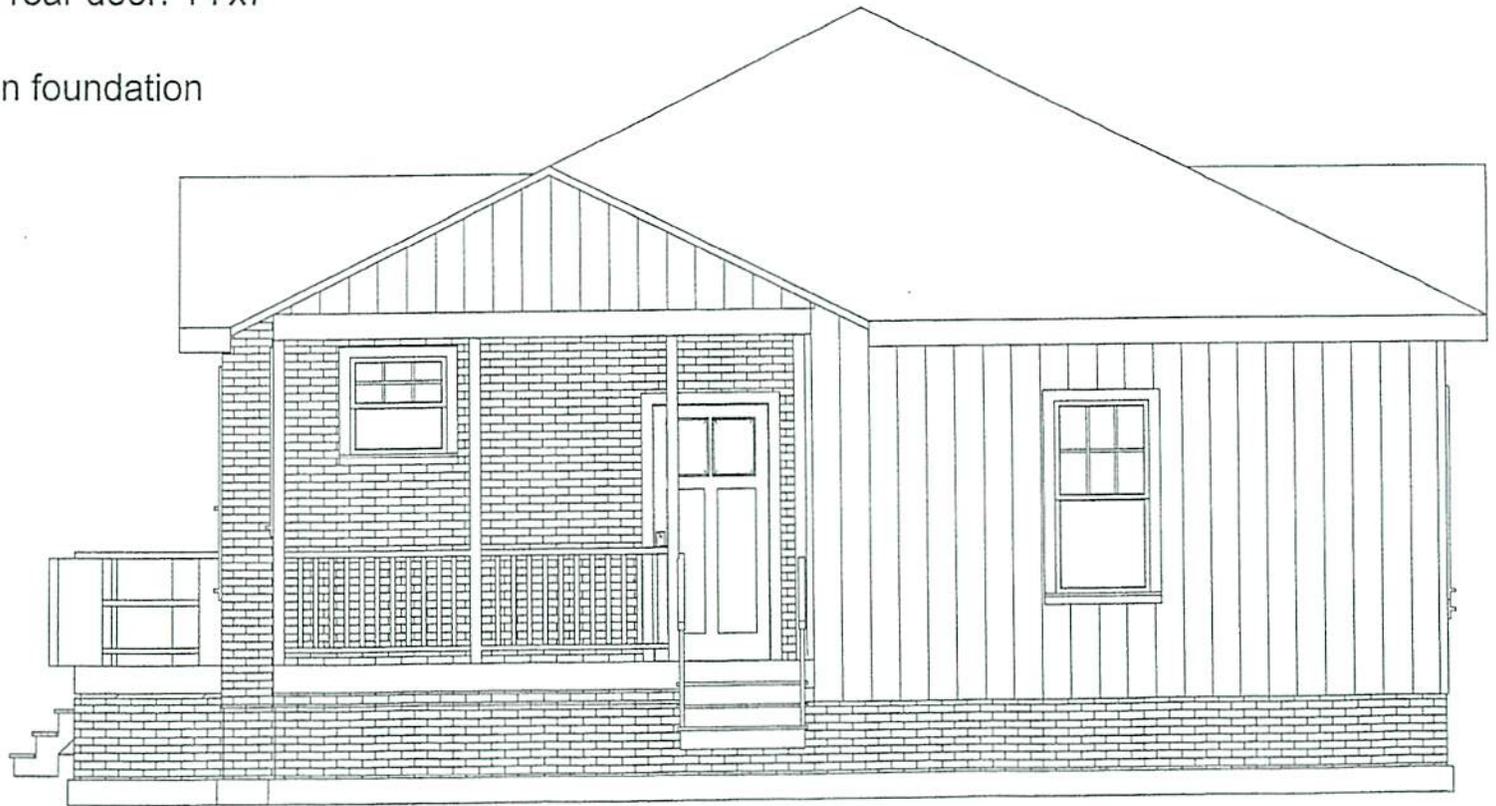
PROPOSED

Addition to extend to the length of house
Approximately 9'-4" x 16'-8"
Existing height of roof will not change, just extend the full width
24" (typ) brick foundation
Remove pump house off rear
Remove window and replace with door on rear
Reuse existing window from house on rear
Siding and trim to match existing gable siding and trim
A covered rear deck built off rear door. 14'x7'
Architectural shingles.
Original brick to be utilized on foundation

The rear porch addition is inset off the corner of the home and will not be highly visible due to shrubbery in the yard. It requires the removal of an original window in order to locate a door there instead but this window will be reused on the enclosure to the right. Again, this is not highly visible.

2. *Design additions to be compatible with the original structure in materials, style and detailing.*
The porch will utilize original brick for its foundation, trim to match that of the house, and the roof will maintain the pitch of the main roof as well as the same architectural shingles. Staff is happy to work with the applicant on any outstanding details.
3. *Limit the size and scale of additions so that the integrity of the original structure is not compromised.*
The size and scale of the new porch are appropriate for the house.
4. *Additions are also subject to the guidelines for new construction.*
The roof shape, materials, scale, etc., of the porch meet the guidelines for new construction.

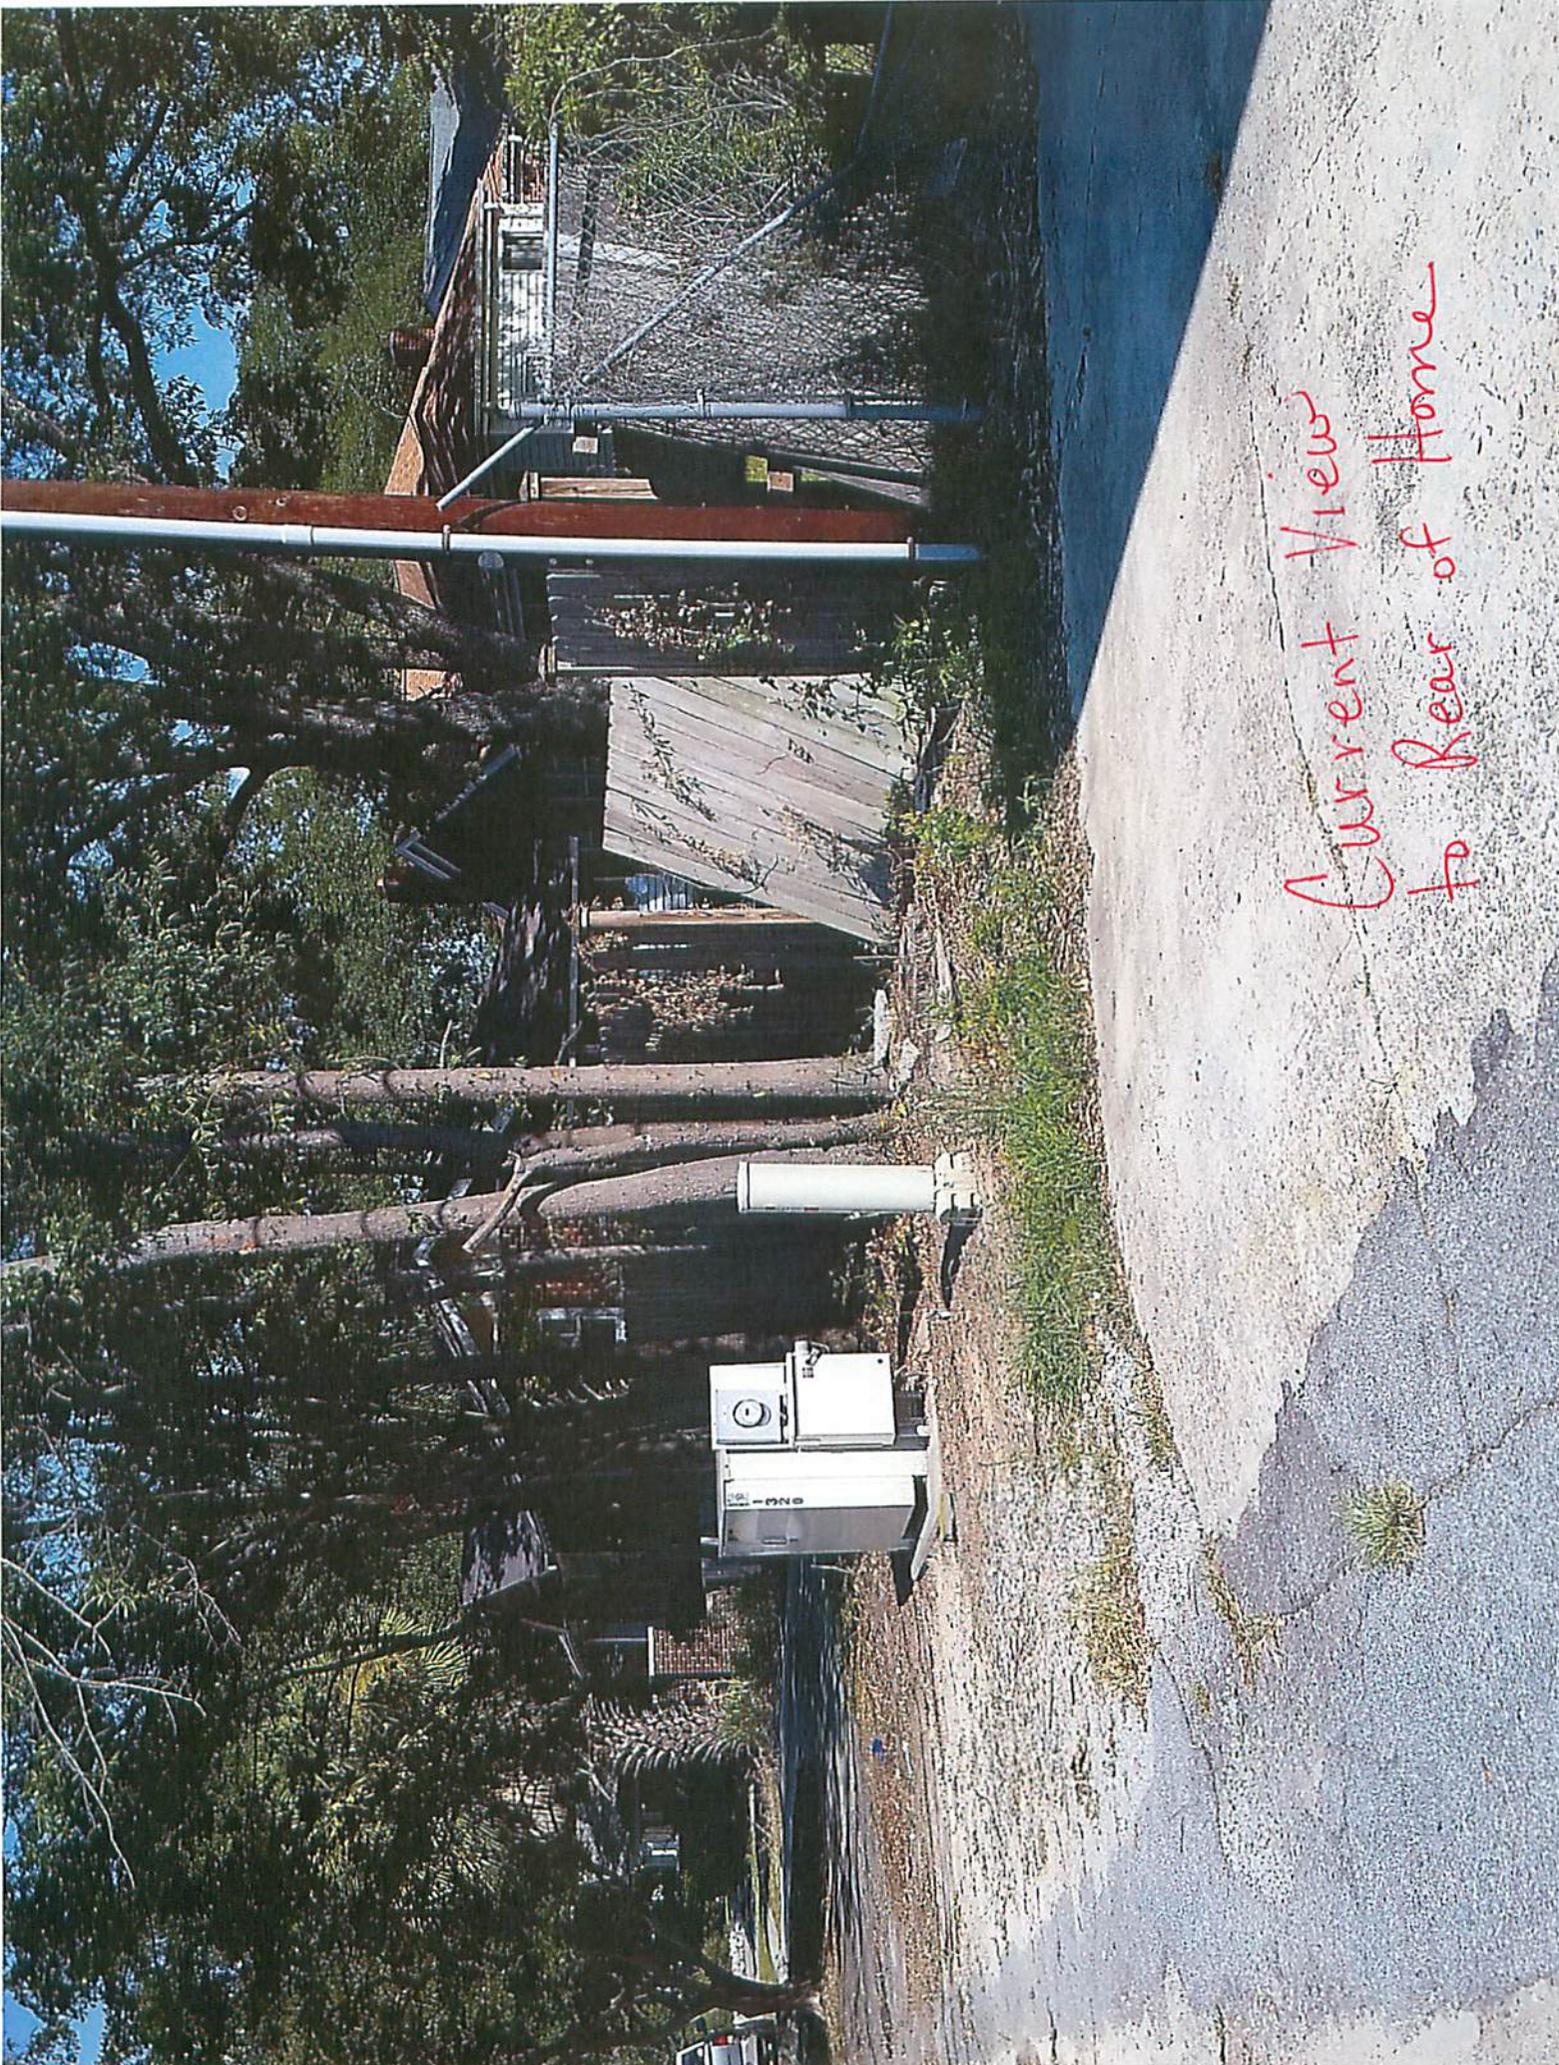
Current View
to Rear of Home

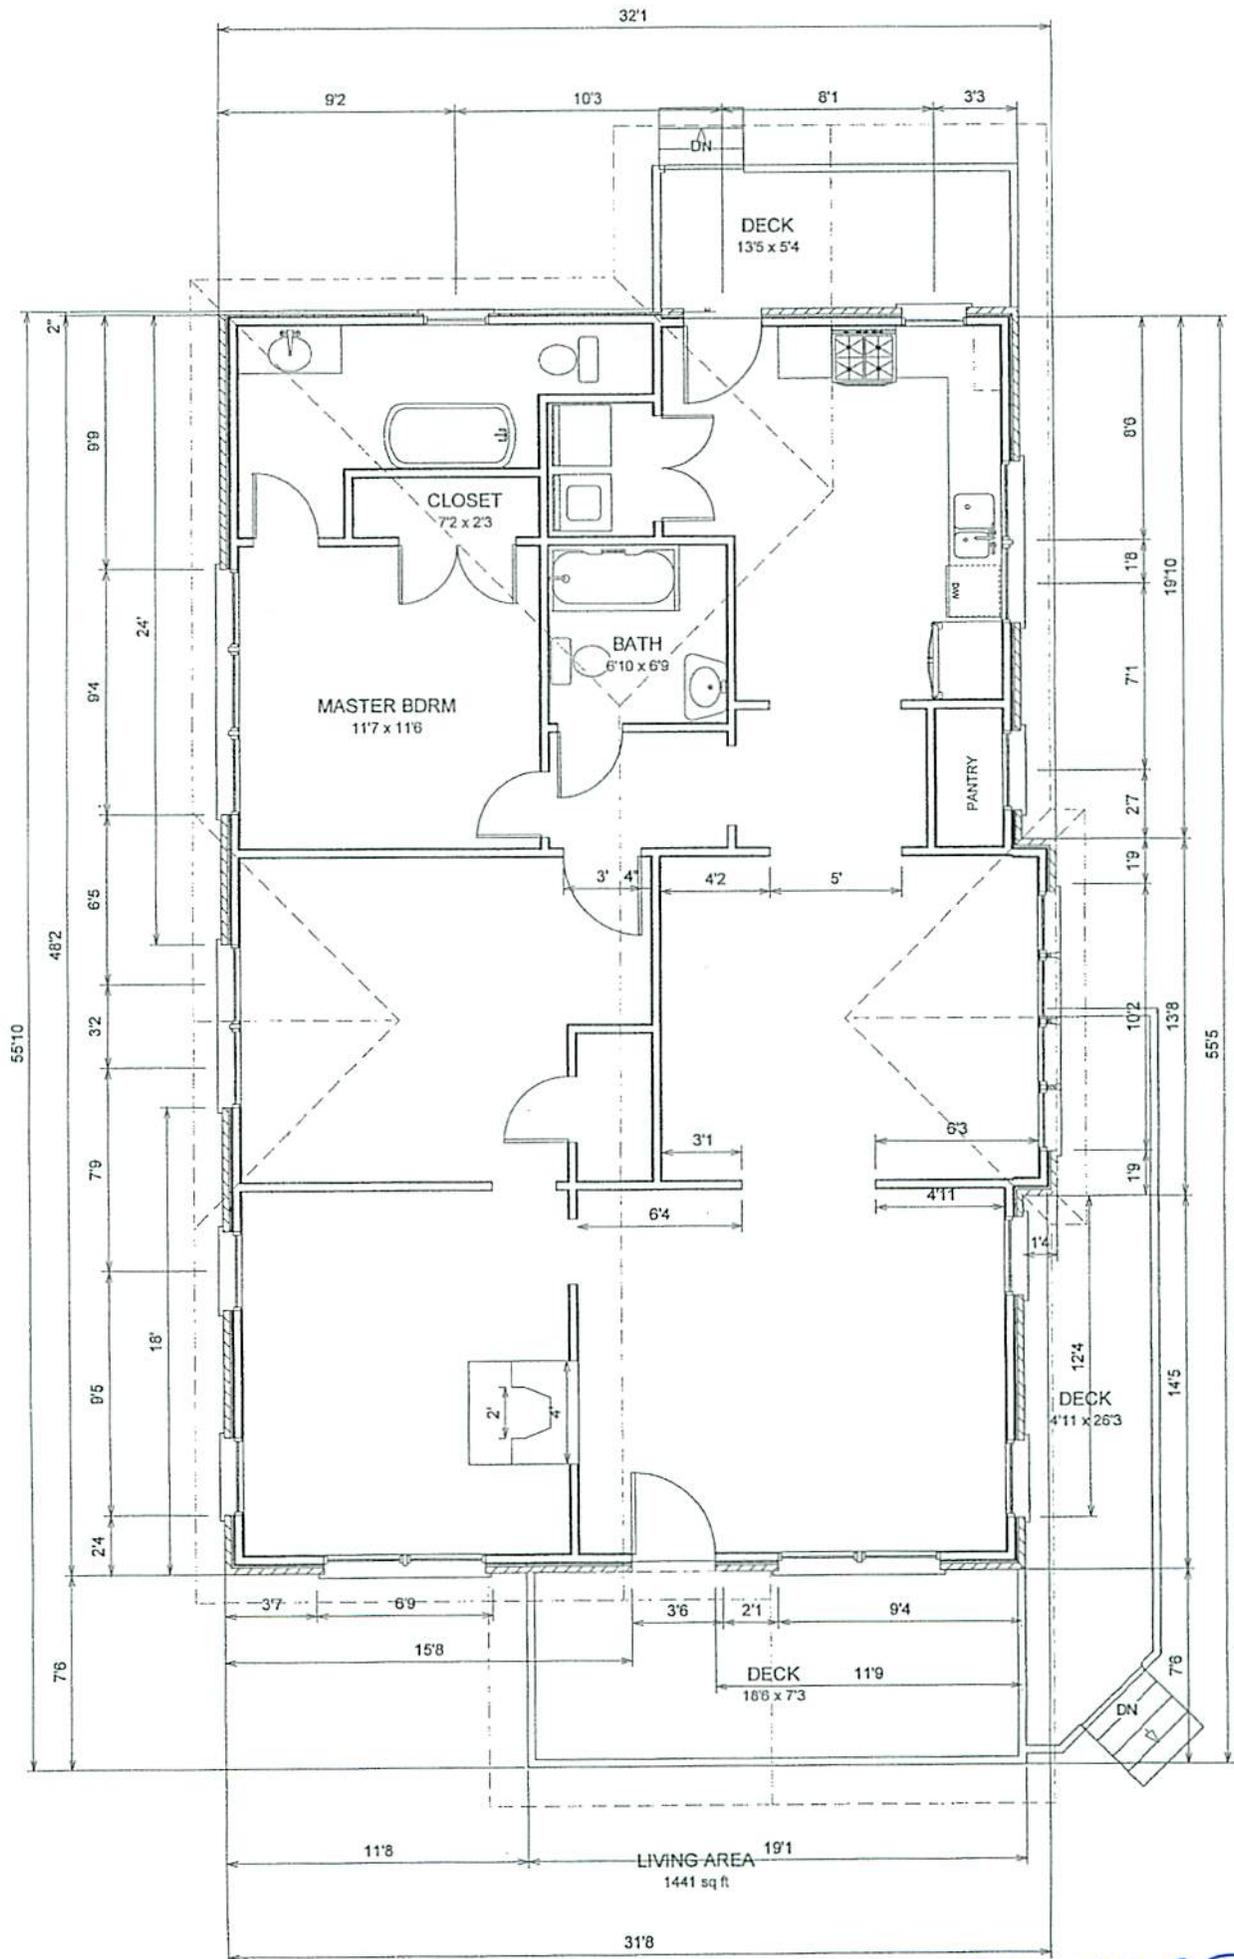
PROPOSED

Architectural feature <u>New Addition</u> Approximate date of feature <u>2016</u> Describe feature and its condition enclose existing rear porch and square off back of house.	Describe work and impact on feature Addition of 1 bedroom closet, 1 full bath, 1 pantry and a laundry room. Move rear door to exit into back yard onto a small porch.
Photograph No. _____ Drawing No. _____	
Architectural feature _____ Approximate date of feature _____ Describe feature and its condition	Describe work and impact on feature
Photograph No. _____ Drawing No. _____	
Architectural feature _____ Approximate date of feature _____ Describe feature and its condition	Describe work and impact on feature
Photograph No. _____ Drawing No. _____	
Architectural feature _____ Approximate date of feature _____ Describe feature and its condition	Describe work and impact on feature
Photograph No. _____ Drawing No. _____
