DESIGN/DEVELOPMENT REVIEW COMMISSION
DESIGN REVIEW DISTRICT
HISTORIC AGENDA
EVALUATION SHEET
Case # 10

ADDRESS: 1721 Gadsden Street

NATURE OF REQUEST: Request Certificate of Design Approval for exterior changes and Preliminary Certification for the Bailey Bill

1721 Gadsden Street Renovation

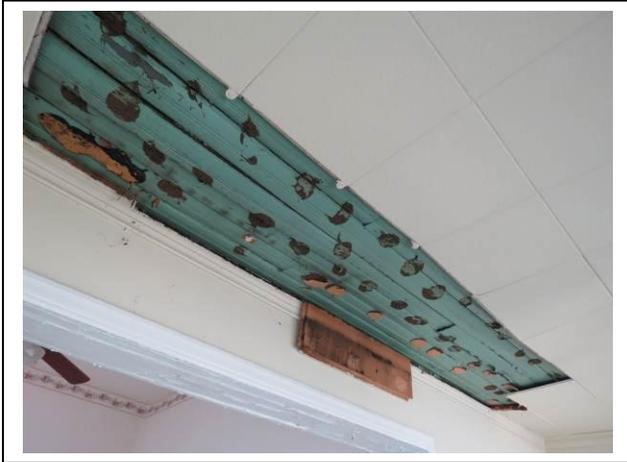
Beadboard porch ceiling

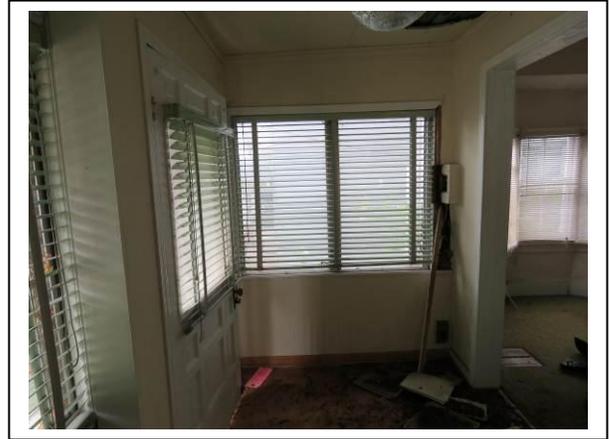
Former front porch, original door

The replacement of the porch is not exact as we do not have a photograph of what originally existed. What is proposed is fairly simple, with square posts and square pickets. Since this house has a Folk Victorian influence with the two bay windows, turned posts and balustrade would also be candidates for what existed here originally. In looking at the proportions of the rather narrow façade and other porch examples in the area it does seem that 10 inch wide columns are too large for this building. Posts closer to 6 or 8 inches would be more appropriate. When the wall enclosure is removed under the porch roof there may be ghost marks from the original columns to indicate size and location.

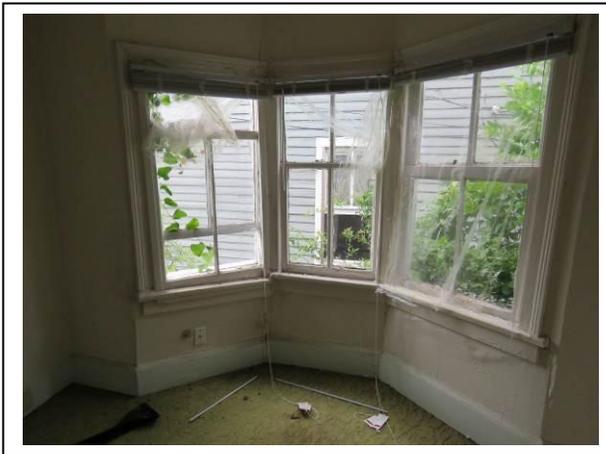
First bay window

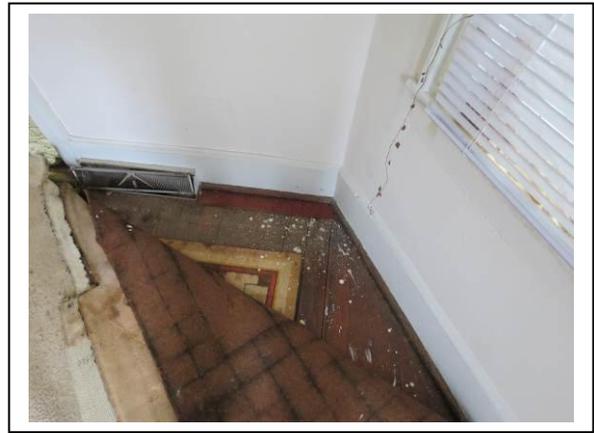
Heart pine flooring

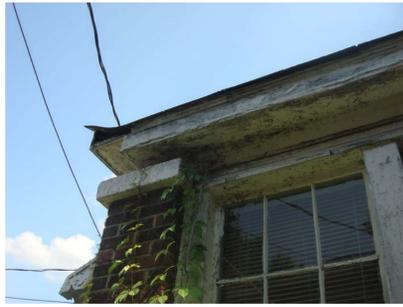
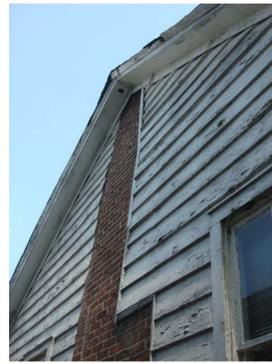
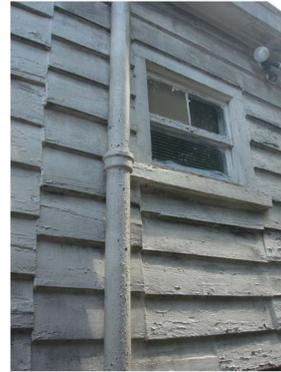
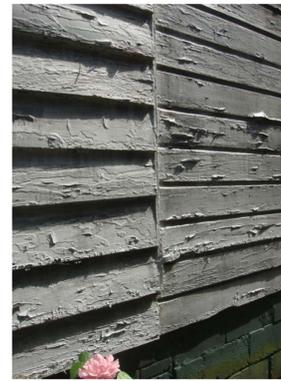
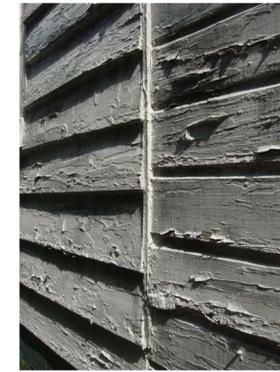
2 Existing Right Elevation
 A-2.02 1/4" = 1'-0"

NOTE EXTENSIVE SIDING REPLACEMENT AND PATCHING HAS OCCURRED ON BACK HALF OF RIGHT SIDE
 REMOVE EXISTING SIDING, STRIP AND PLANE AND THEN REINSTALL WITH CONSISTENT LAPS

The treatment for the wood siding as proposed is to remove all of the siding, strip the paint and plane where necessary to smooth out imperfections and then re-install the siding. This is a fairly aggressive process that has the potential to damage siding during removal so the

utmost care should be taken. Stripping may sufficient without the added step of planing. Fortunately the oldest siding on the front half of the building is exceptionally thick so it may handle the removal better than thinner wood siding. Given the massive paint failure occurring on the oldest siding it will require a great deal of effort to get back to a wood surface, but removal efforts should not damage the original siding. For the “newer” siding on the rear addition of the building, which may not have as extensive of paint failure, scraping and sanding in place may produce favorable results.

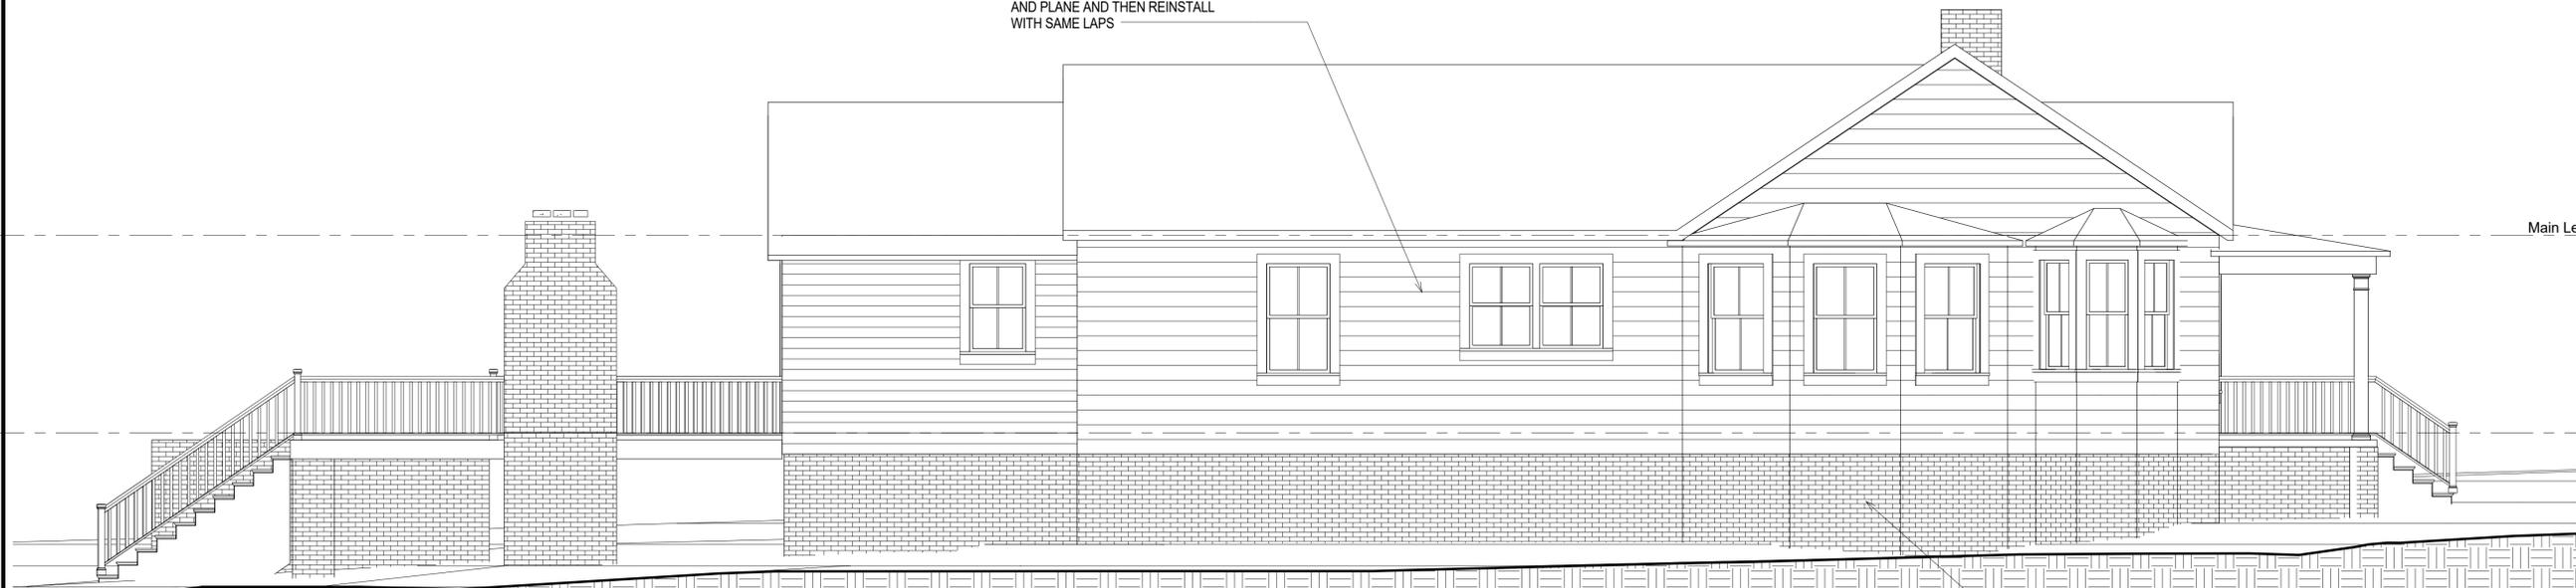
1 Proposed Left Elevation
A-2.03 1/4" = 1'-0"

The only item that is proposed that suggests “removal” of a historic characteristic of the property is a note on the architectural plans to repair a part of the brick foundation and then to “paint or parge.” The unpainted brick foundation that is visible on the front and sides should remain as brick and not be covered with a mortar or stucco system, nor should it gain a coat of paint as that would not retain and preserve a historic feature. For the foundation under the front bay, which appears to be either parged or to have concrete block, brick veneer or paint added to this feature may help it to blend in to the rest of the building, but would also leave the original foundation intact.

REMOVE EXISTING SIDING, STRIP
AND PLANE AND THEN REINSTALL
WITH SAME LAPS

PATCH & REPAIR EXISTING
FOUNDATION WALL & PAINT OR PARGE
