D/DRC Case

DESIGN/DEVELOPMENT REVIEW COMMISSION
DESIGN REVIEW DISTRICT
CONSENT AGENDA
EVALUATION SHEET
Case # 5

ADDRESS: 1504-1508 Main Street, Kress Building

NATURE OF REQUEST: Request for Certificate of Design Approval for exterior changes and for preliminary certification for the Bailey Bill

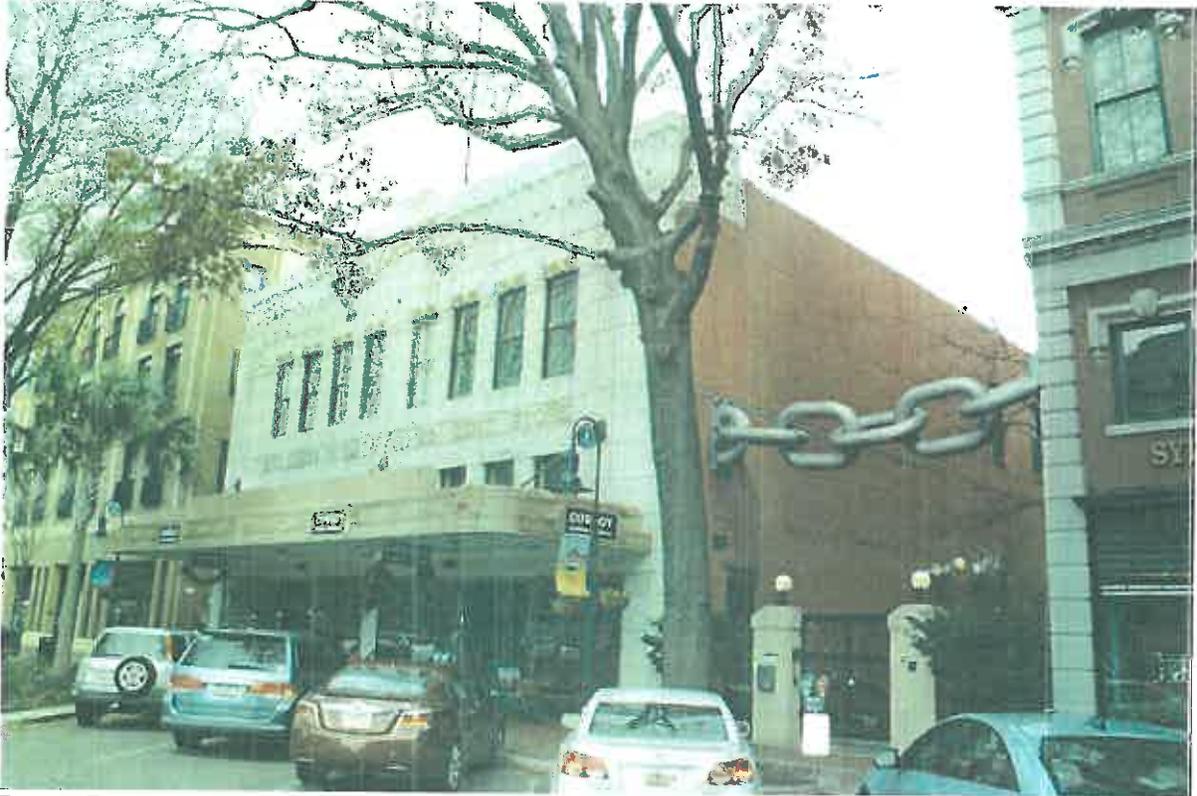
Image I

Property overview, illustrating façade ornamentation and fenestration.

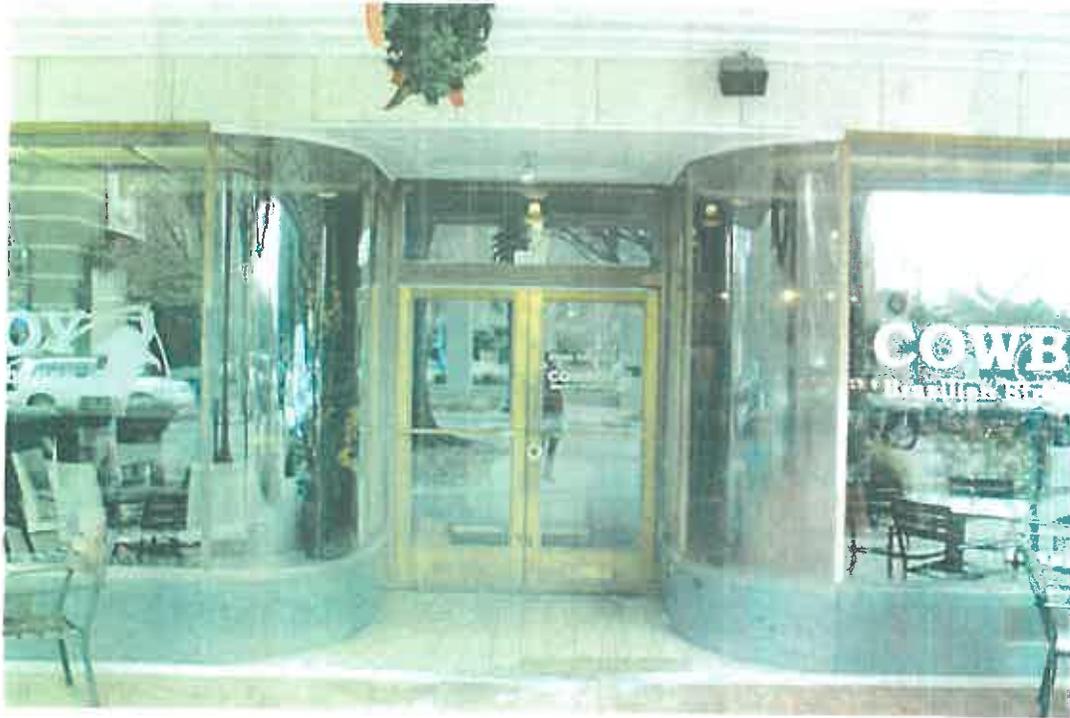
Image II

Second bay (north entrance) of Property, illustrating storefront glass, granite knee walls, tiled entry, and metal doors. Note mismatched entryway tile.

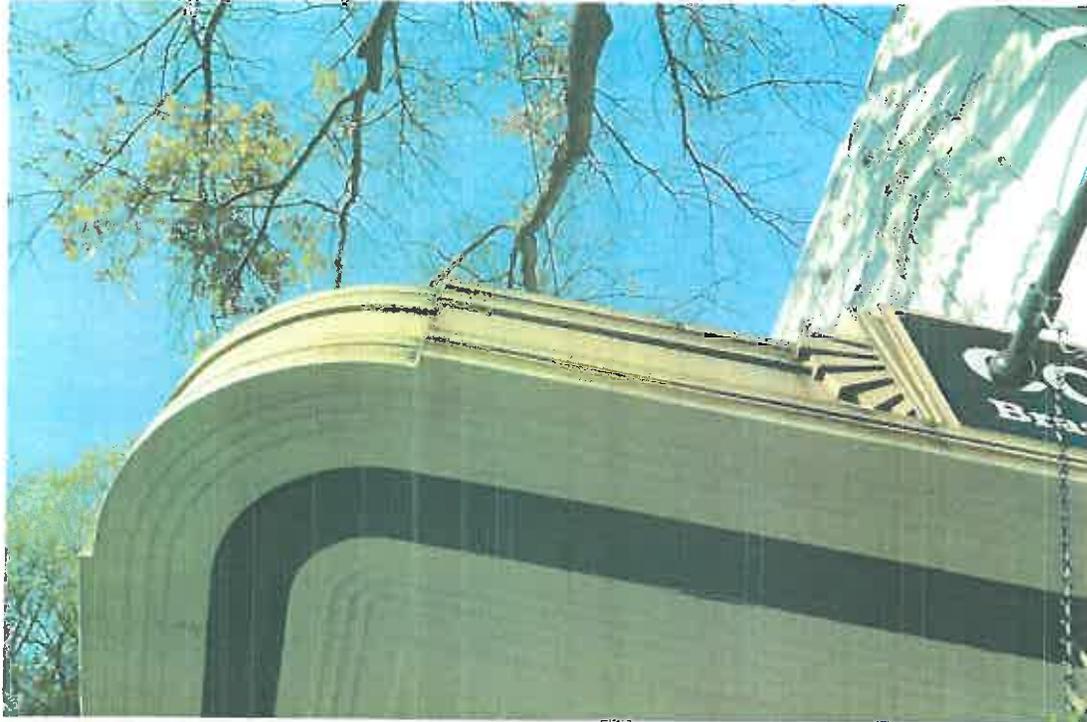
Image XIII

Detail of south corner of painted copper marquee showing Art Deco-style fluting. Note damage to and staining on finish.

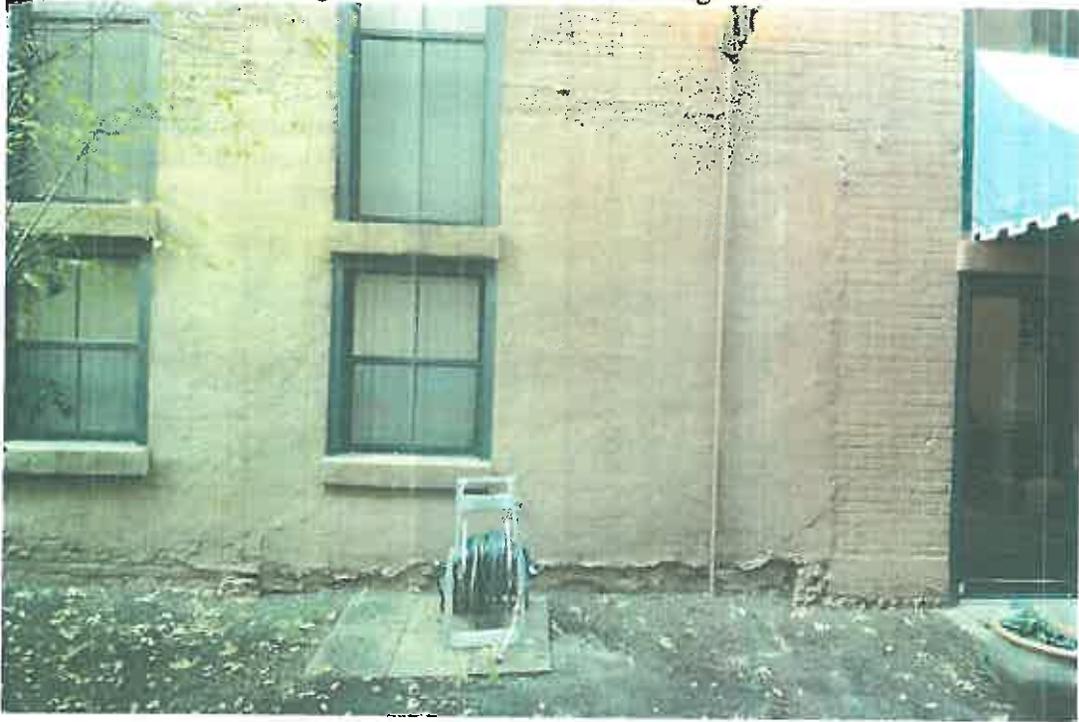
Image XVII

Detail image of wall showing deteriorated embedded wood nailer blocks and roofline of demolished building.

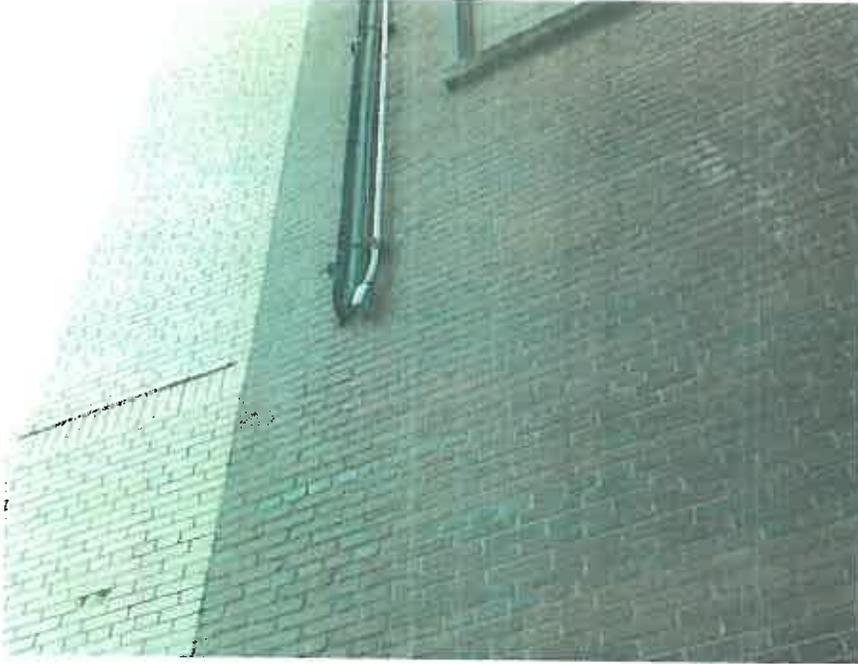
Image XXIV

Detail of damage resulting from the conduit entry point at the southeast corner of the building (at the entry point of the driveway between the building and the hospital parking deck).

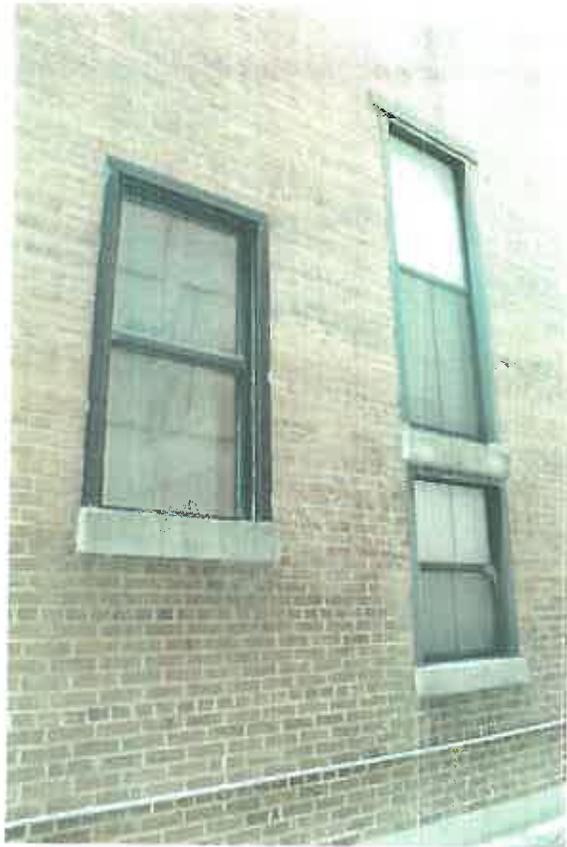
Image XXV

Detail of windows on the east (driveway) façade; all appear to be replacement windows and the window on the left appears to have been added at a later date.

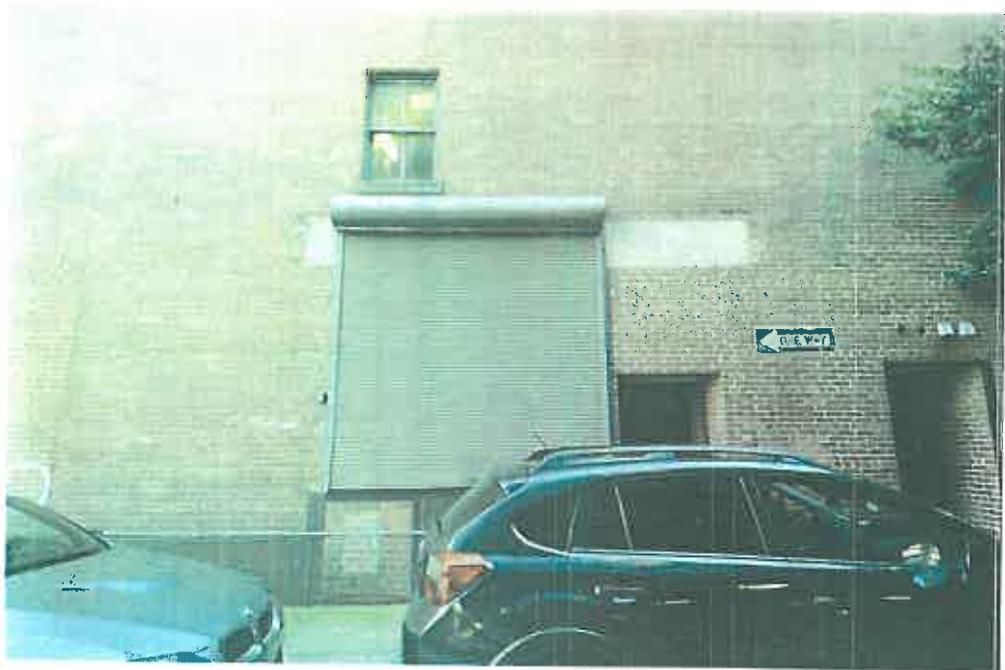
Image XXIX
Roll-up metal door with ghost lines of a larger historic loading door that was bricked in.

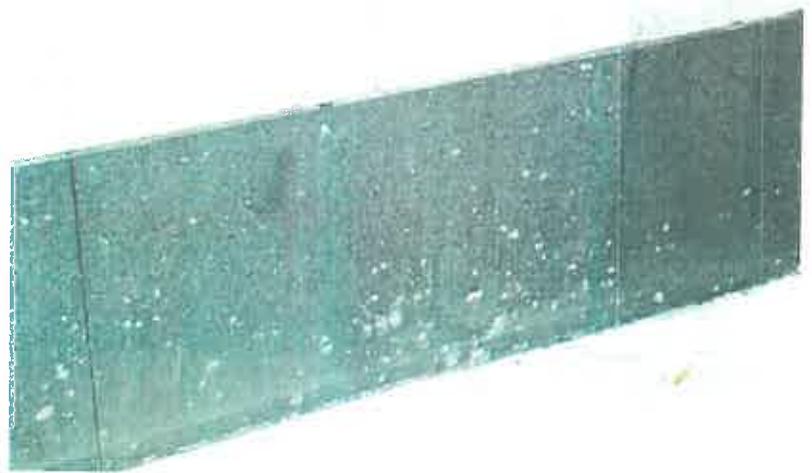
Image XXXI
Concrete splatter (likely from sidewalk laying) on the granite kneewall at the northwest corner of the building.
