# SMITH BRANCH WATERSHED ASSESSMENT

MAY 20, 2016

CITY OF COLUMBIA  
UTILITY AND ENGINEERING DEPARTMENT  
1136 WASHINGTON STREET, 7TH FLOOR  
COLUMBIA, SOUTH CAROLINA 29201

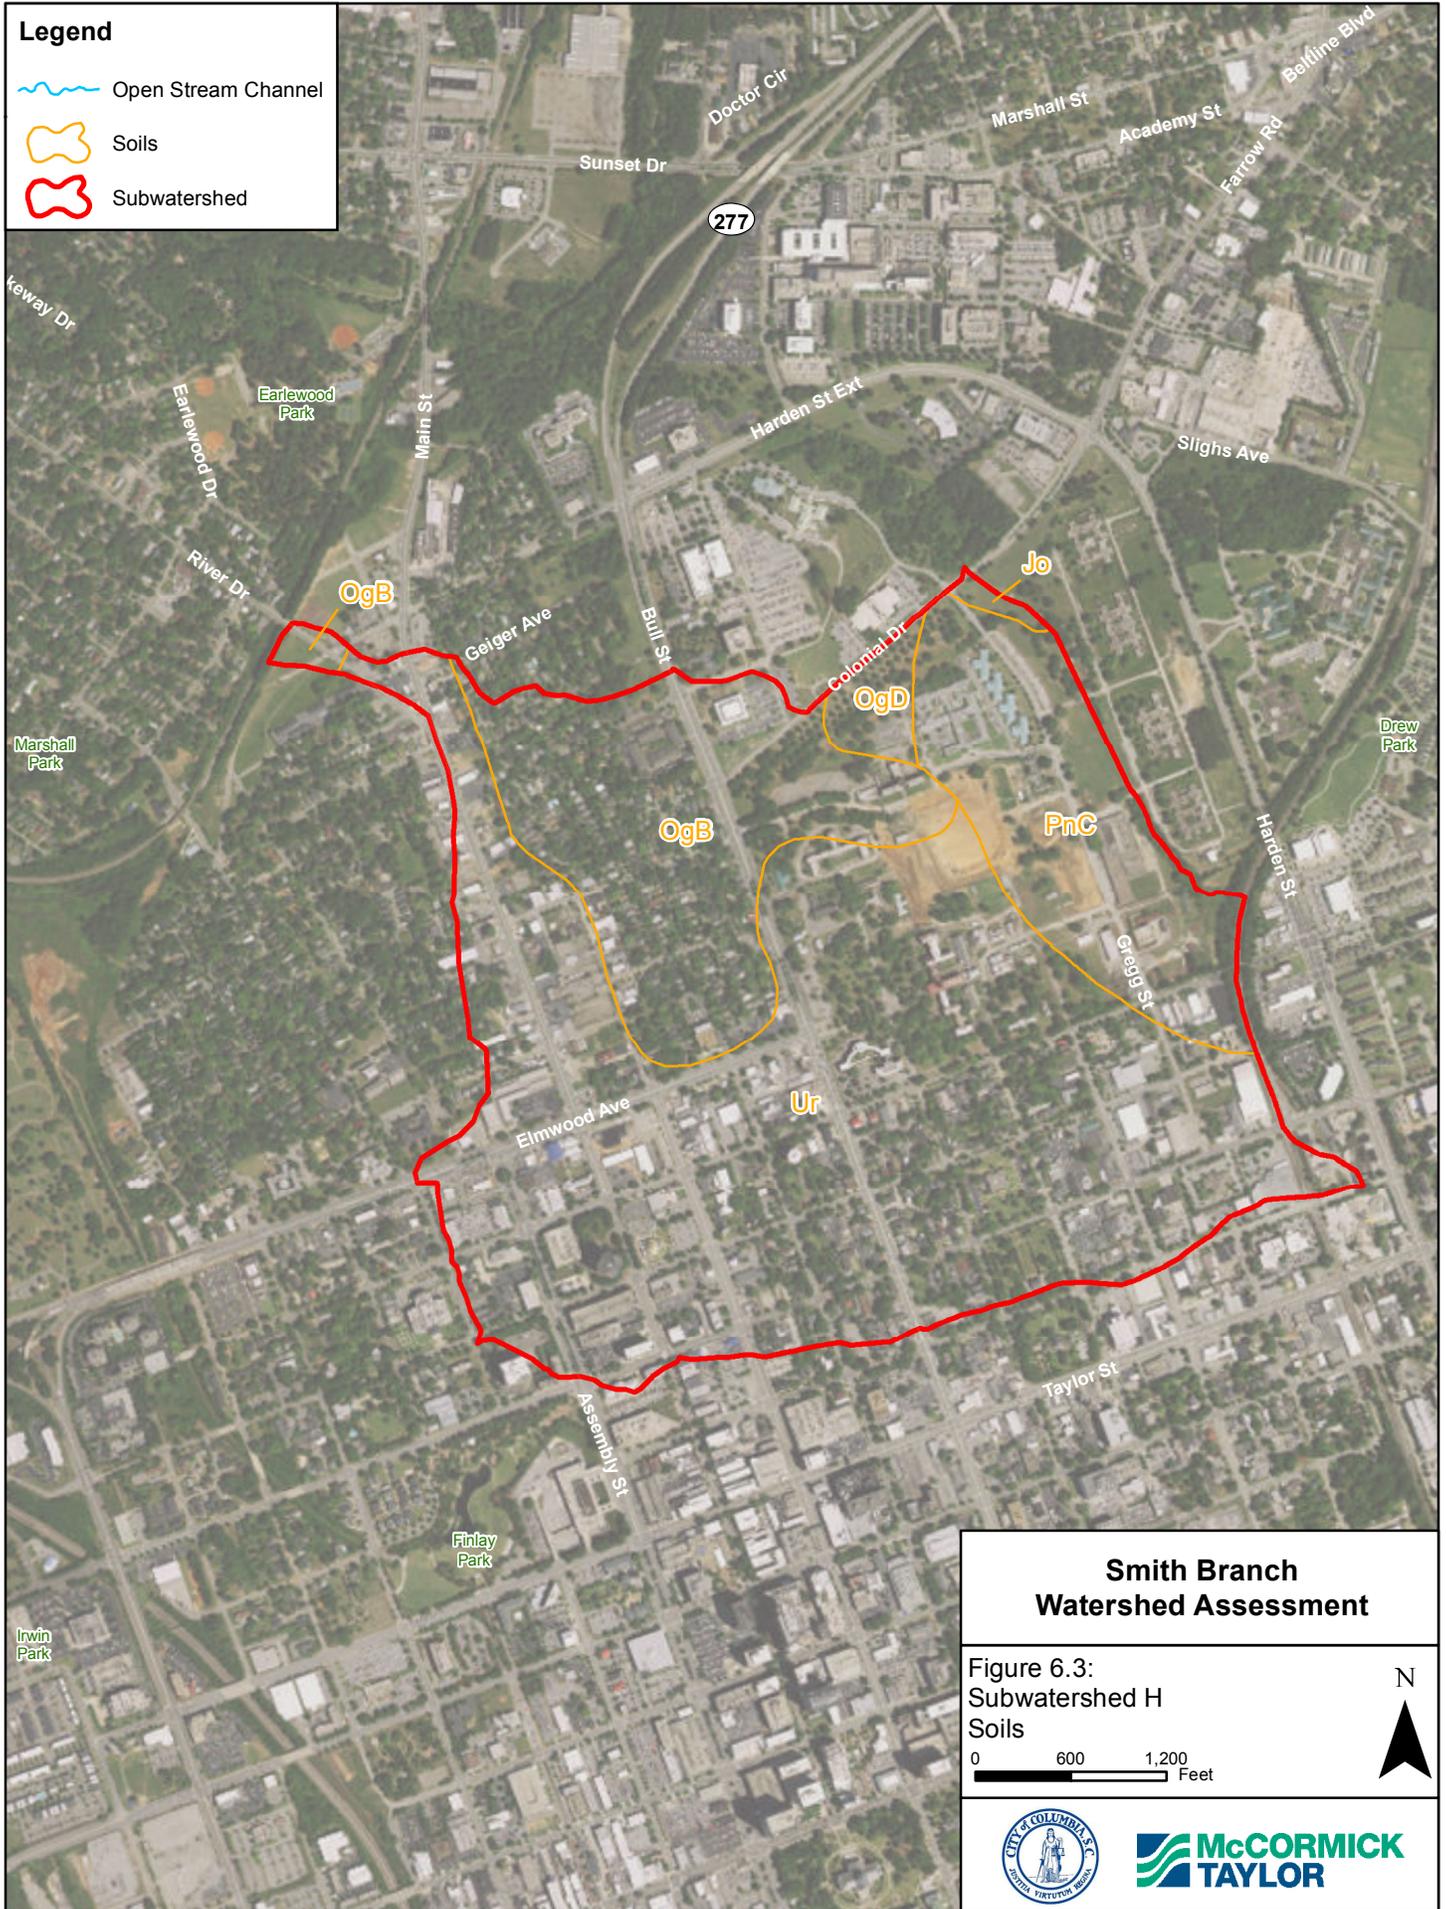
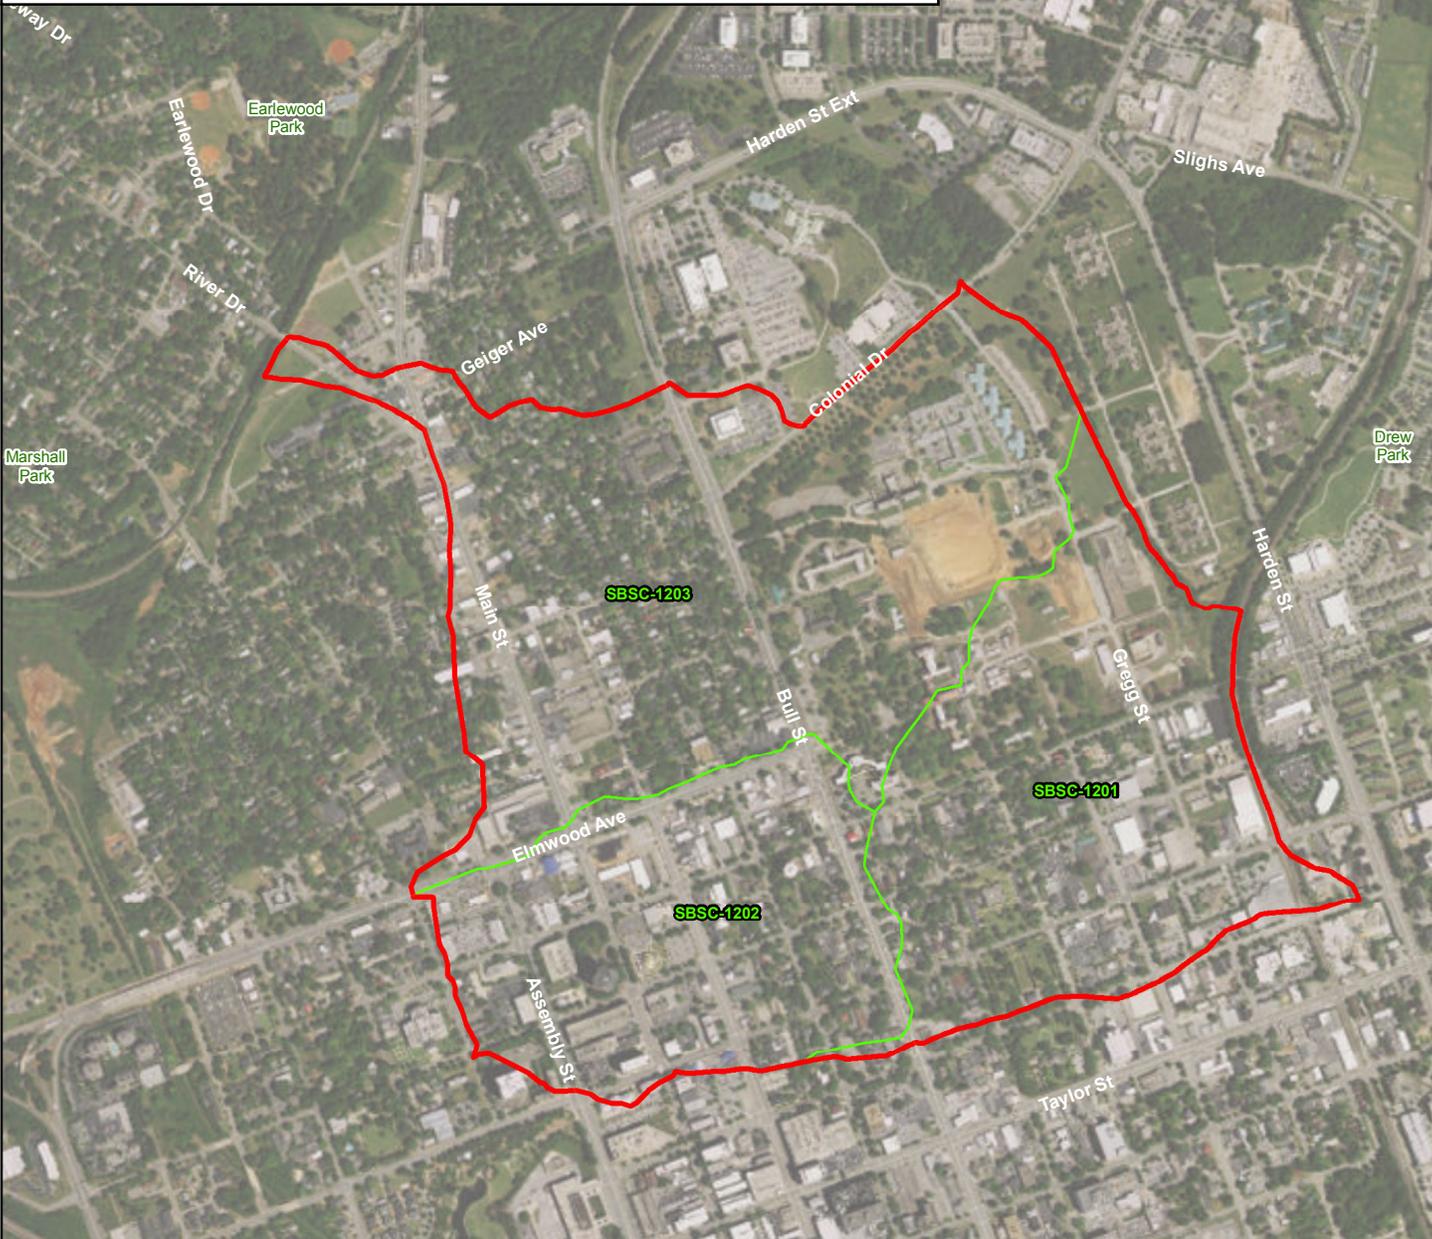
Figure 6.4:  
Subwatershed H  
Existing Conditions

**Figure 6.4** highlights existing conditions that were either captured during the stream cruising effort or developed using GIS data.

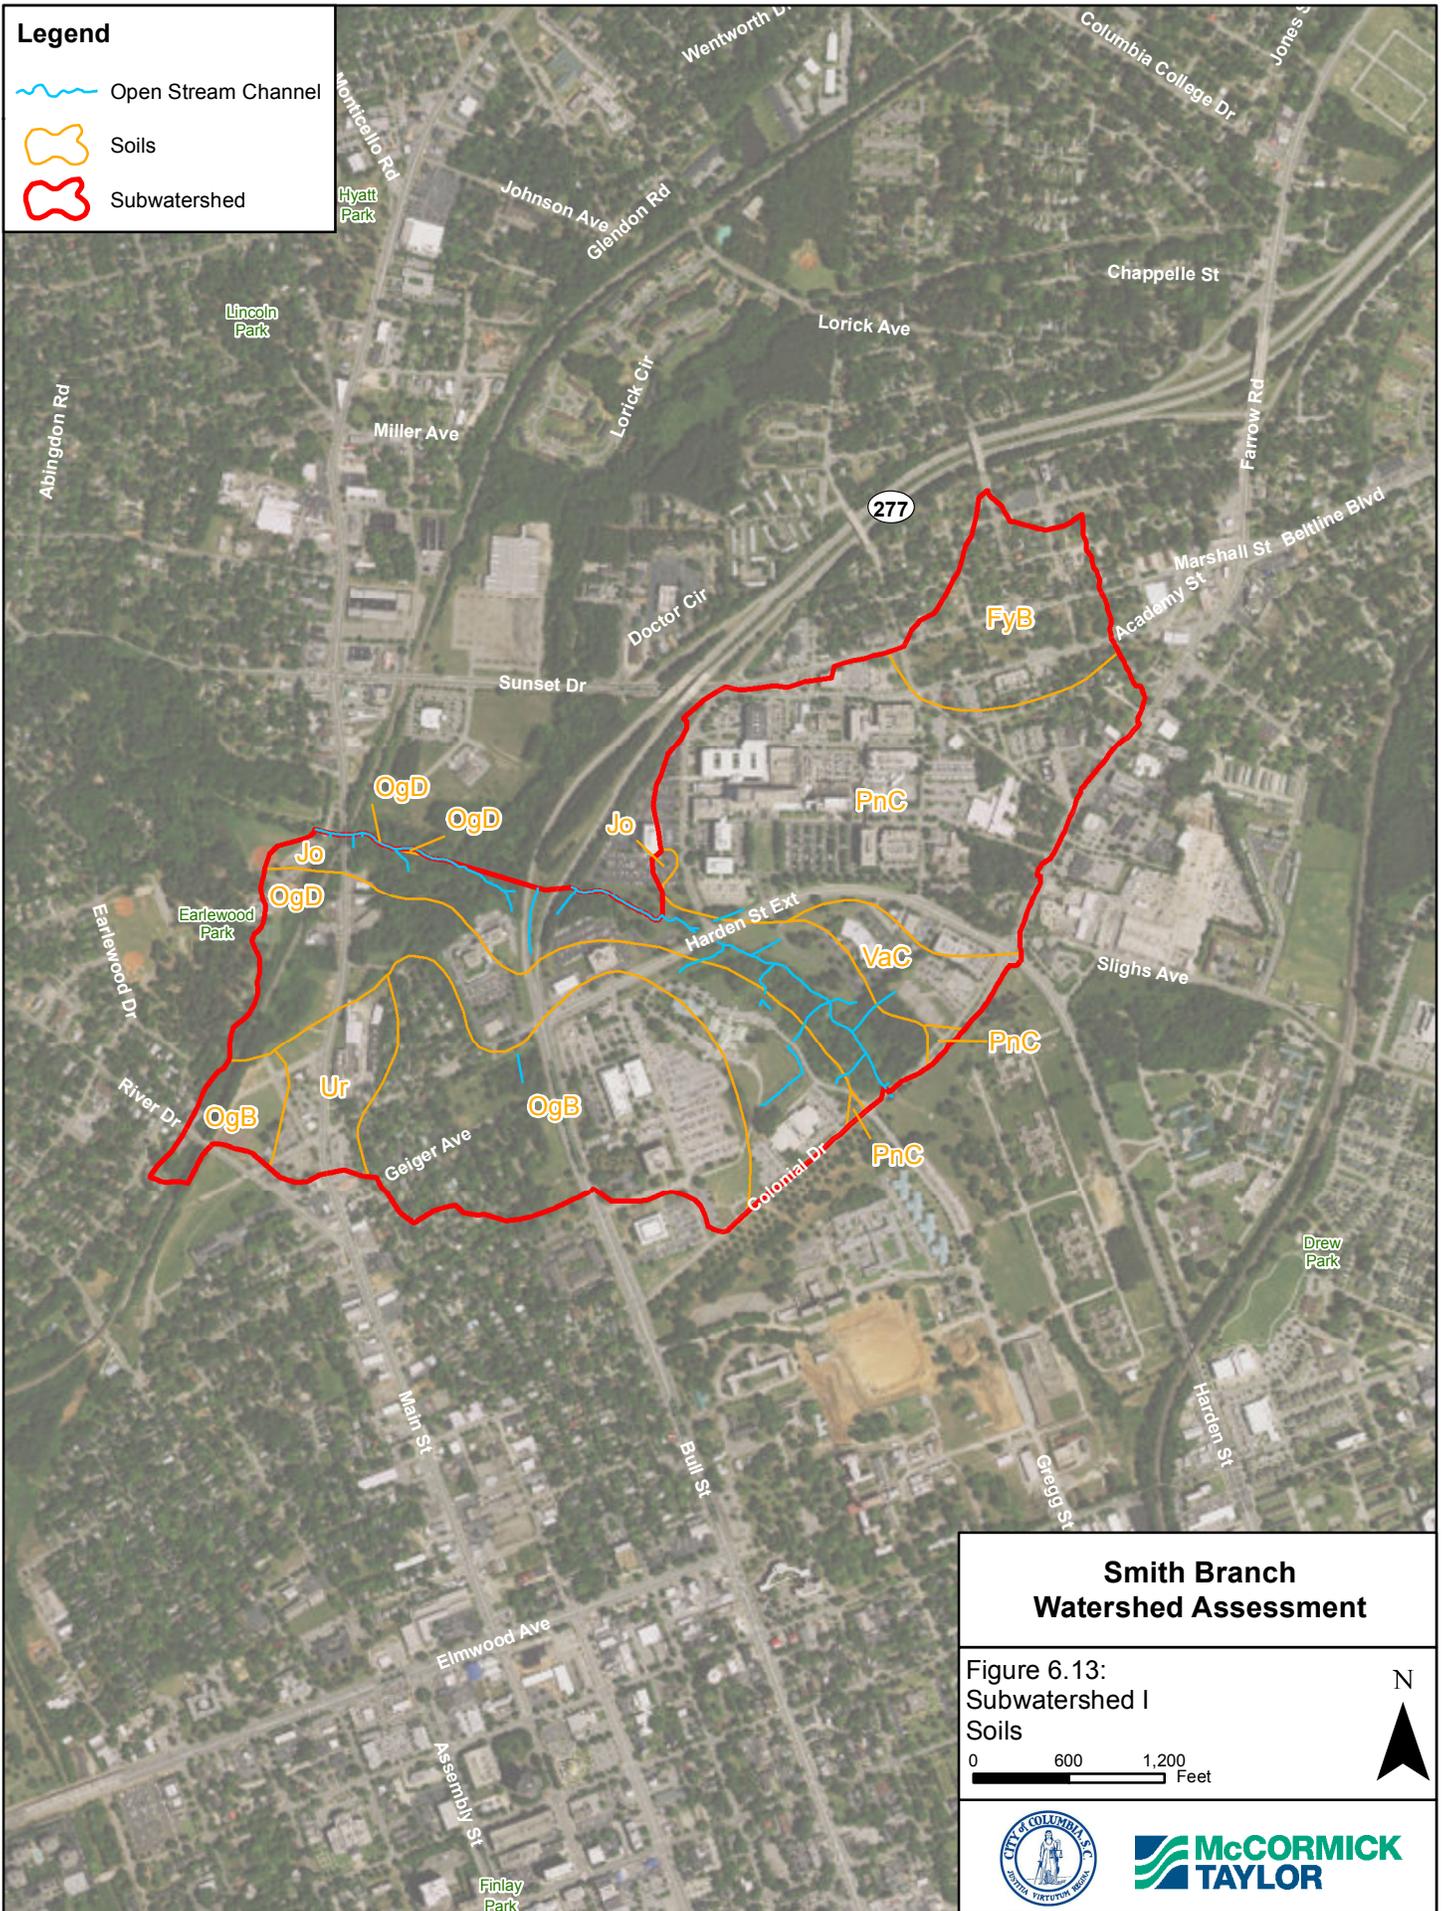
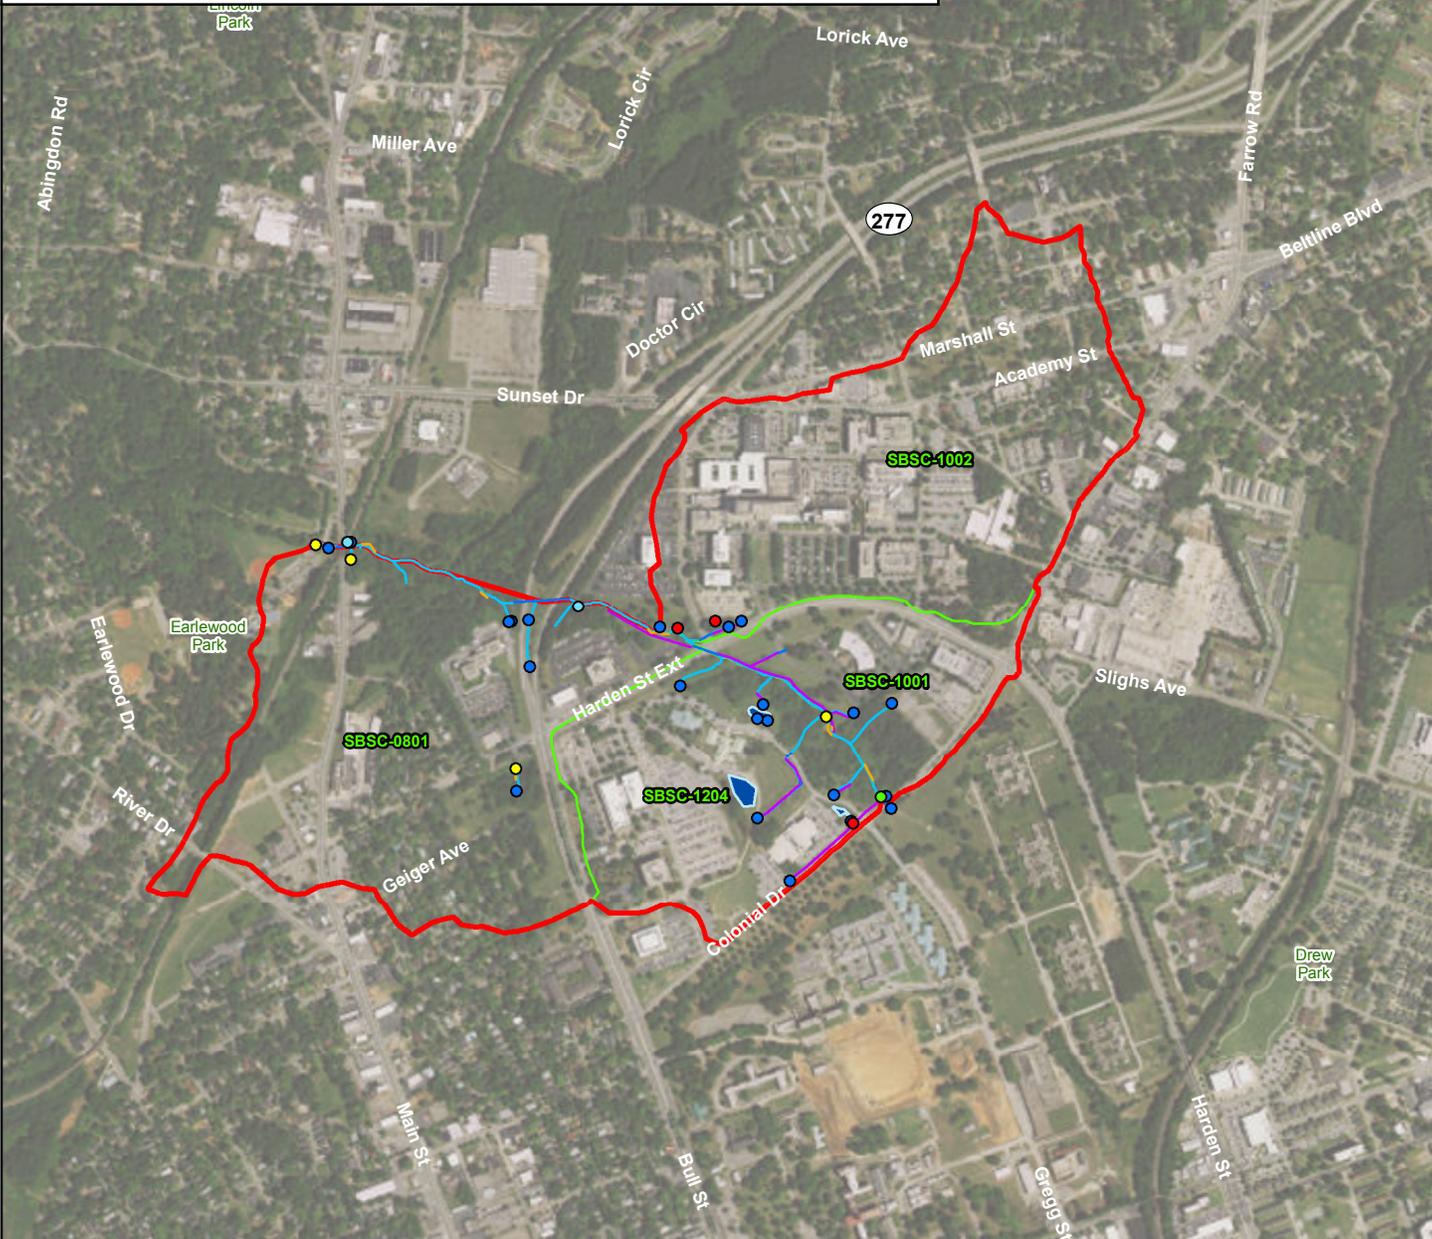
Figure 6.14:  
Subwatershed I  
Existing Conditions

**Figure 6.14** highlights existing conditions that were either captured during the stream cruising effort or developed using GIS data.

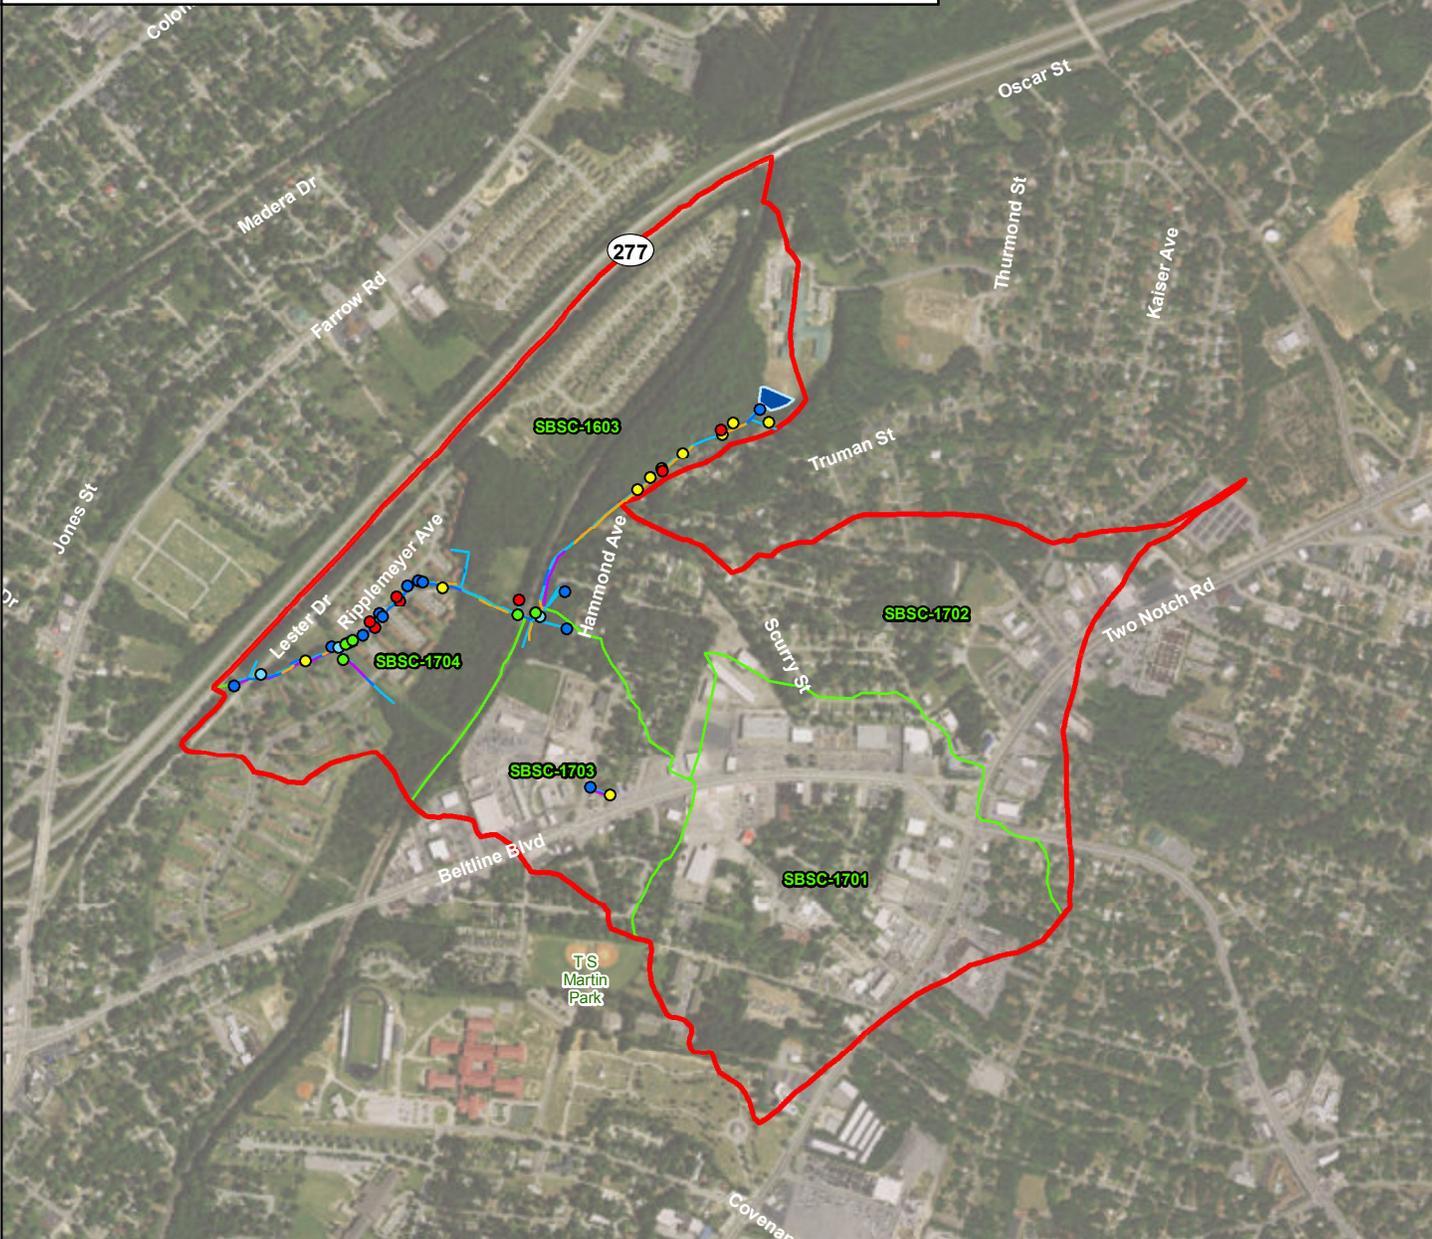
Figure 6.19:  
Subwatershed B  
Existing Conditions

Existing Condition	Count
Exposed Pipes	6
Pipe Outfalls	13
Unmanaged Runoff	7
Unusual Condition	11
Trash Dumping	0
Possible Fish Barrier	5
	<b>Linear Feet</b>
Erosion Site	2,241
Channel Alteration	1,507
Inadequate Forest Buffer	7,942

The stream then becomes channelized with concrete bed and banks, flowing parallel to Ripplemeyer Avenue. Channel conditions along this segment show signs of severe degradation of the concrete channel; soil slump has caused the right bank to fracture and sag. Downstream of the concrete channel, the stream returns to a natural state with earthen bed and banks. Debris caught in understory brush and saturated soils provides evidence of possible flooding. Stream banks are sparsely vegetated with herbaceous material and contain areas of instability. The stream then flows through an 8-foot wide, 6-foot high twin box culvert crossing westerly under Lester Drive. Large sand bars define the channel upon the streams emergence. The stream flows approximately 100 feet before being conveyed through a culvert beneath SC-277 and beyond the SW-B boundary.

There were a total of 13 outfalls identified during the field assessment, none of which were assessed to be in severe or very severe condition.

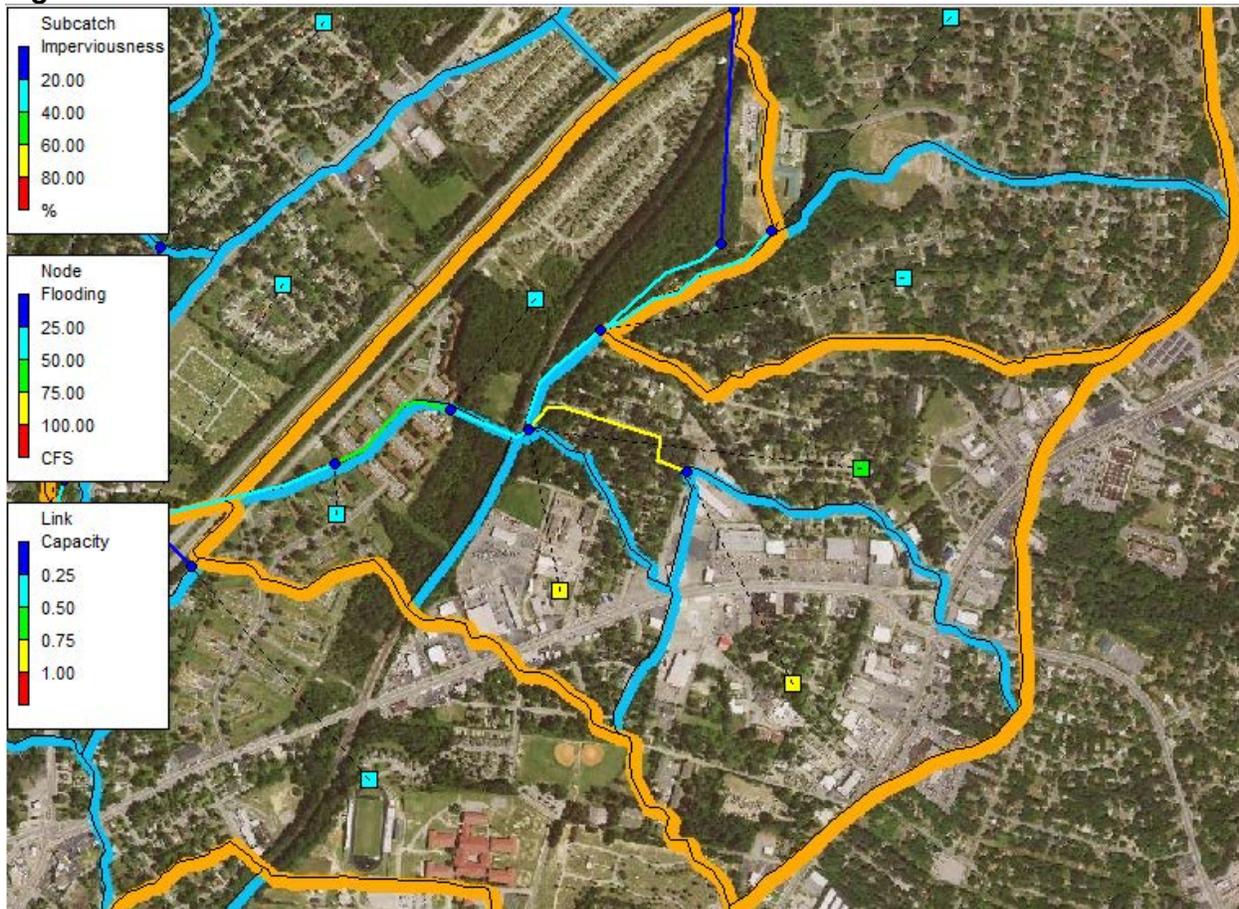
**Figure 6.20 SW-B SWMM Model**

SW-B is modeled in SWMM as five subcatchments draining to the pipe and open channel conveyance systems that make up the headwaters of Bay Branch. The large areas of impervious surface in this watershed are visible in the aerial imagery. At the modeled 2-year event in SWMM, the subwatershed's runoff is approaching capacity (81% modeled capacity) in the 54" RCP outlet pipe (seen mapped as yellow lines in **Figure 6.20**).

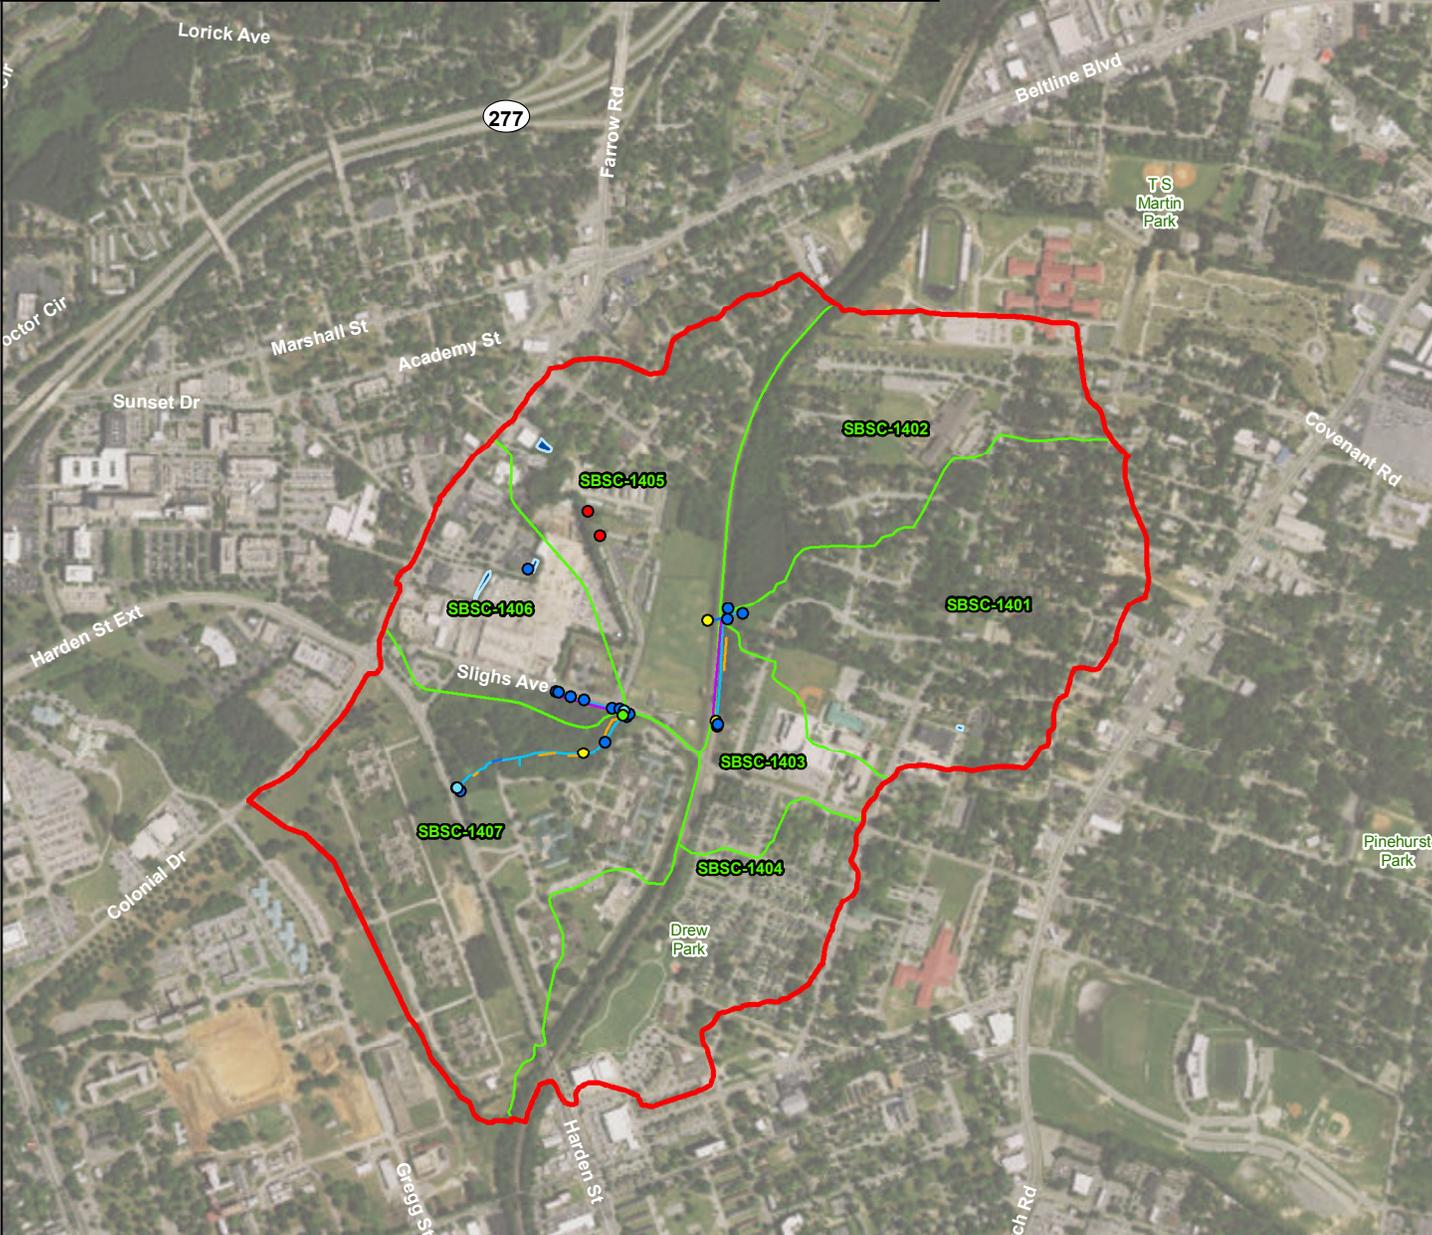
Figure 6.24:  
Subwatershed G  
Existing Conditions

Existing Condition	Count
Exposed Pipes	2
Pipe Outfalls	16
Unmanaged Runoff	2
Unusual Condition	4
Trash Dumping	0
Possible Fish Barrier	1
	<b>Linear Feet</b>
Erosion Site	1,006
Channel Alteration	121
Inadequate Forest Buffer	1,092

A 450 foot long tributary extends parallel to Slighs Avenue south of the City of Columbia Fleets Services building. The upstream extent of the tributary begins at two 36 inch RCPs. Channel incision and slumping along the left bank within this segment encroaches upon the roadway and endangers outfalls. The tributary converges with the main channel, described above and below, east of Howell Avenue.

During the field review, a total of 16 storm drain outfalls were identified within SW-G, all of which were in minor to moderate condition with the exception of two rated severe. The first severely rated outfall is a 48 inch CMP, 30 feet from the mainstem tributary, located west of Dove Terrace. The structure has a six foot vertical drop to the stream channel. Extreme downcutting has undermined the endwall which has begun to slump and crack above the pipe as the stream bank support erodes away. The second outfall rated in severe condition is downstream, adjacent to Harden Street. The discharge contained a chemical smell with a blue/green color and downcutting has undermined and destabilized the concrete pad.

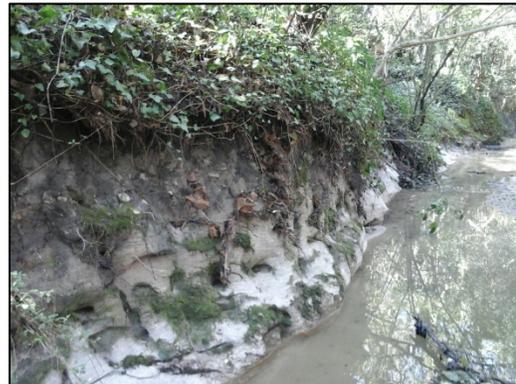
After the tributary flows into the receiving main channel, the channel becomes deeply incised downstream. The 10-foot tall banks are nearly vertical and composed mostly of silt with some bedrock at the toe. As the stream meanders west, bedrock intrusion becomes more frequent in the left bank and there are isolated areas of slumping, while the right bank is more densely vegetated and stable. Depositional mid-channel and point bars frequently constrict and divide baseflow. The stream extends through twin culverts at Eagle Avenue. Downstream

of the road crossing, there are isolated areas of erosion. The stream is then piped west under Harden Street and beyond the SW-G boundary onto the Bull Street Redevelopment property.

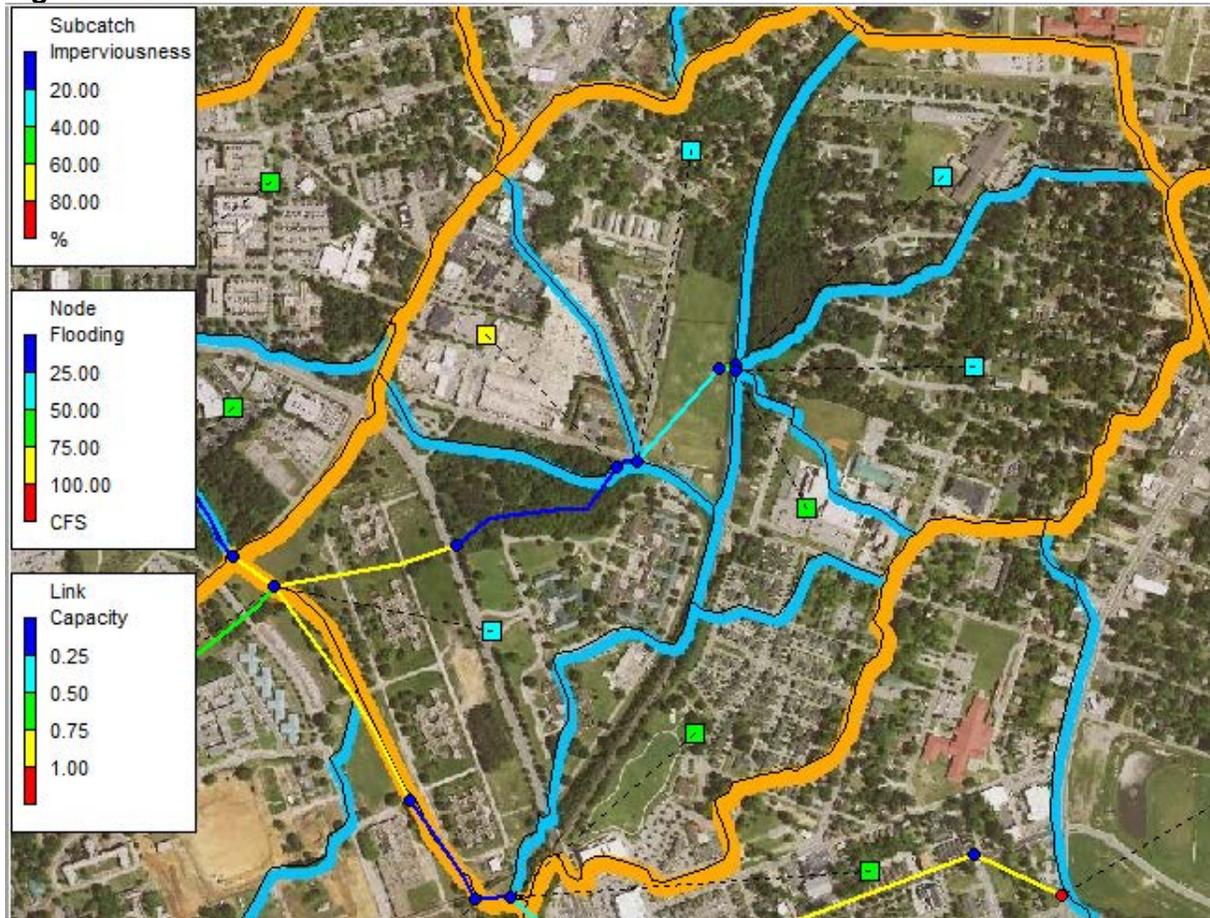
**Figure 6.25 SW-G SWMM Model**

SW-G is modeled as seven subcatchments (**Figure 6.25**). Six of these subcatchments drain to the 84 inch RCP at the western end of the subwatershed. The remaining subcatchment is modeled as draining to the upper end of the large dual culverts at Preston Drive. One subcatchment in this subwatershed is mostly commercial and approximately 70% impervious. The dual 84 inch RCPs that begin at Preston Drive are estimated to be at almost 80% capacity

due to the flows from SW-F and SW-G during a 2-year storm event. The undeveloped green space in this area should be further investigated for ways to store and infiltrate water.

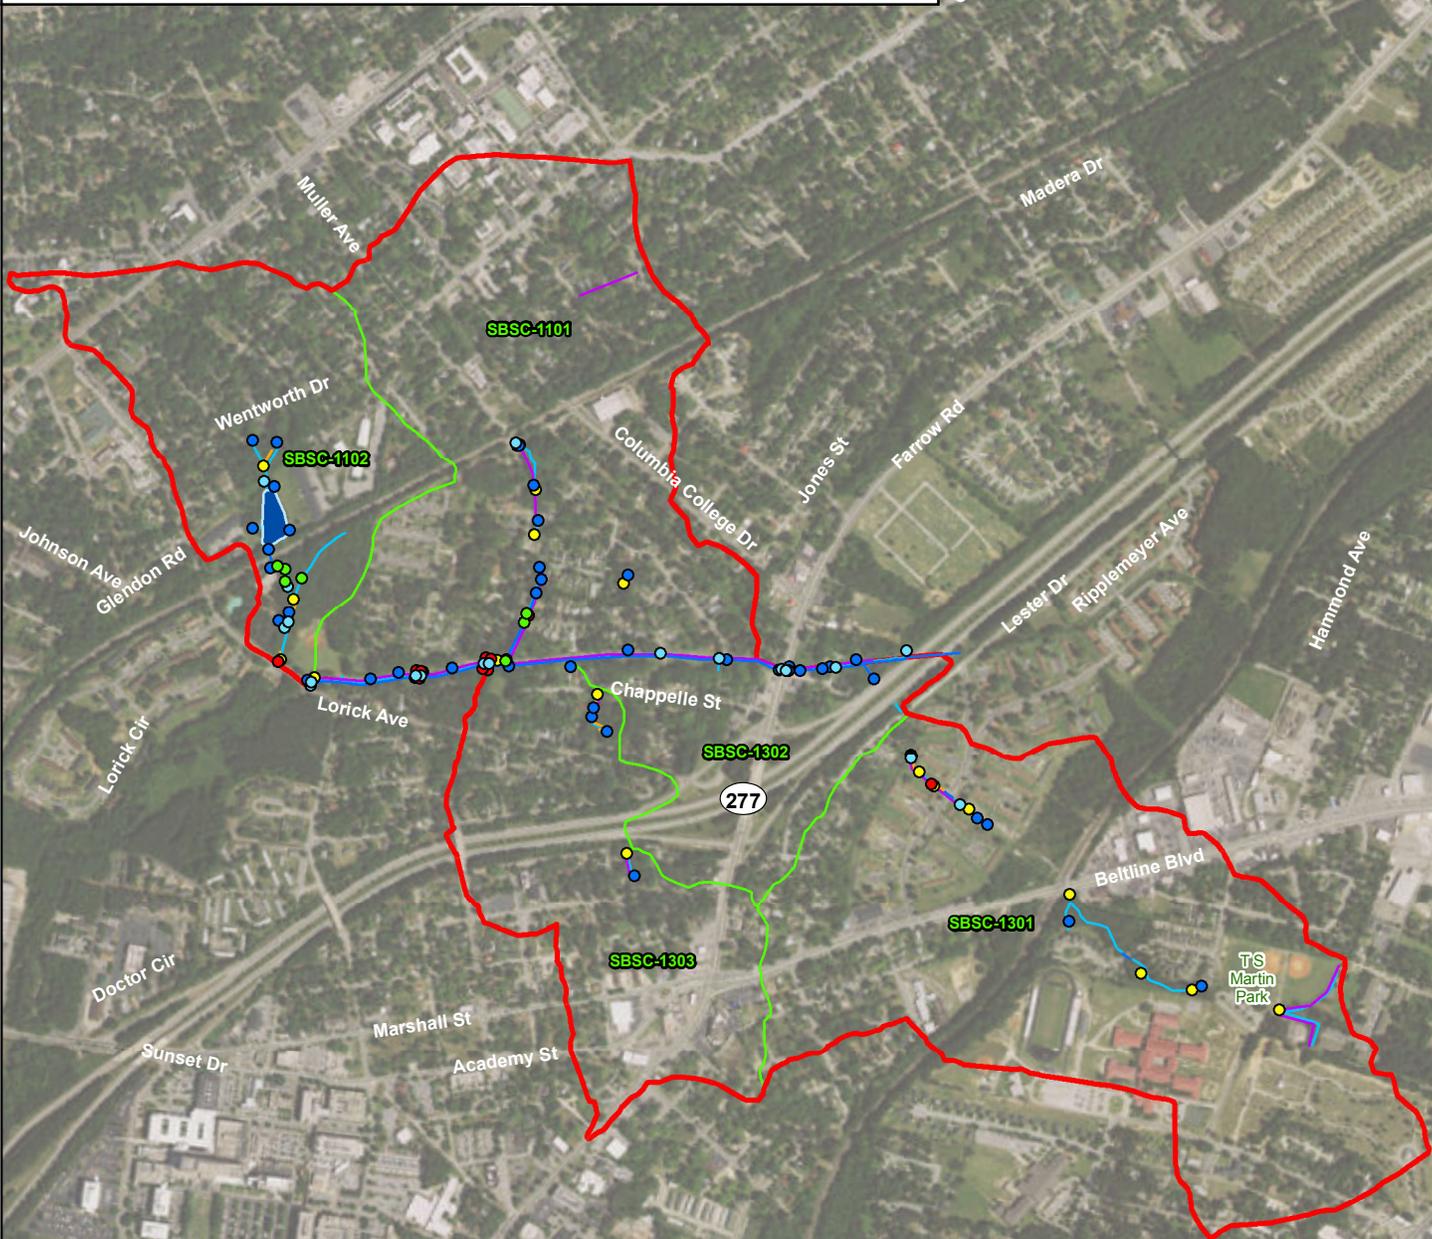
Figure 6.29:  
Subwatershed D  
Existing Conditions

Existing Condition	Count
Exposed Pipes	24
Pipe Outfalls	43
Unmanaged Runoff	11
Unusual Condition	19
Trash Dumping	0
Possible Fish Barrier	7
	<b>Linear Feet</b>
Erosion Site	1,268
Channel Alteration	5,121
Inadequate Forest Buffer	13,613

Within SW-D, the upstream extent of Bay Branch mainstem begins west of the culvert underneath SC-277. The stream flows west through a degraded trapezoidal cellular concrete channel. Large sand bars/benches are prevalent within the reach between SC-277 and Shaw Street. At Shaw Street, the condition of the channel changes, the concrete channel downstream of Shaw Street is smooth concrete, less degraded than the upstream reach, and with little to no deposition or vegetation present within the concrete margins. The channel becomes less degraded, with a

During the stream cruising effort, a total of 43 storm drain outfalls were identified within SW-D. Most outfalls are in minor or moderate condition; however, there are three identified as being in severe or very severe condition. One outfall rated as severe is located on the east side of the Colonial Drive roadway embankment between Seaboard Avenue and Cromer Street. Channel incision and base level lowering threaten the stability of the outfall and it was rated severe due to the proximity of instability to the travel lanes of Colonial Drive. The outfall rated very severe is a 36 inch RCP located upstream at the corner of Seaboard Avenue and Colonial Drive. During the stream cruising effort it appeared as though recent flooding and erosion had undermined the road and exposed underground utilities in this location. The third outfall, rated in severe condition, is adjacent to the very severe 36 inch outfall and has been given the severe rating due to separation at the joints of the two terminal segments of this pipe. Recent erosion in this area undermined road and utility lines and closed the road due to damage at the time of the stream cruising effort.

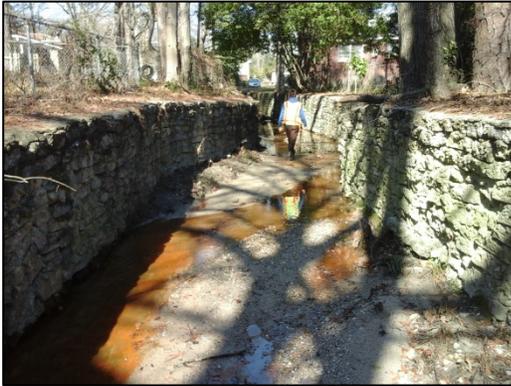
The second major tributary originates from south of SC-277 and west of Farrow Road. Open stream channel originates from a 36 inch RCP southwest of the intersection of Water Street and Adams Street. The tributary is then piped north under SC-277. Another segment of open channel originates from 52 inch RCP west of Water Street between Chappelle Street and Lorick Avenue. A third of the banks within this segment are actively eroding where the channel is tightly confined between private residential properties. The stream is piped underneath Chappelle Street then emerges from a 48 inch RCP into the Bay Branch mainstem east of Colonial Drive.

Open stream channel within the third major tributary originates at three pipe outfalls east of the Seaboard Avenue and Colonial Drive intersection. Seaboard Avenue was closed at the time of the stream cruising effort. It had appeared as though recent flooding and erosion had undermined the road and underground utilities. The outfall instability is discussed in further detail below. Channel substrate in the downstream tributary reach primarily consists of sand with some silt and gravel. The downstream end of this segment is incised, with 6-foot tall, vegetated banks with isolated

regions of scour. As the stream flows south it is piped under Cromer and Hurst Streets. Downstream of Hurst Street, the stream bed is concrete with vertical 5-foot grouted stone walls. There are large sand deposits in the reach between Hurst and Manse Streets. The channel extends under Manse Street, with similar concrete channel conditions downstream. The tributary joins Bay Branch approximately 120 feet east of Colonial Drive.

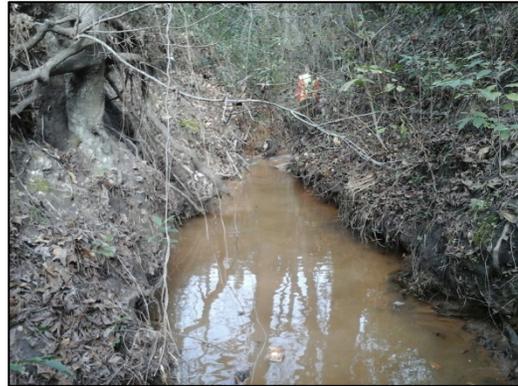
The upstream extent of the fourth major tributary initiates in a forested parcel south of Wentworth Drive and east of Kinderway Avenue. Streambanks are mostly stable and well vegetated, with some isolated areas of moderate erosion. Channel substrate consists of silt and sand, with some gravel along the riffles. Downstream, the stream is routed through a large pond before passing underneath railroad tracks to the south and entering Lorick Park. The railroad culvert appears to be blocked on the downstream side by riprap recently placed on the embankment face. Downstream of the railroad, the channel is incised with 7-foot banks, thick established vegetation, and bedrock at the toe and in the bed. A wetland seep flows into this tributary north of the baseball diamond. Stream conditions change downstream of the confluence; the bank heights lower and the understory vegetation thins as the stream enters the maintained section of the park. Bed substrate changes to primarily gravel with substantial quantities of sand and cobble. The stream is then piped along Lorick Avenue, and enters Bay Branch immediately upstream of the Lorick Avenue crossing.

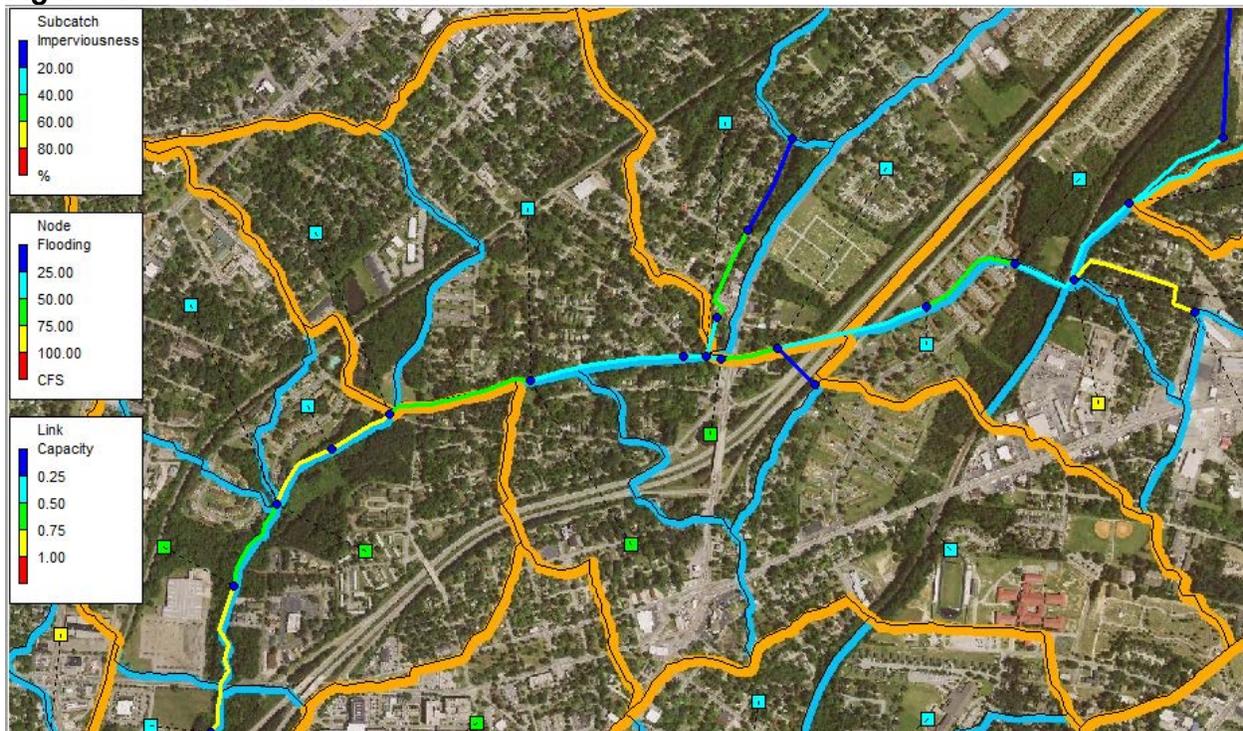
**Figure 6.30 SW-D SWMM Model**

SW-D is modeled in SWMM as five subcatchments on either side of Bay Branch. Bay Branch is a concrete-lined trapezoidal channel as it flows through the subwatershed. Due to the low Manning's roughness of concrete, water in this channel will flow at higher velocities. Where the concrete-lined portion of the channel ends, the flow is modeled to enter a backwater condition, causing the link to near its capacity, changing the mapped color to yellow (**Figure 6.30**) at 88% modeled capacity.
