# SMITH BRANCH WATERSHED ASSESSMENT

MAY 20, 2016

CITY OF COLUMBIA  
UTILITY AND ENGINEERING DEPARTMENT  
1136 WASHINGTON STREET, 7TH FLOOR  
COLUMBIA, SOUTH CAROLINA 29201

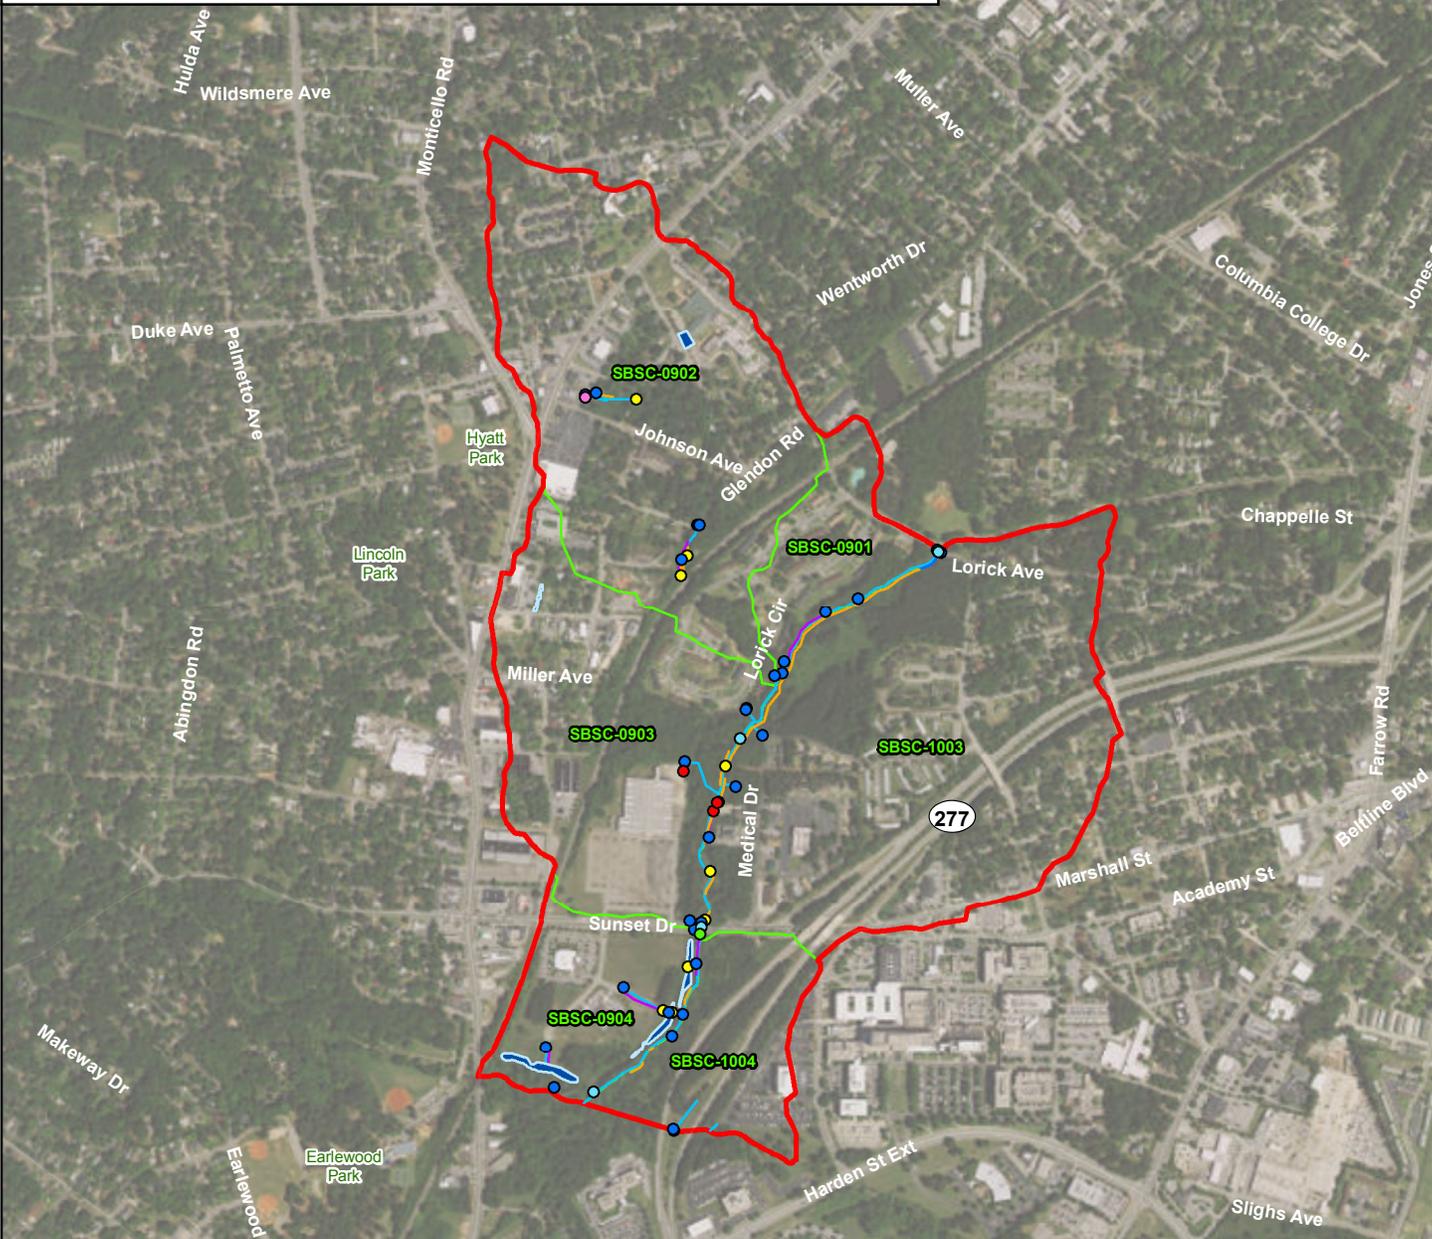
Figure 6.34:  
Subwatershed E  
Existing Conditions

Existing Condition	Count
Exposed Pipes	4
Pipe Outfalls	29
Unmanaged Runoff	3
Unusual Condition	11
Trash Dumping	1
Possible Fish Barrier	1
	<b>Linear Feet</b>
Erosion Site	4,901
Channel Alteration	234
Inadequate Forest Buffer	2,433

The upstream extent of the main channel (Bay Branch) in SW-E begins at the Lorick Avenue crossing. The channel bed and banks are initially concrete, changing to natural channel approximately 170 feet downstream of Lorick Avenue. Paralleling Lorick Circle and flowing in a south/southwest direction the channel is entrenched and straight. The cross-sectional area through this reach is significantly smaller than the concrete channel immediately upstream, combined with the increased roughness within the natural channel segment, a backwater condition would be anticipated

as flood flows leave the concrete channel downstream of Lorick Avenue. Channel incision and widening has begun to threaten surrounding infrastructure through this reach. Bedrock is now likely slowing the rate of incision and widening as past erosion has exposed bedrock in the bed and banks. Channel substrate consists of a mix of sand, gravel, and cobble, with bedrock exposed in cascades and riffles.

During the field review, a total of 29 stormwater outfalls were identified within SW-E, all of which were noted to be in minor to moderate condition with the exception of two outfalls that were in severe condition. The first severe outfall is west of the Medical Drive, Doctors Circle intersection, 80 feet from Bay Branch. The outfall channel has downcut and the 30 inch CMP outfall has destabilized with a minimum of two terminal segments disjointed. The other severe

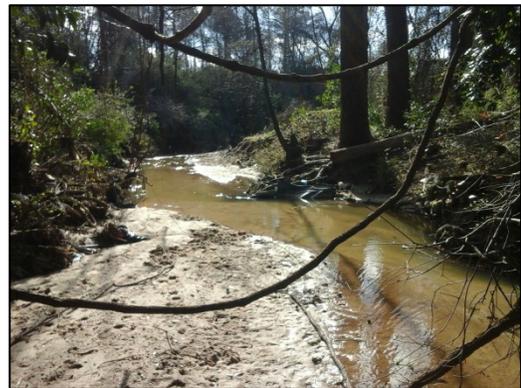
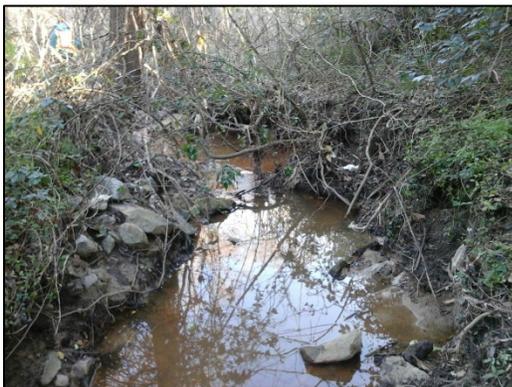
Along Bay Branch downstream of Lorick Circle, erosion continues to impact the streams surrounding environment and threatens overhead utility poles, sanitary lines, and the parking lot of the Alston Wilkes Veterans Home off Medical Drive. Downstream of the Veterans Home parking lot, sinuosity increases, and there is isolated erosion at the outside of bends with depositional point bars on the inside. The percent sand increases within the bed through this reach, with some gravel and cobble along riffles. The stream extends through a quad box culvert under Sunset Drive. Downstream of the quad culvert is an 18-inch vertical baseflow water surface drop. Downstream of Sunset Drive, the substrate is primarily sand. The banks are fairly stable and well established with woody vegetation. A few areas of isolated minor to moderate erosion exist, undercutting trees and scouring the outside of bends. Bay Branch within SW-E concludes at the downstream subwatershed boundary, where it flows into the mainstem of Smith Branch.

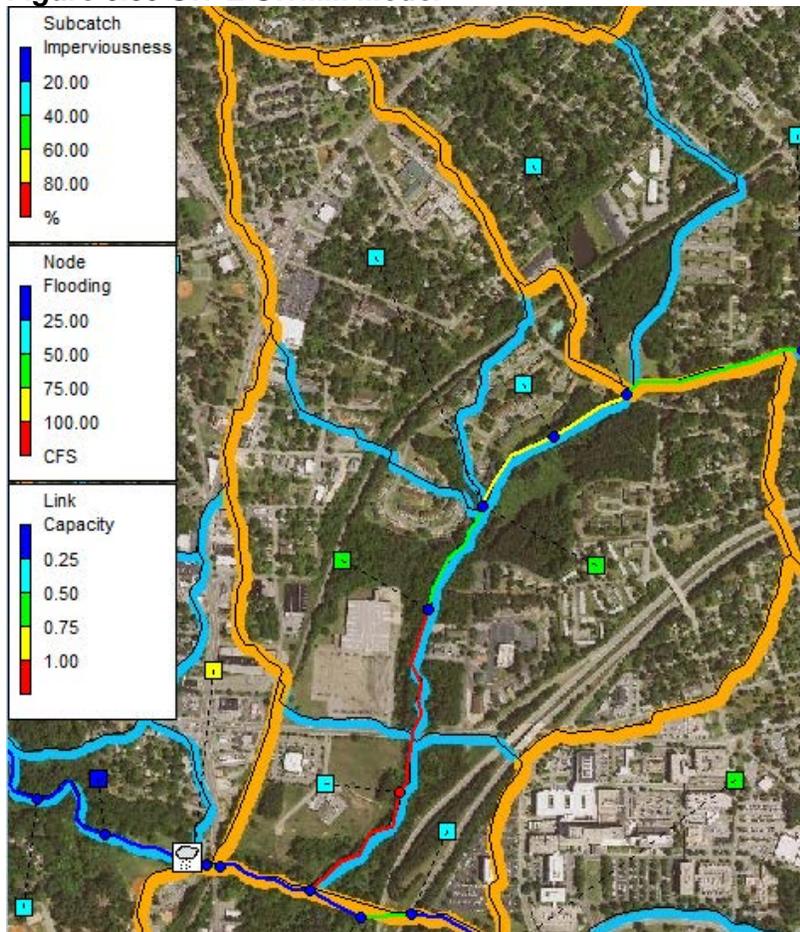
**Figure 6.35 SW-E SWMM Model**

SW-E is another one of the contributing subwatersheds to Bay Branch and consists of mixed development. The SWMM modeling for SW-E predicts that a 2-year storm event would produce a peak of 1.1 cfs/acre, which is average for the watershed. The subwatershed has just above average impervious surface at 40% compared to the rest of the subwatersheds. The subwatershed is average in size at 342 acres, and as a result, the total runoff volume modeled for a 2-year storm event is 13.0 million gallons, also average for the watershed. The runoff per area is 5,073 cubic feet/acre, slightly above average among the subwatersheds.

SW-E is modeled as six subcatchments in SWMM. It makes up the lower portion of Bay Branch. The more impervious commercial areas of this subwatershed can be seen along the western boundary in the aerial imagery (**Figure 6.35**). Where Bay Branch meets Smith Branch, flooding issues are modeled to occur during the 2-year event as this area of the tributary reaches 100% capacity and water begins to flow into the overbank areas. Bay Branch itself has been highly

altered in areas with concrete linings at the top of this catchment that cause more rapid stream flow peaks down the tributary to Smith Branch, resulting in more flooding issues downstream.

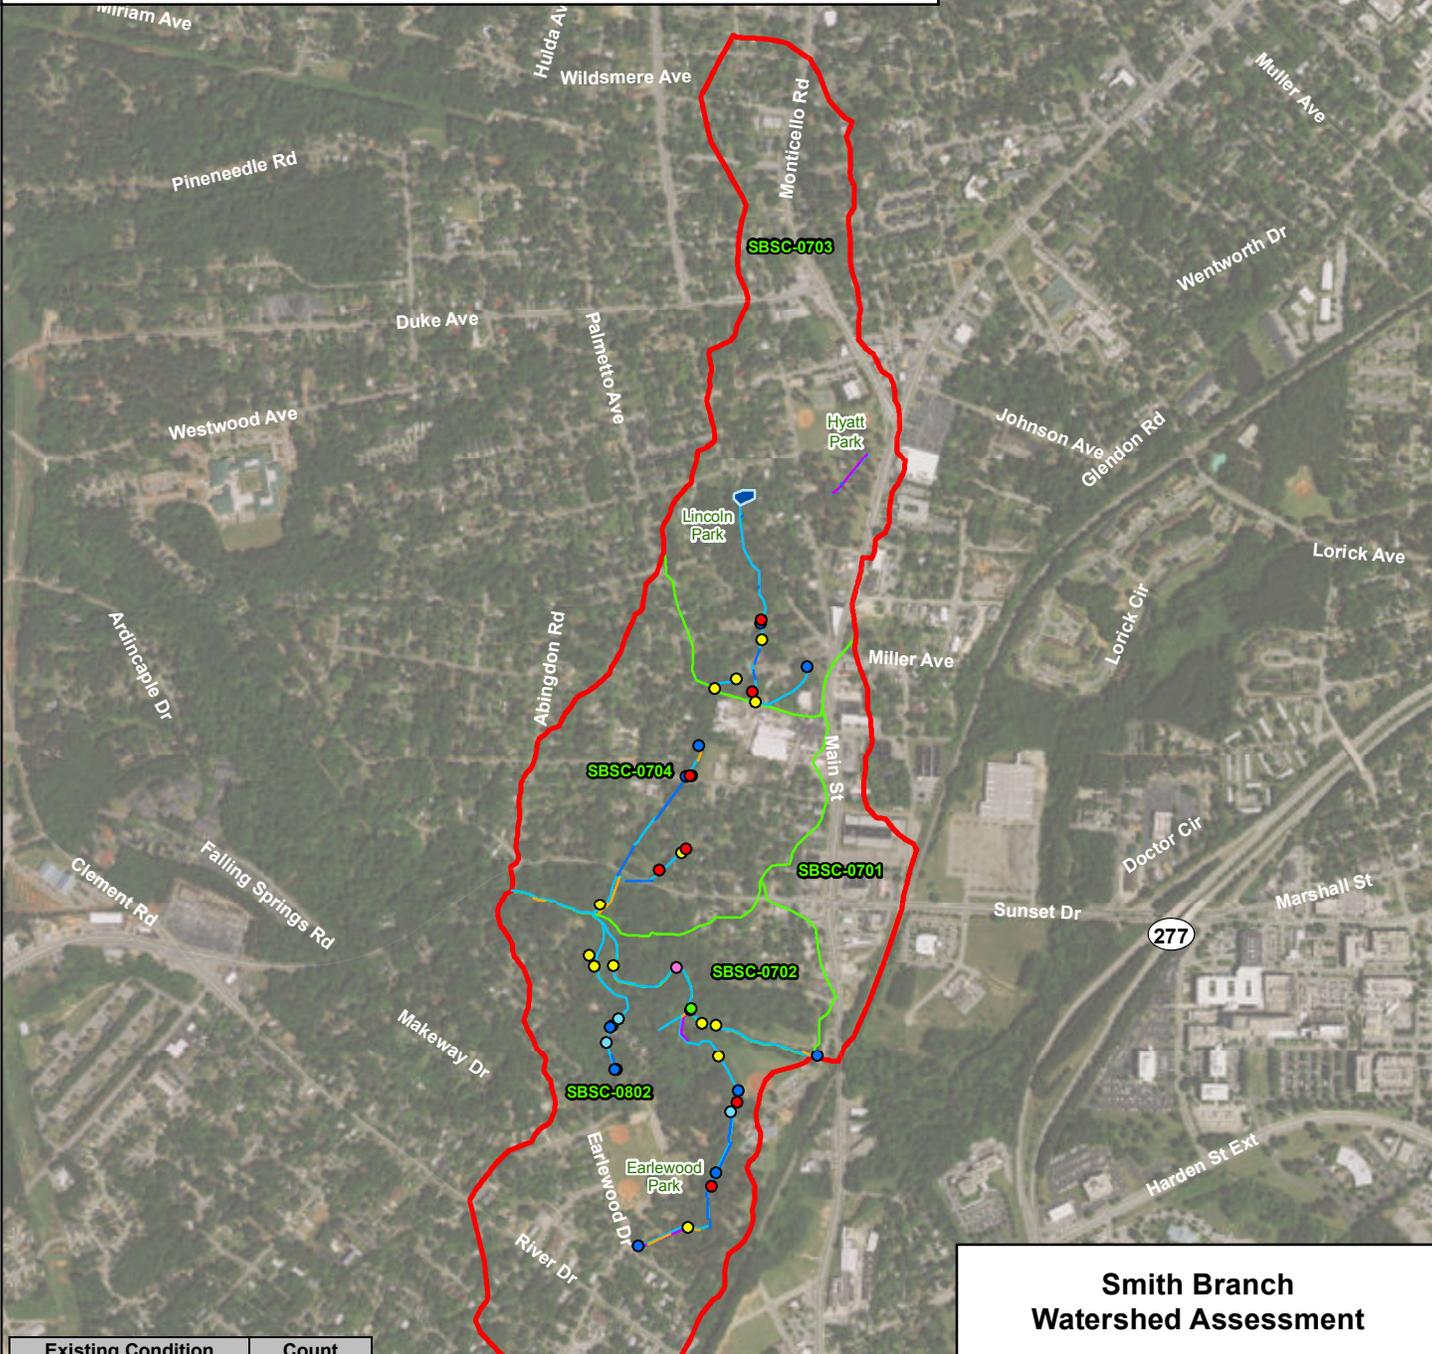
Existing Condition	Count
Exposed Pipes	3
Pipe Outfalls	12
Unmanaged Runoff	7
Unusual Condition	15
Trash Dumping	1
Possible Fish Barrier	1
	<b>Linear Feet</b>
Erosion Site	1,380
Channel Alteration	1,934
Inadequate Forest Buffer	2,670

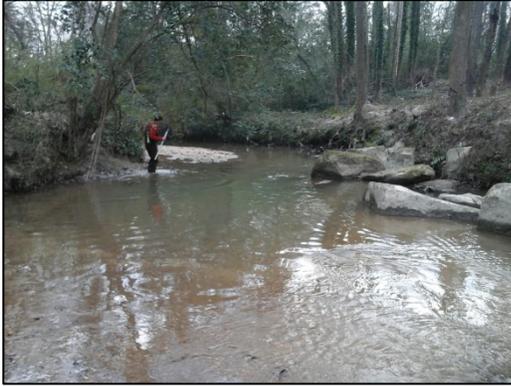
Within SW-J the upstream extent of the Smith Branch mainstem begins within Earlewood Park, approximately 120 feet west of Main Street. Banks along this segment are fairly stable, with mature vegetation offering protection. A beaver dam, approximately 800 feet downstream, has created a backwater that extends throughout the upstream limit of this segment. Downstream of the beaver dam, the channel is more sinuous. Banks remain vegetated and stable, and large point bars have formed throughout. Substrate primarily consists of sand, with boulder and

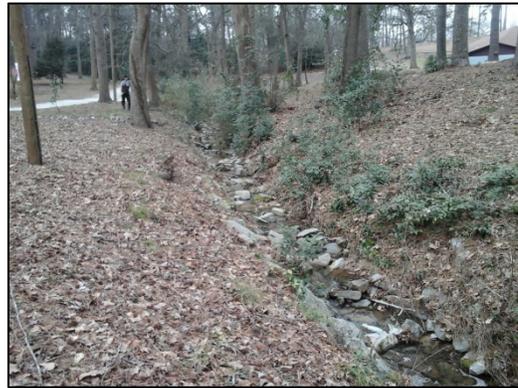
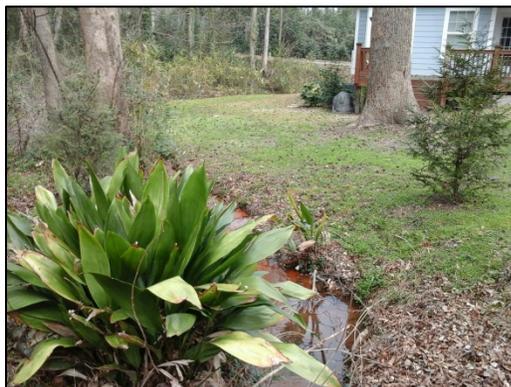
Three large tributaries drain to the Smith Branch mainstem within SW-J. The first and easternmost tributary flows into the mainstem 275 feet west (downstream) of Earlewood Park. This stream channel initiates northeast of the Earlewood Drive and Union Street intersection from a 24 inch, concrete outfall. The steep gradient downstream of the outfall has resulted in the migration of a headcut up the slope. The stream extends downstream through multiple small culverts associated with park paths. Substrate in this tributary is primarily riprap, with sand and cobble filling voids between the boulders. Downstream, north of Parkside Drive, the channel is not clearly defined due to a large beaver dam downstream that has created a wetland-like area. Downstream of the beaver dam, the stream lacks a defined single thread channel as it flows through a mudflat and drains into the mainstem at multiple points.

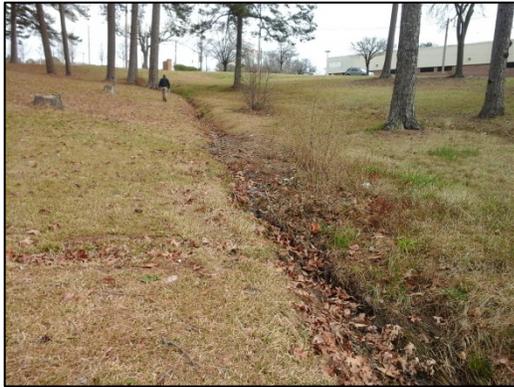
Approximately 90 feet downstream of the second tributary confluence, the third tributary joins the Smith Branch mainstem from the right bank. Upstream limits of this tributary begins within a wet swale in Hyatt Park. The stream is piped from Hyatt Park to south of Miller Avenue,

where the channel is more entrenched with thick vegetation stabilizing the banks. There is a confluence point southeast of the Miller Avenue and Ridgewood Avenue intersection with another tributary originating from Lincoln Park. The stream segment originating from Lincoln Park is characterized by low, stable banks with heavy vegetation and a sandy bed. Downstream, the channel is piped along a large commercial property southeast of the Miller Avenue and Ridgewood Avenue intersection. Open stream channel emerges from a 60 inch RCP northeast of the

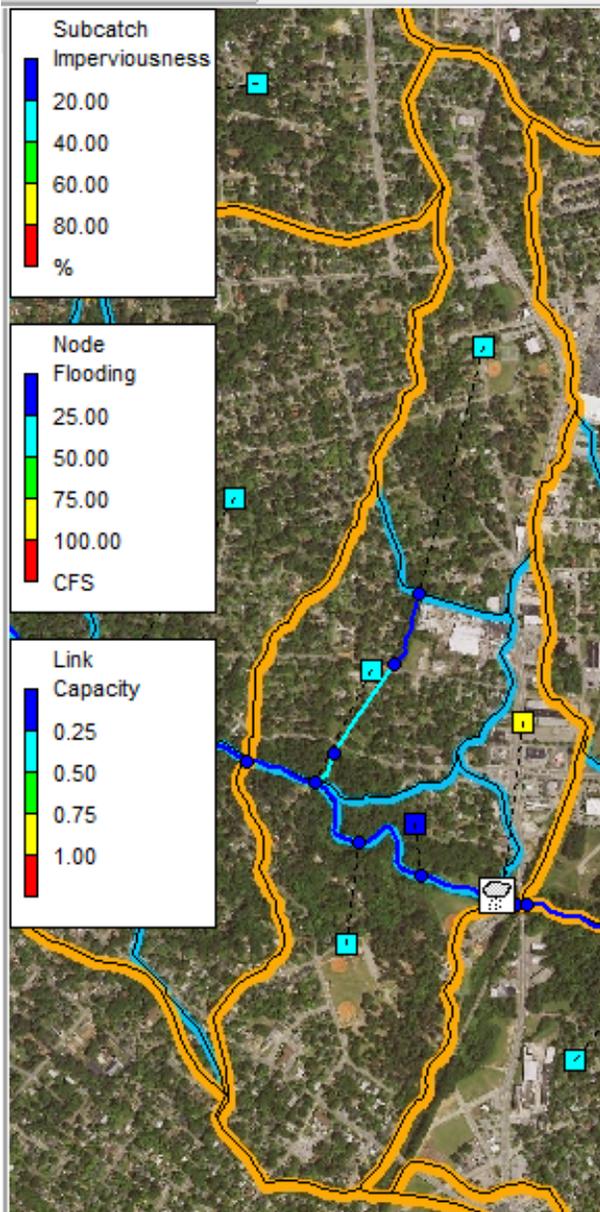
**Figure 6.40 SW-J SWMM Model**

SW-J is modeled in SWMM as five subcatchments (**Figure 6.40**). One subcatchment, along Main Street, is highly impervious at approximately 78%. The areas further from Smith Branch are more suburban and lower in imperviousness. These less-developed areas and any open space in the floodplain by Smith Branch are candidates for additional protection where flood attenuation and/or storage may be more feasible.

**Total Subwatershed Runoff Ranking: 8**

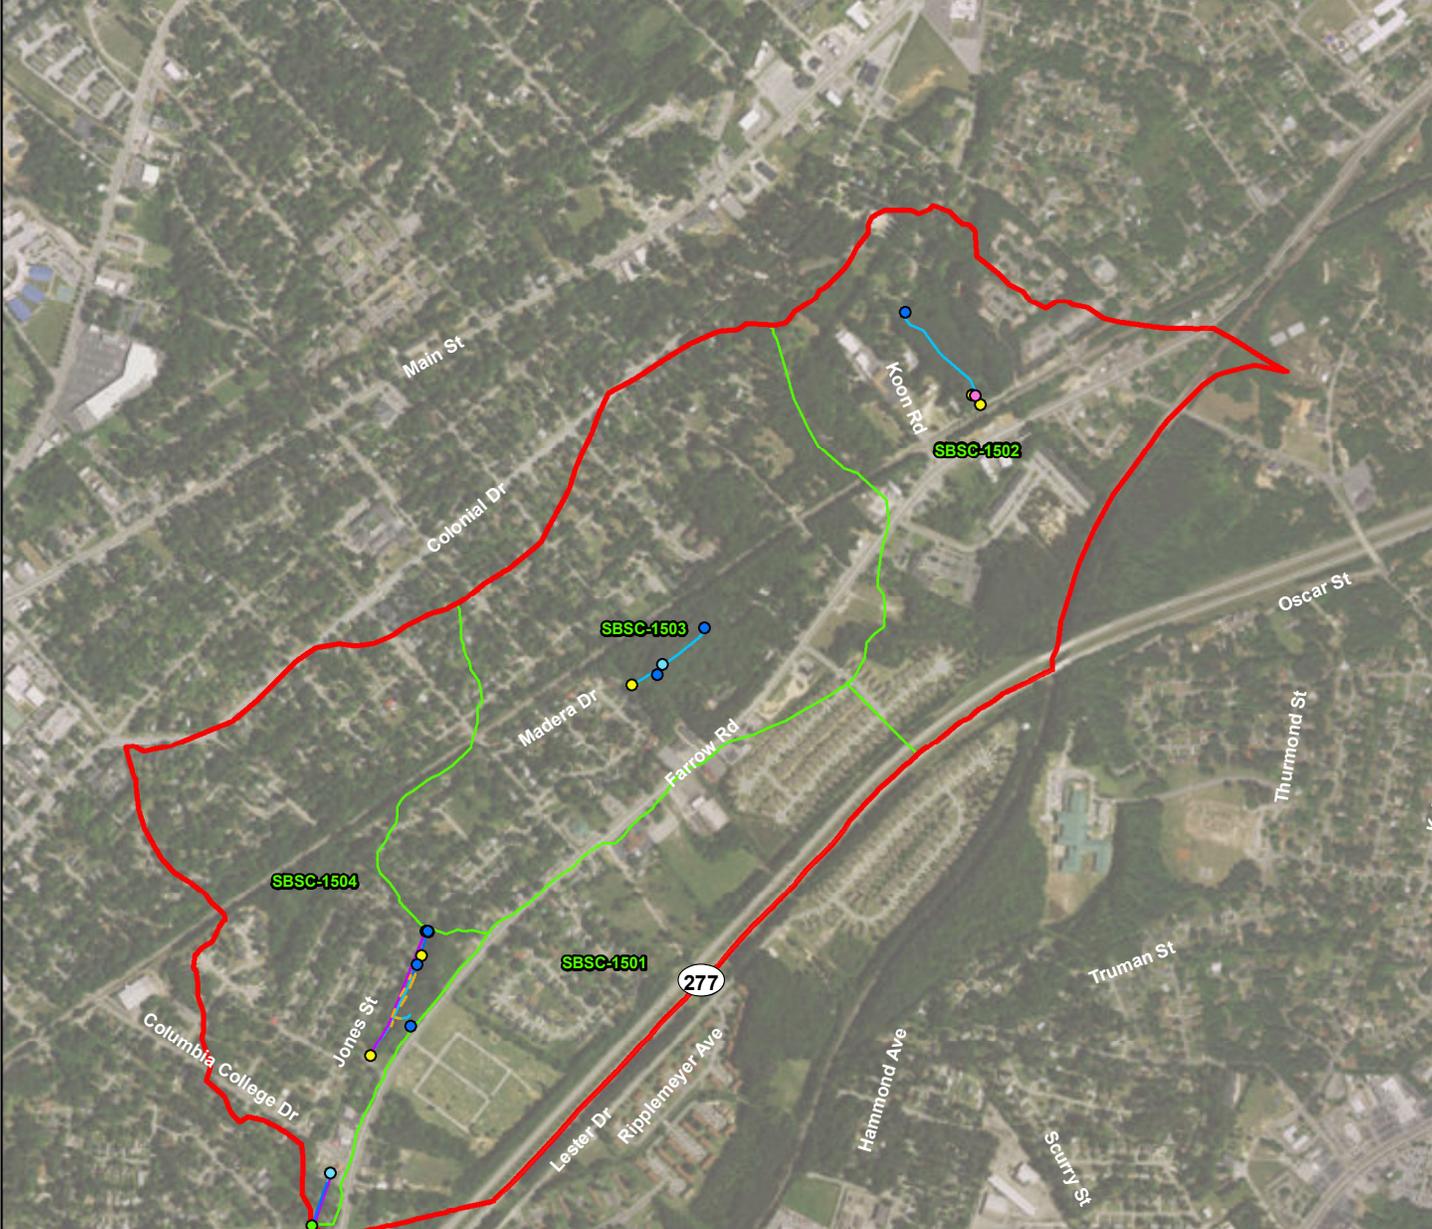
Figure 6.44:  
Subwatershed C  
Existing Conditions

Existing Condition	Count
Exposed Pipes	2
Pipe Outfalls	9
Unmanaged Runoff	0
Unusual Condition	5
Trash Dumping	1
Possible Fish Barrier	1
	<b>Linear Feet</b>
Erosion Site	403
Channel Alteration	631
Inadequate Forest Buffer	1,554

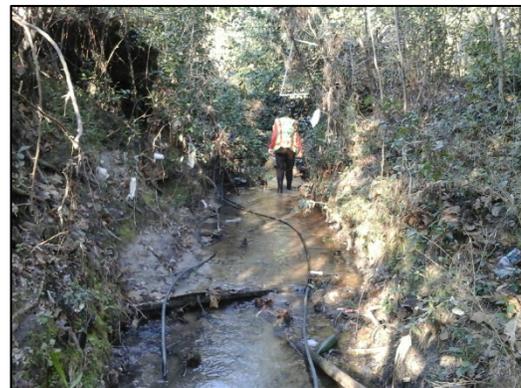
Downstream, the stream emerges from a 6-foot wide, 3-foot high twin box culvert east of the Vann Street, Jones Street intersection. The stream is channelized with grouted stone walls and a grouted bed with multiple imbricated stone weirs. The rigid channelization continues for approximately 320 feet. Immediately downstream of the grouted segment the banks become sheer and near vertical, and consist of highly erodible materials. Sediment deposition has created small point bars, and riprap and brick in the bed alter flow. A small tributary with a severe headcut contributes flow to the receiving channel approximately 280 feet downstream of the end of concrete channelization. This tributary appears to collect drainage from Farrow Road and an outfall point was collected in the location of suspected drainage along the western side of Farrow Road and is discussed further below. The main open stream channel in this segment enters a 48 inch RCP under Isabel Street.

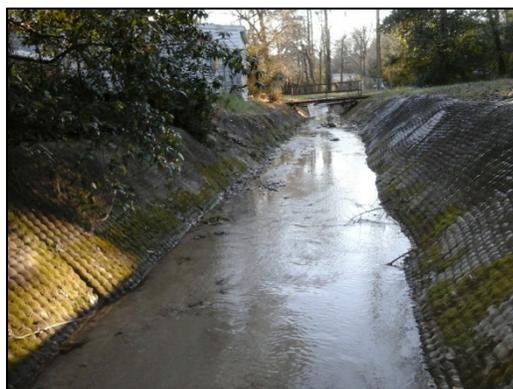
The downstream most segment of open channel emerges from a 48-inch CMP with a grouted stone headwall south of Columbia College Drive. A 6-inch smooth metal pipe utility crosses the downstream opening of the 48-inch CMP. The left bank is steep and layered with thick vegetation. Approximately 70 feet downstream of the culvert, the stream is channelized with concrete bed and banks. Fine sand deposits are extensive throughout the stream bed within the concrete channel. The stream converges with the receiving main channel (Bay Branch) at the

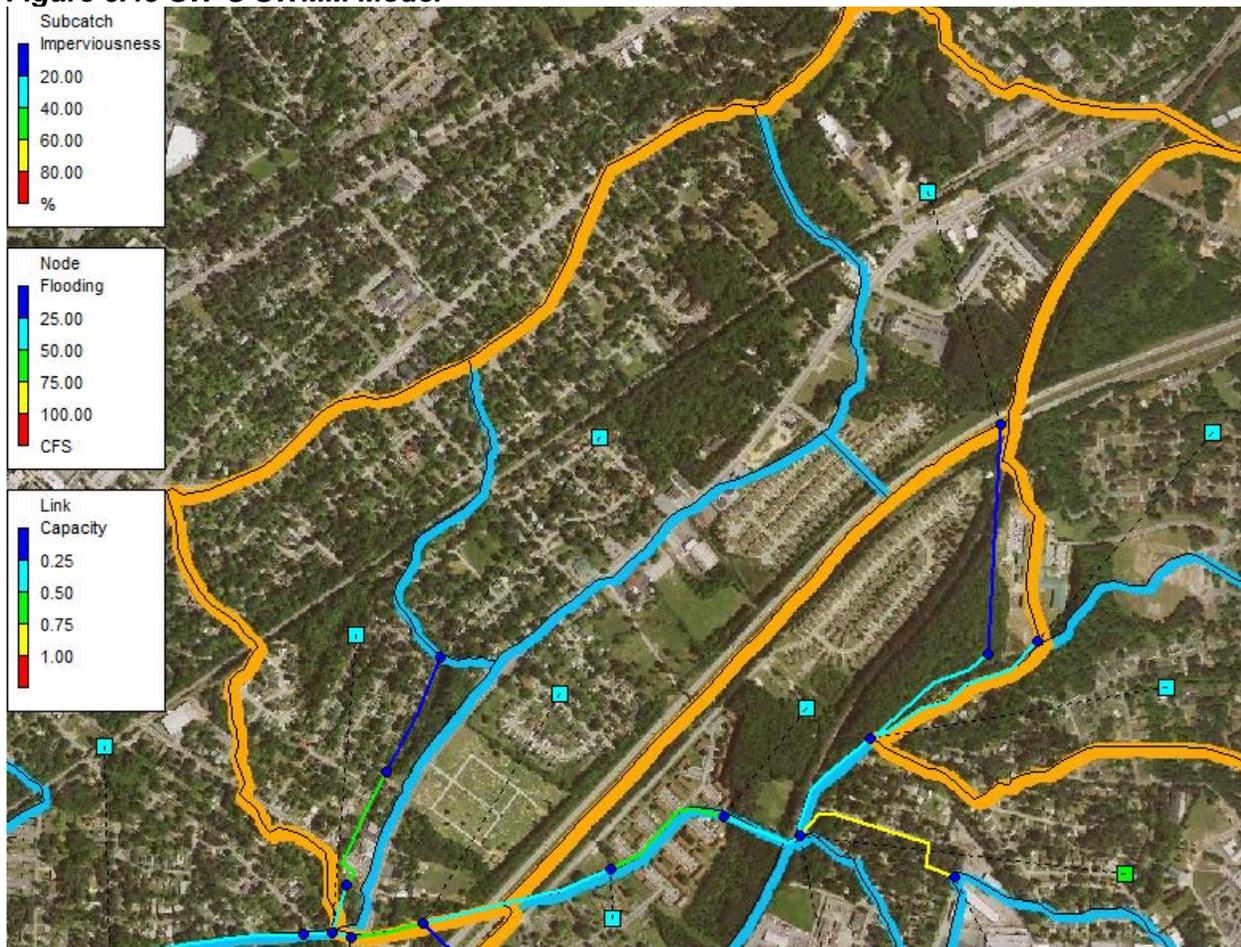
**Figure 6.45 SW-C SWMM Model**

SW-C is modeled as four subcatchments in SWMM. Its suburban nature and undeveloped areas can be seen in **Figure 6.45** below. There is a 48 inch RCP, mapped in green below, at the southern end of this subwatershed that is already at approximately 60% modeled capacity during the 2-year event.

**Total Subwatershed Runoff Ranking: 9**

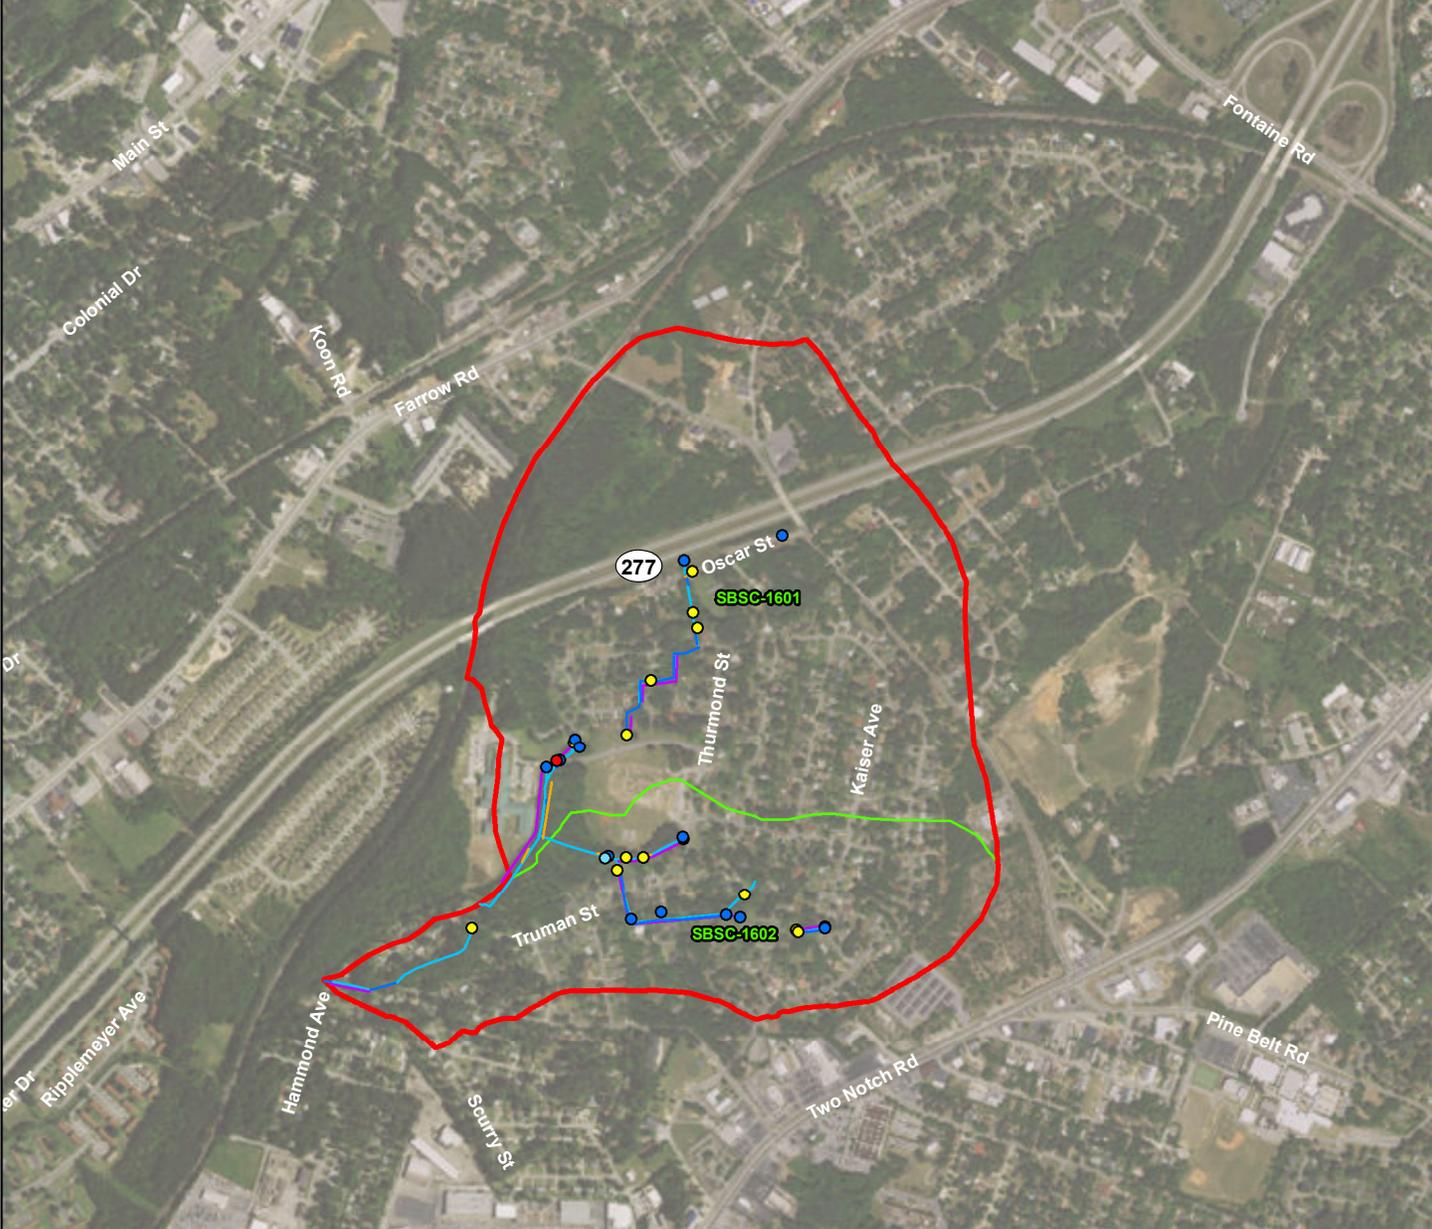
Figure 6.49:  
Subwatershed A  
Existing Conditions

Existing Condition	Count
Exposed Pipes	1
Pipe Outfalls	15
Unmanaged Runoff	1
Unusual Condition	13
Trash Dumping	0
Possible Fish Barrier	0
	<b>Linear Feet</b>
Erosion Site	1,001
Channel Alteration	2,475
Inadequate Forest Buffer	6,125

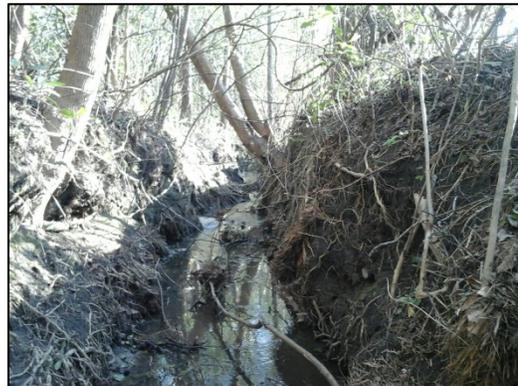
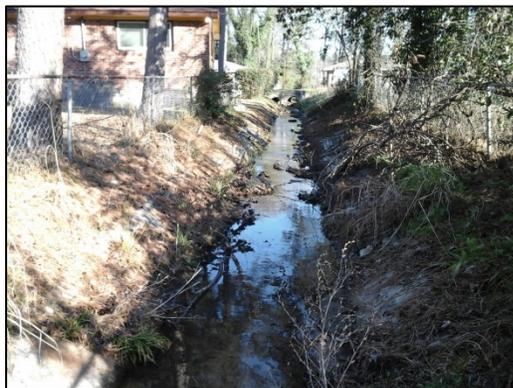
The stream is piped west along the north side of the school entrance for 300 feet before it is again daylighted. Immediately downstream, there is a confluence point with a tributary emerging from a 36 inch RCP. The adjacent landowner expressed concern over frequent flooding in this location. The stream then flows south through a culvert under the school entrance road. The channel is deeply incised downstream of the culvert, with approximately 6 to 7-foot tall banks that are raw in sections but with root structure offering some stability. Bed substrate is primarily sand, with some bedrock intrusion visible at the toe of the banks. A significant tributary converges with the main channel from the left bank approximately 430 feet downstream from the school entrance road culvert. The main channel continues downstream with similar conditions before taking a 90 degree turn west at Truman Street, exiting the subwatershed.

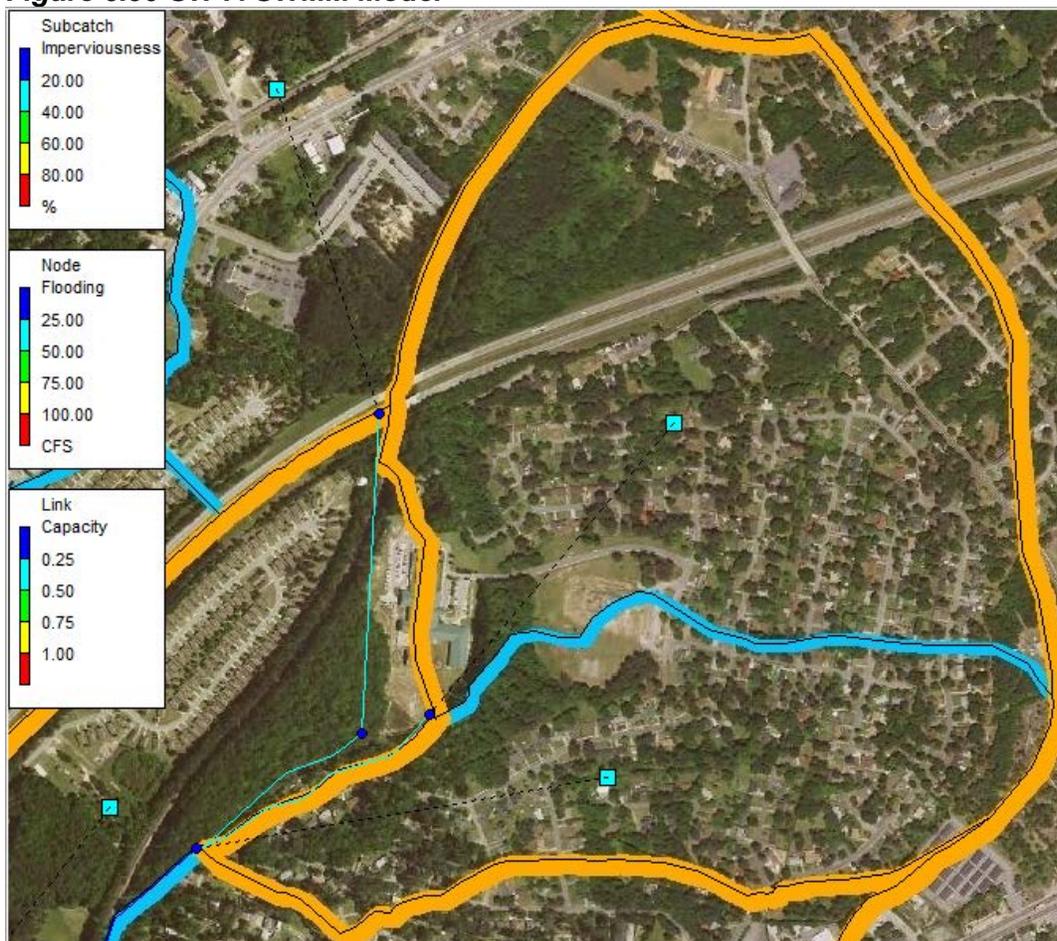
**Figure 6.50 SW-A SWMM Model**

SW-A is modeled in SWMM as two subcatchments (**Figure 6.50**), each contributing flows directly to open channel conveyance. The open channel conveyance in this part of the watershed has 50% capacity at the 2-year storm event. The suburban nature of this subwatershed can be seen in the aerial imagery, as well as the undeveloped areas in the northern end of it.

**Total Subwatershed Runoff Rating: 10**

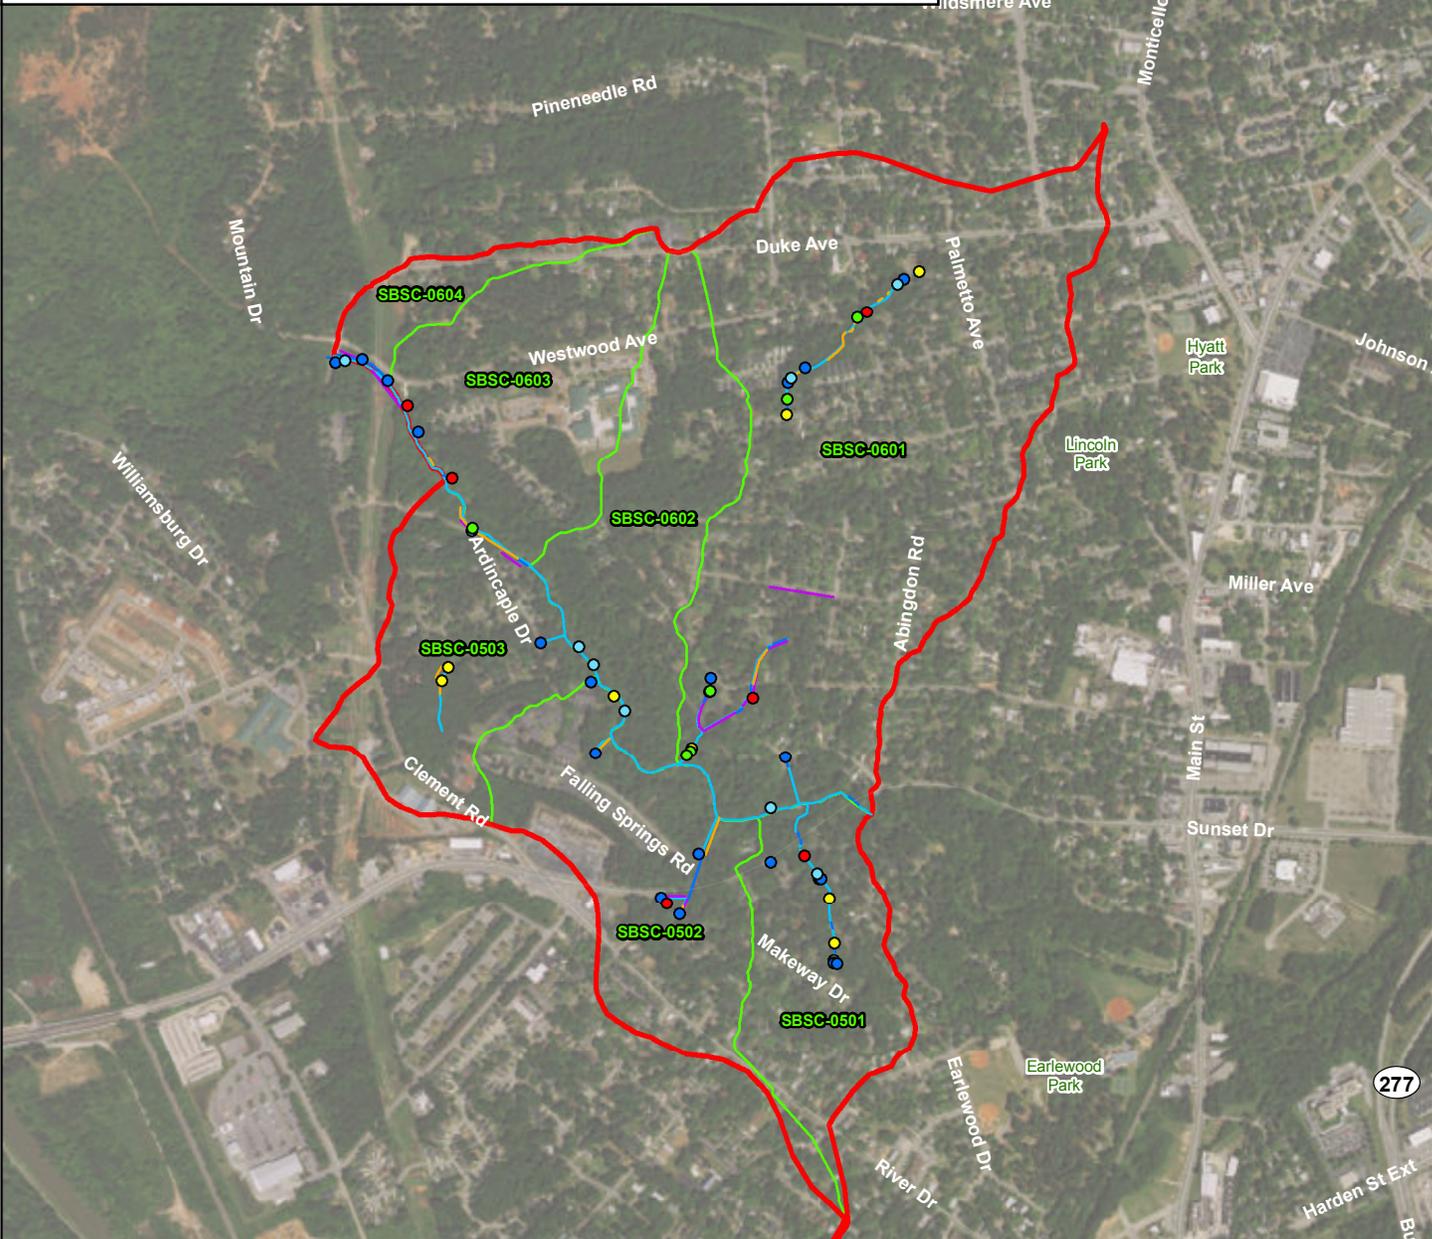
Figure 6.54:  
Subwatershed K  
Existing Conditions

Existing Condition	Count
Exposed Pipes	10
Pipe Outfalls	19
Unmanaged Runoff	6
Unusual Condition	10
Trash Dumping	0
Possible Fish Barrier	6
<b>Linear Feet</b>	
Erosion Site	2,912
Channel Alteration	1,674
Inadequate Forest Buffer	4,413

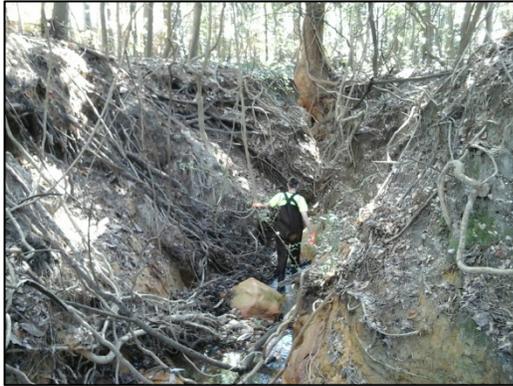
Downstream, the third and largest tributary in SW-K flows into the mainstem from the right bank, southwest of the Avondale Drive and Summerlea Drive intersection. The upstream extent

of open channel along this tributary begins at a 48 inch RCP under Margrave Road near the Duke Avenue intersection. The channel is shallow and vegetated, with channel material consisting of mostly gravel and cobble. The stream extends through a culvert under Abingdon Road. Downstream of the culvert, severe channel incision contributes to bank instability for the majority of this segment, extending downstream to Myles Avenue. Downcutting has undercut trees and exposed bedrock in the bed and at the toe of the 15-foot tall banks. Incision lessens immediately upstream

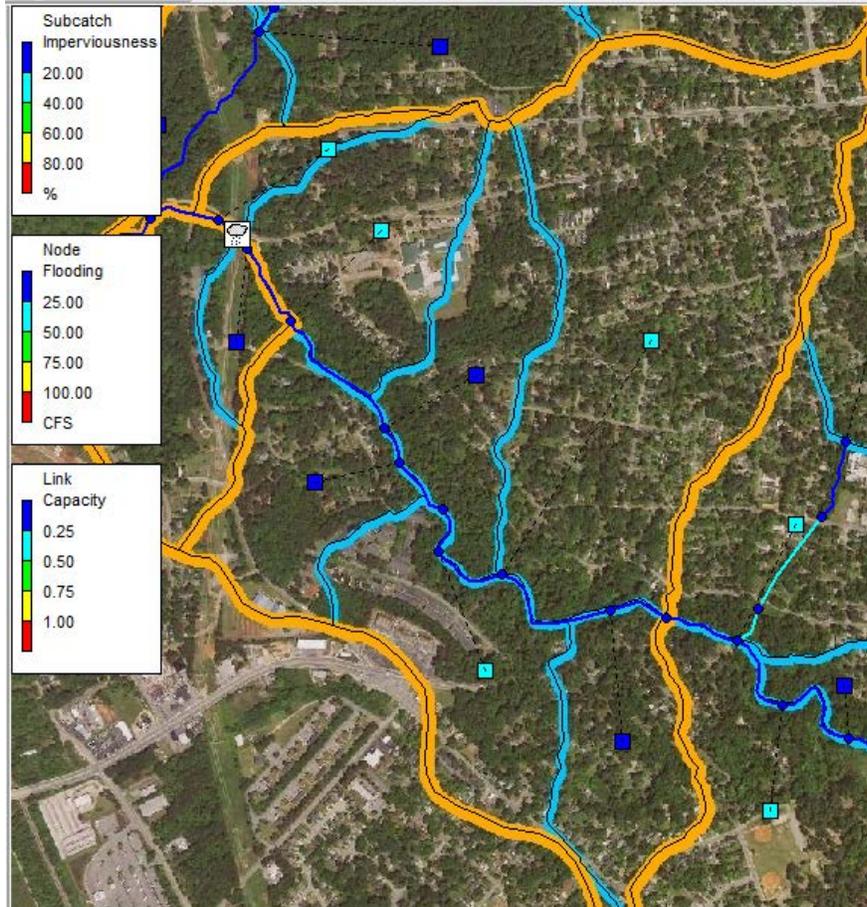
**Total Subwatershed Runoff Ranking: 11****Figure 6.55 SW-K SWMM Model**

SW-K is modeled in SWMM as six subcatchments (**Figure 6.55**), three on either side of Smith Branch. All of these subcatchments are low in imperviousness, with the highest only nearly 30%. The suburban nature and unencumbered floodplain areas of this watershed should be preserved given the identified problems and needs for flood storage/relief in upstream subcatchments. The relatively low amount of runoff generated here is allowed to flow out of the watershed without exacerbating flooding issues.
