# SMITH BRANCH WATERSHED ASSESSMENT

MAY 20, 2016

CITY OF COLUMBIA  
UTILITY AND ENGINEERING DEPARTMENT  
1136 WASHINGTON STREET, 7TH FLOOR  
COLUMBIA, SOUTH CAROLINA 29201

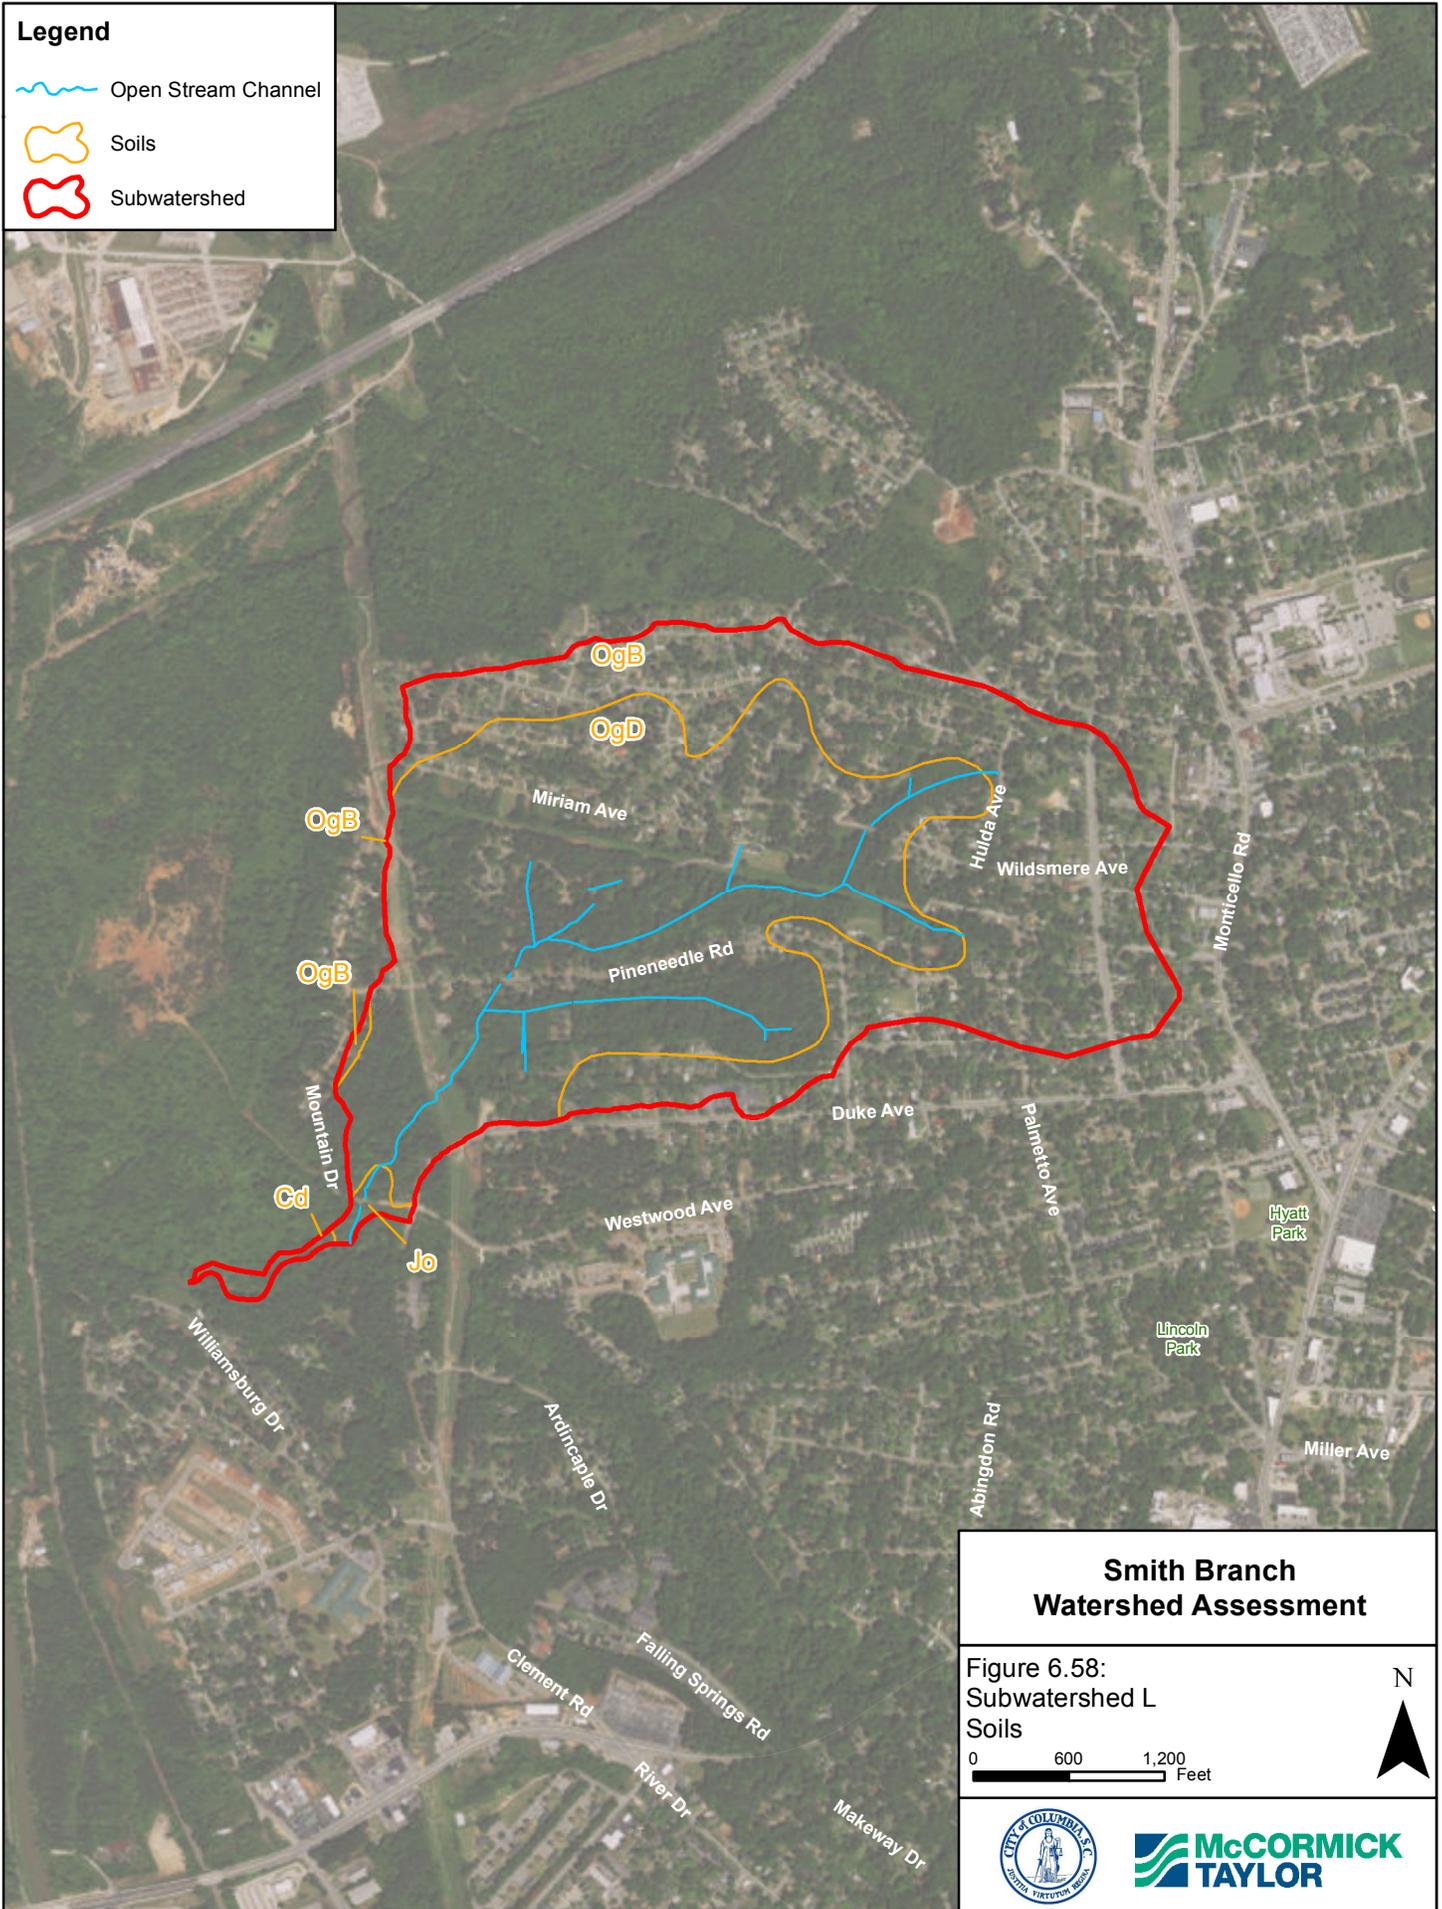
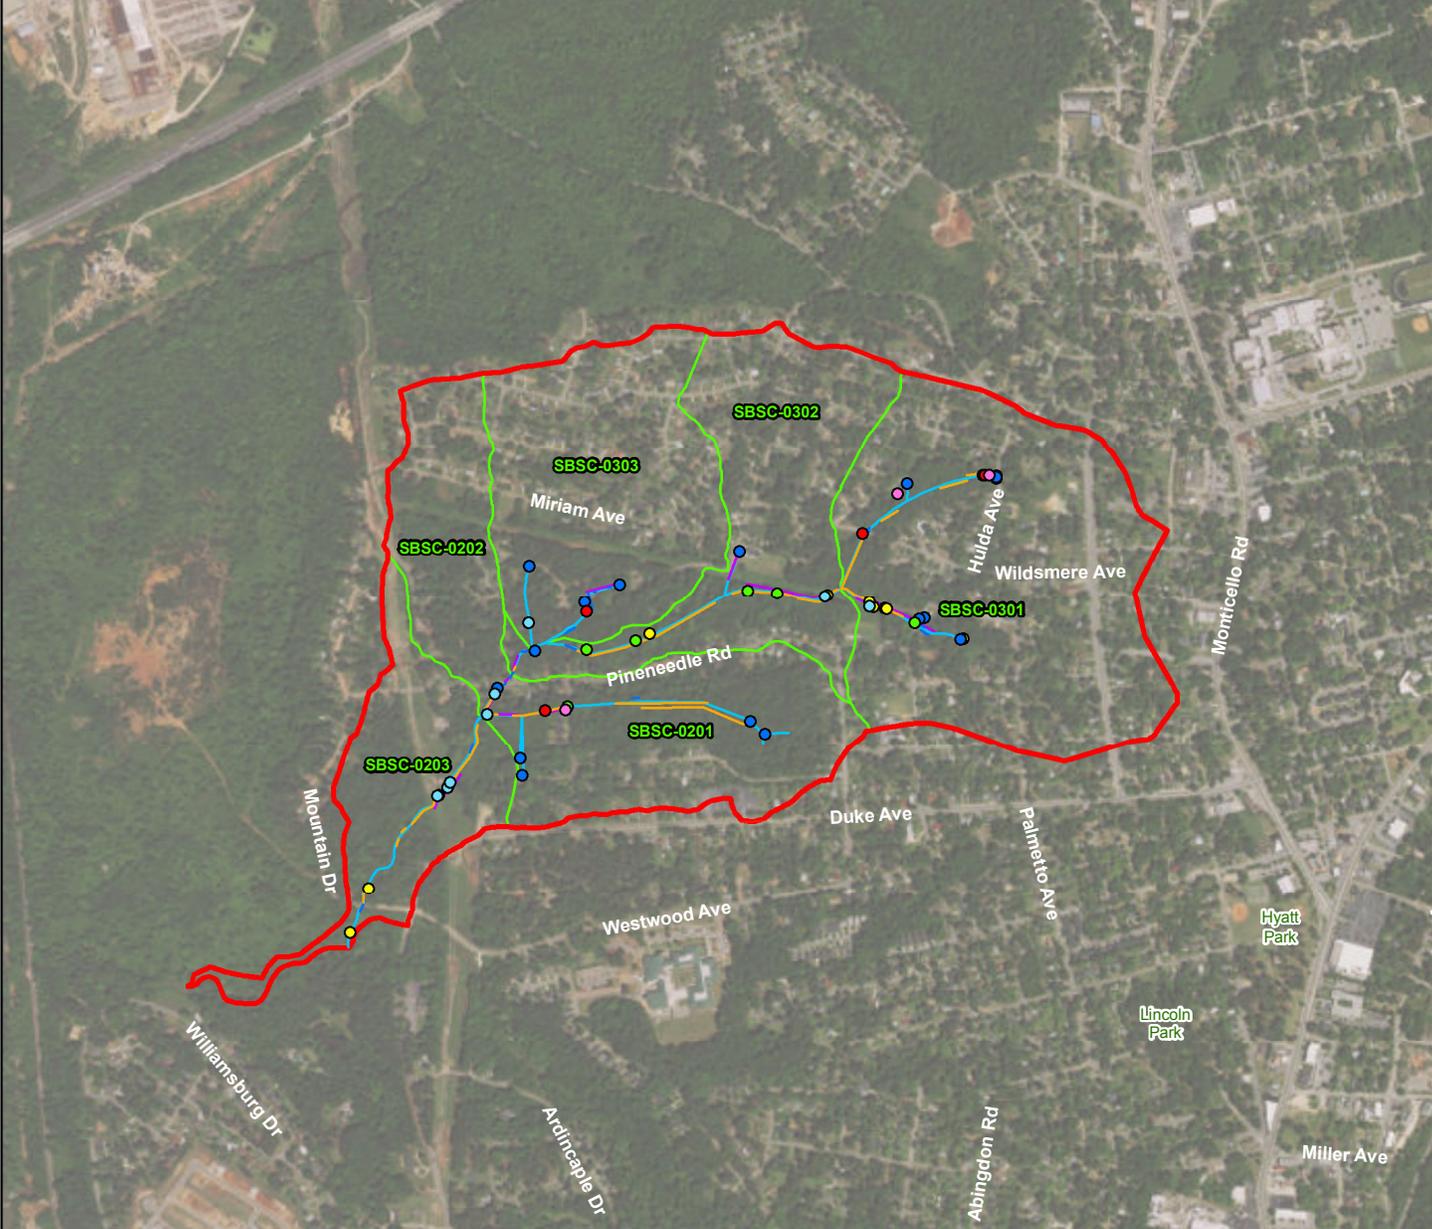
Figure 6.59:  
Subwatershed L  
Existing Conditions

Existing Condition	Count
Exposed Pipes	8
Pipe Outfalls	17
Unmanaged Runoff	5
Unusual Condition	10
Trash Dumping	3
Possible Fish Barrier	6
	<b>Linear Feet</b>
Erosion Site	9,534
Channel Alteration	843
Inadequate Forest Buffer	3,515

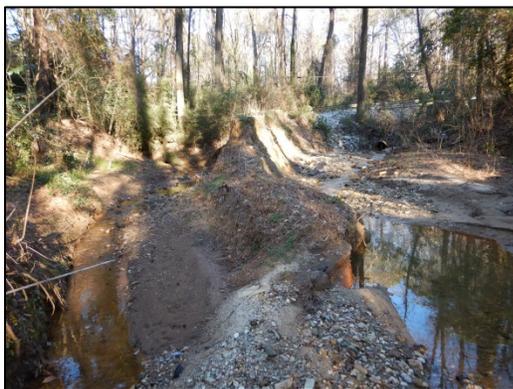
Downstream of the confluence of the two tributaries previously described, the channel incision continues, with 6 to 8 foot banks. Downtcutting into bedrock has created a series of steep cascades with large scour pools downstream. Substrate in this segment is mainly bedrock with sand in the pools and gravel and cobble along the riffles. The stream then extends through a 42 inch road culvert under Woodridge Drive.

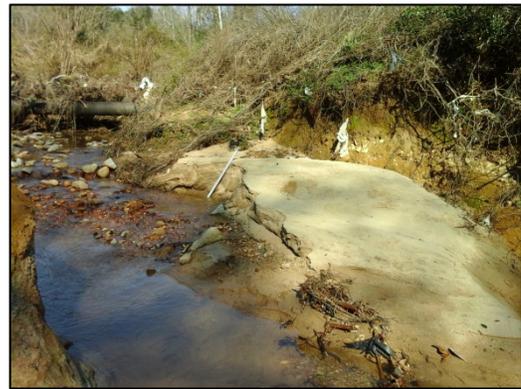
Incision down to bedrock exposure resumes in the main channel downstream of the confluence mentioned above. The stream crosses a large cleared utility right of way, where downcutting has exposed multiple utility lines within the bed. Banks become lower, well vegetated and stable approximately 350 feet downstream of the right of way. Substrate dominance shifts from bedrock to sand. The stream then extends under Mountain Drive through a 48 inch road culvert. Although the upstream face of the culvert has been recently stabilized with riprap, there is slumping around and above the pipe and the pipe itself shows signs of degradation. At the southern end of the subwatershed, the tributary converges with the Smith Branch mainstem. It appears likely that incision of these streams is endemic, however, the October 2015 flood event exacerbated more channel erosion and is evident by a large splay deposition of sands and gravels prior to the confluence with Smith Branch at Mountain Road.

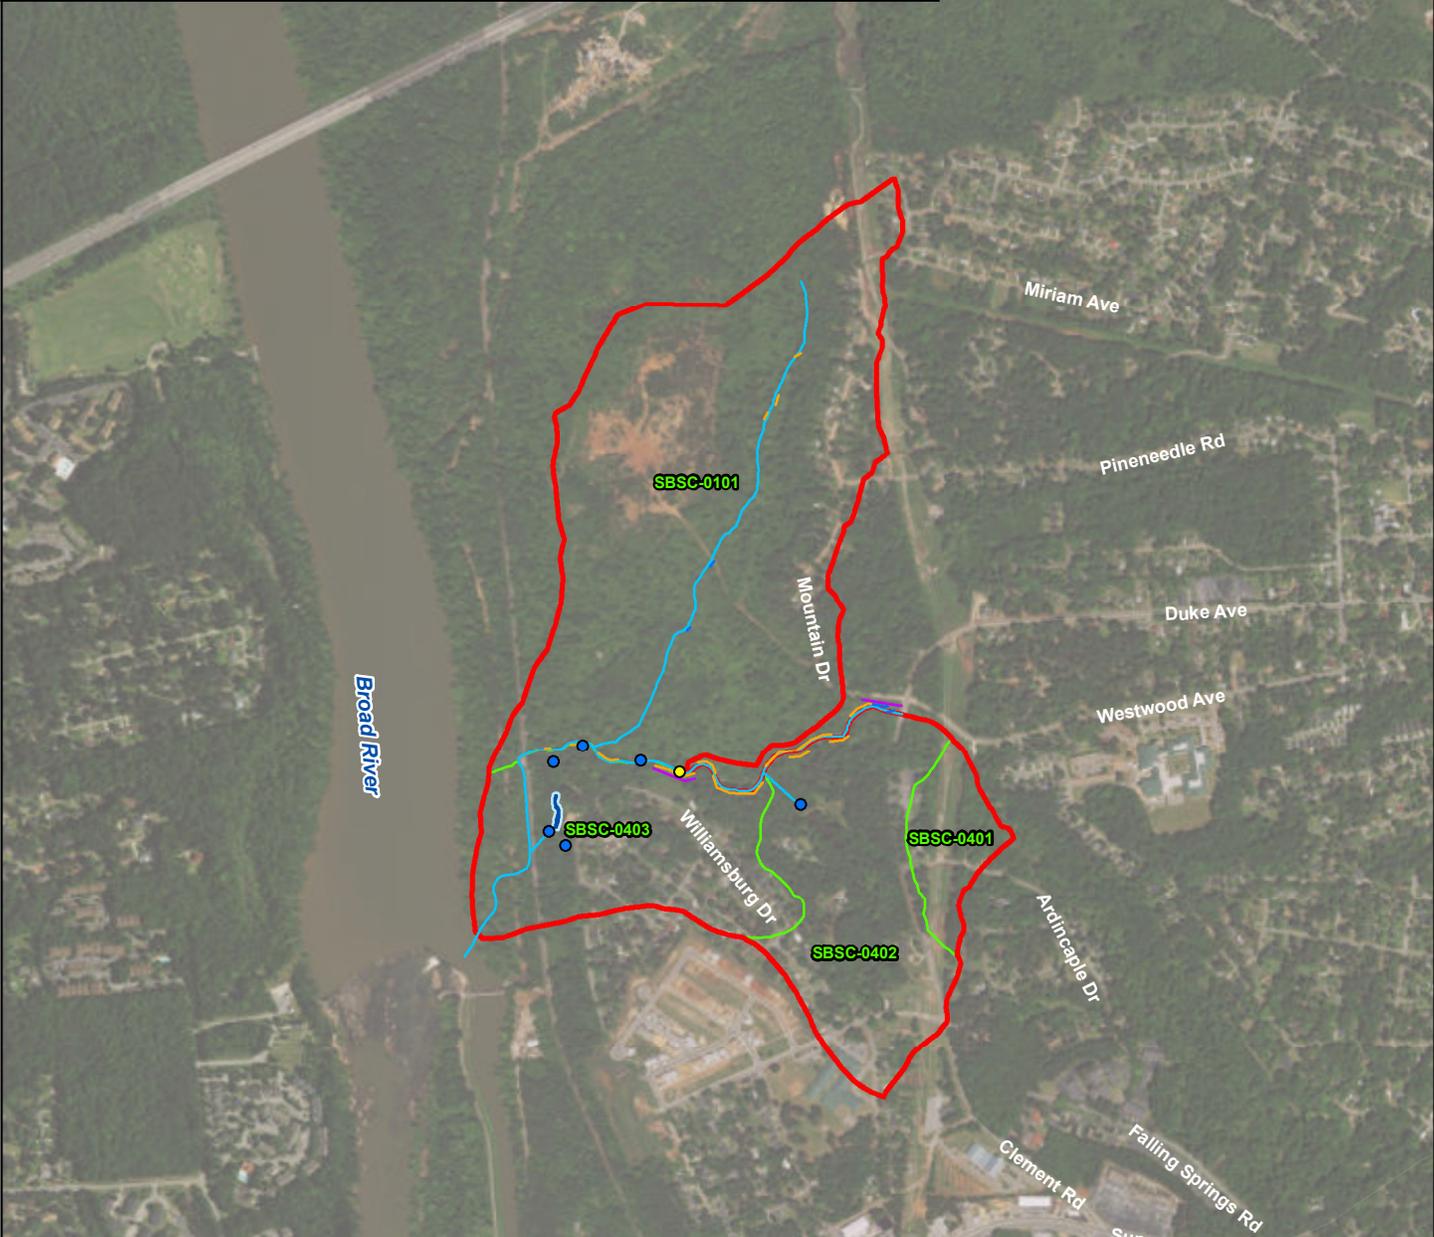
Figure 6.64:  
Subwatershed M  
Existing Conditions

Existing Condition	Count
Exposed Pipes	0
Pipe Outfalls	6
Unmanaged Runoff	0
Unusual Condition	1
Trash Dumping	0
Possible Fish Barrier	0
	<b>Linear Feet</b>
Erosion Site	2,255
Channel Alteration	226
Inadequate Forest Buffer	532

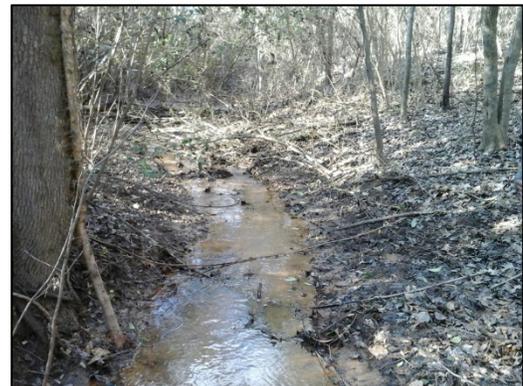
A large tributary within SW-M flows southwest to the mainstem through a forested parcel along Mountain Drive, beginning approximately 350 feet west of Miriam Avenue. The upstream extent of the tributary is a braided headwater system. A seep evolves into an established perennial stream as it flows downstream. Substrate consists of mostly clay within the bed. Approximately 2,000 feet downstream from the headwaters, a gravel access road has dammed the stream, causing the single-thread channel to be inundated by ponded water upstream of the crossing and filled by deposited sediments downstream. A second access road cuts through the stream channel approximately 450 feet downstream, interrupting flow. Downstream of the access roads, the stream continues as braided and lacks clear bank definition. The channel becomes more established near the confluence with the Smith Branch mainstem.
