DESIGN/DEVELOPMENT REVIEW COMMISSION
DESIGN REVIEW DISTRICT
HISTORIC AGENDA
EVALUATION SHEET
Case # 3

ADDRESS: 1501 Lady Street

NATURE OF REQUEST: Request Certificate of Design Approval for preliminary certification for the Bailey Bill

This is a 1949 office known as the Seibels Bruce Building. Designed by architectural firm Lafaye, Fair & Lafaye recently became an Individual Landmark.

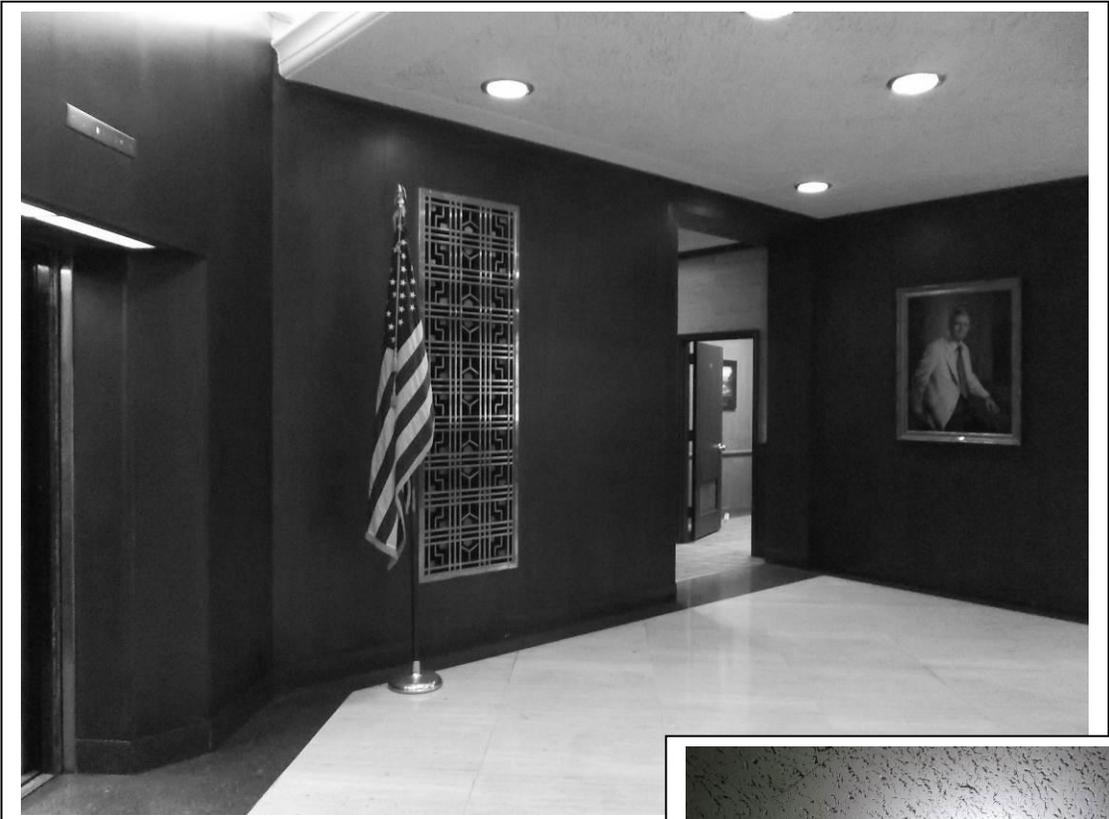
Above: Lobby showing floor, walls and ceilings with “seamless” appearance (image grayed to highlight details)

The first-floor lobby of this building has the highest level of detailing of any lobbies or corridors within the structure. Clearly designed to impress, it features a marble and granite floor, dark stained wood walls and indirect lighting behind a dropped ceiling used to highlight the elevator doors. The materials of the floor and wall are smooth and do not allow for any mortar lines between the large marble floor tiles and seams are almost invisible on the smooth wood-paneled walls. Likewise, the dropped ceiling features a concealed grid system, minimizing any strong lines and generating a unified appearance. The tiles used are small and square with a pocked appearance, framed along the wall line by a smooth plaster band approximately a foot wide. The creation of smooth, unified surfaces is a hallmark of mid-century design and is also evidenced by the tightly spaced stone panels on the exterior of the building, which lends an almost monolithic appearance to the wall cladding.

The current proposal is to remove the concealed grid system in the lobby ceiling and install smooth gypsum boards. As a primary public space this area should have its historic character retained and preserved; removing the historic material from the ceiling and replacing it with a different material does not meet this guideline. The current ceiling is in excellent condition. It is a feature that characterizes the lobby due to its inherent characteristics of shape and texture, items that would be eliminated in a smooth gypsum board ceiling. The proposal does not meet this guideline.

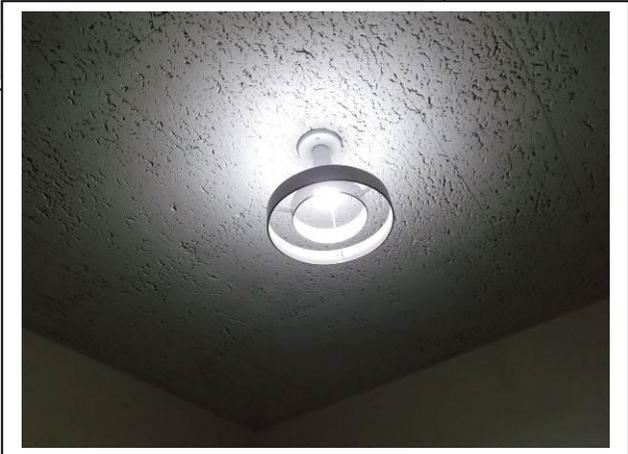
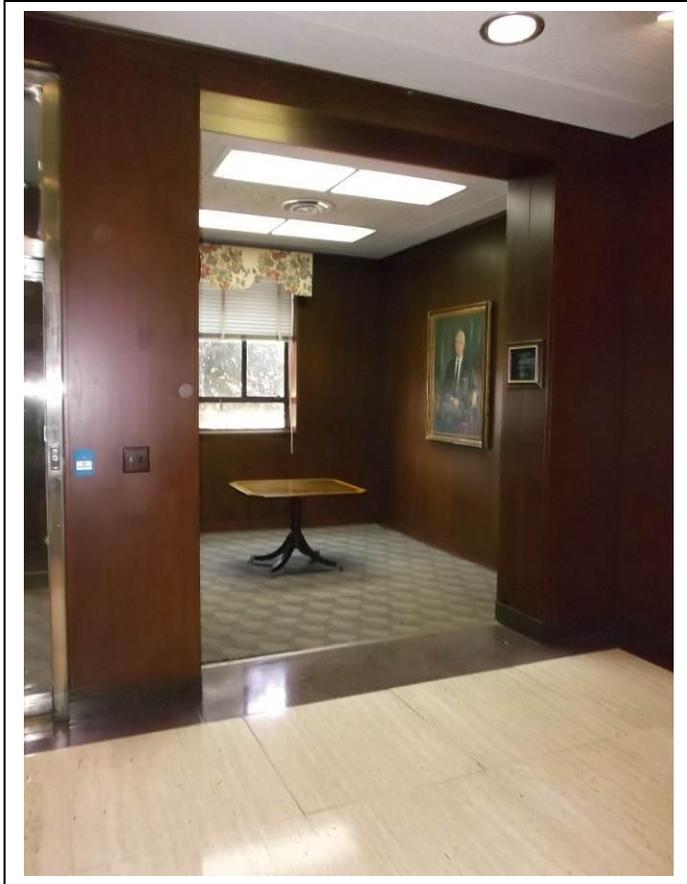
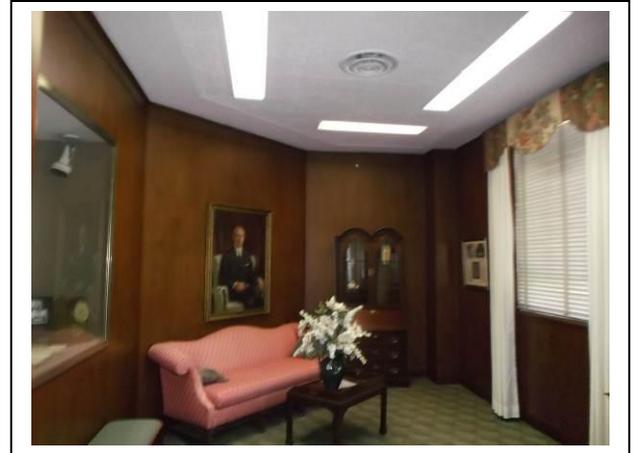
Top: small room in lobby
Left: Small room in lobby
Bottom: Lobby view to elevators
Staff photos

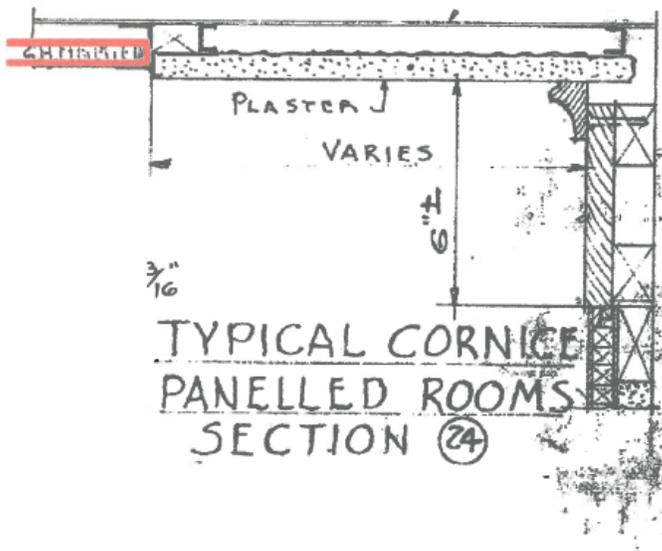
Lobby ceiling changes

Presumably the area in red will be the affected area

I think as long as the gyp is in the same plane as the APC, it would have the same architectural character.

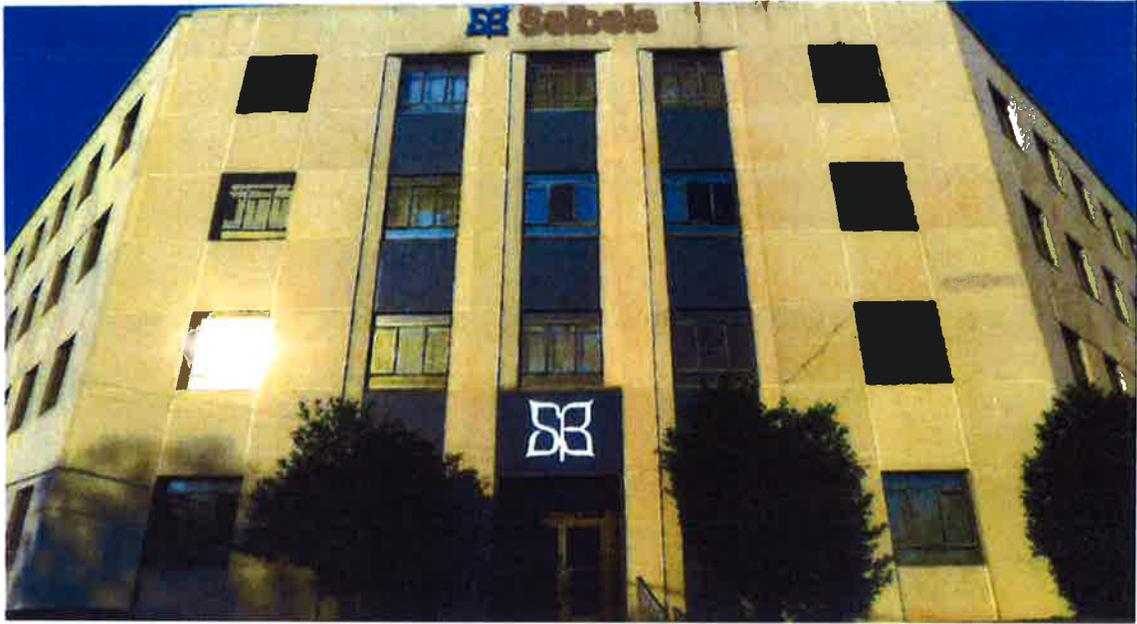
1 of 42- Southwest elevation, primary façade of building. Camera facing northeast.

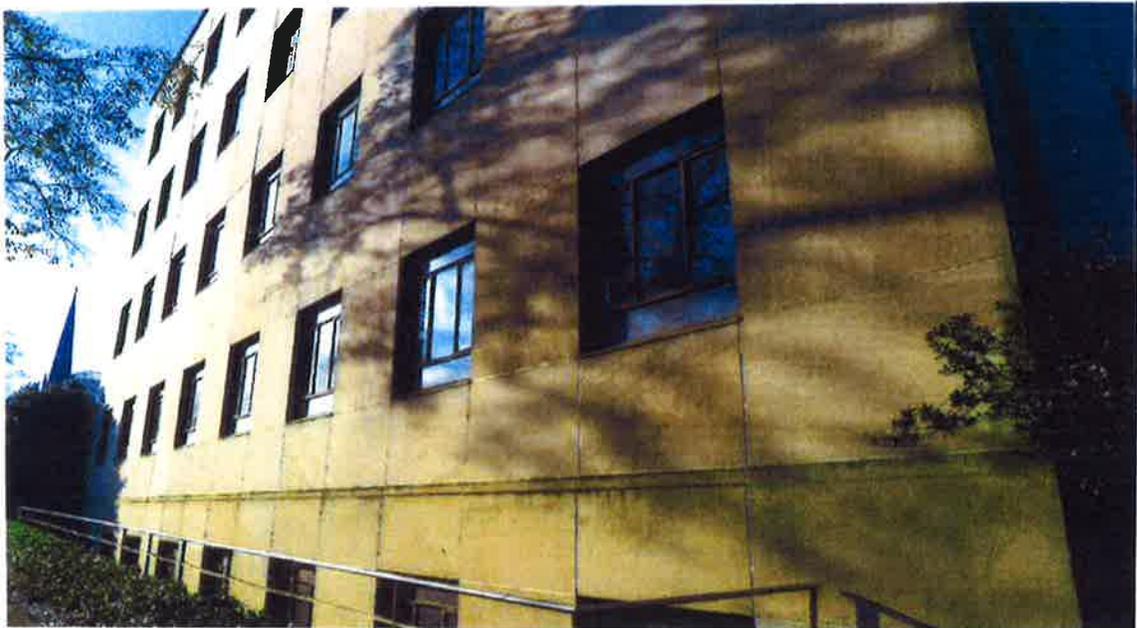
2 of 42- Southeast elevation. Camera facing northwest.

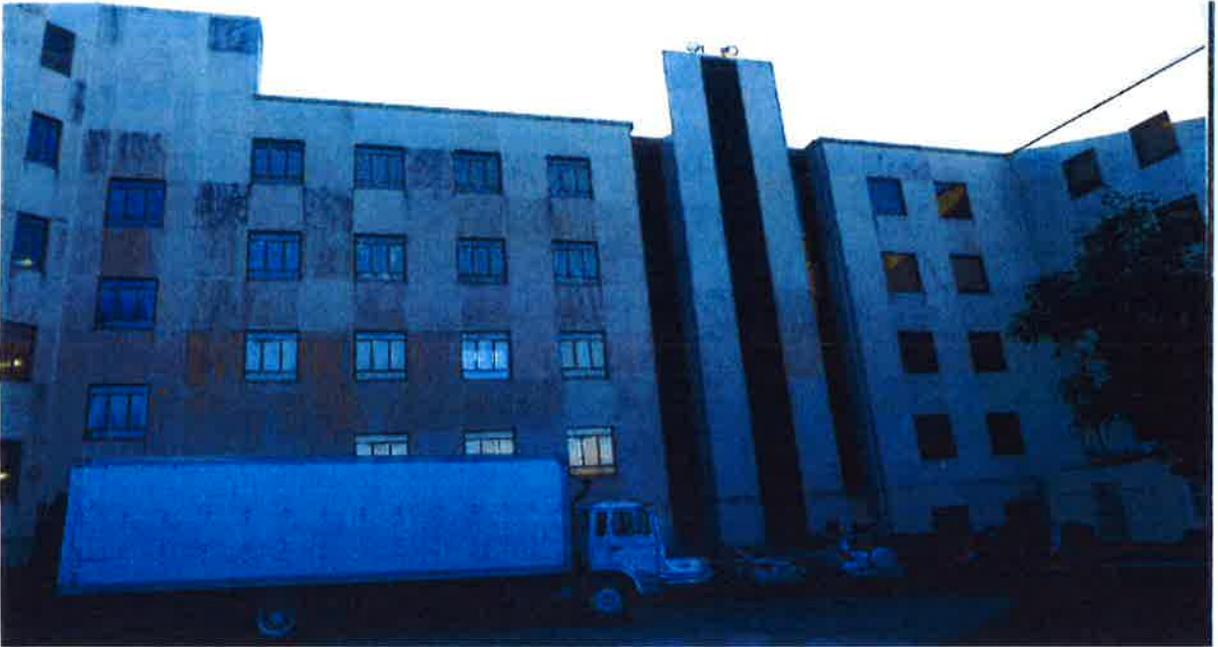
3 of 43-East elevation of west wing, 1949 building and 1977 addition. Camera facing west.

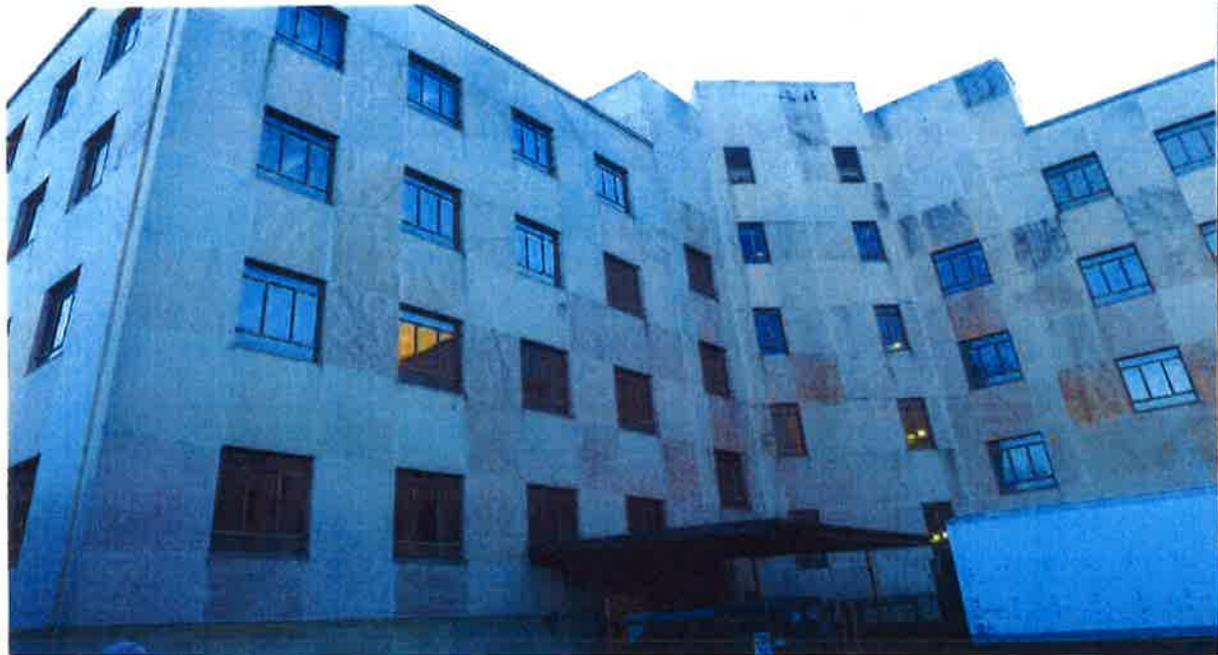
4 of 42-Northeast aspect, 1949 building. Camera facing southwest.

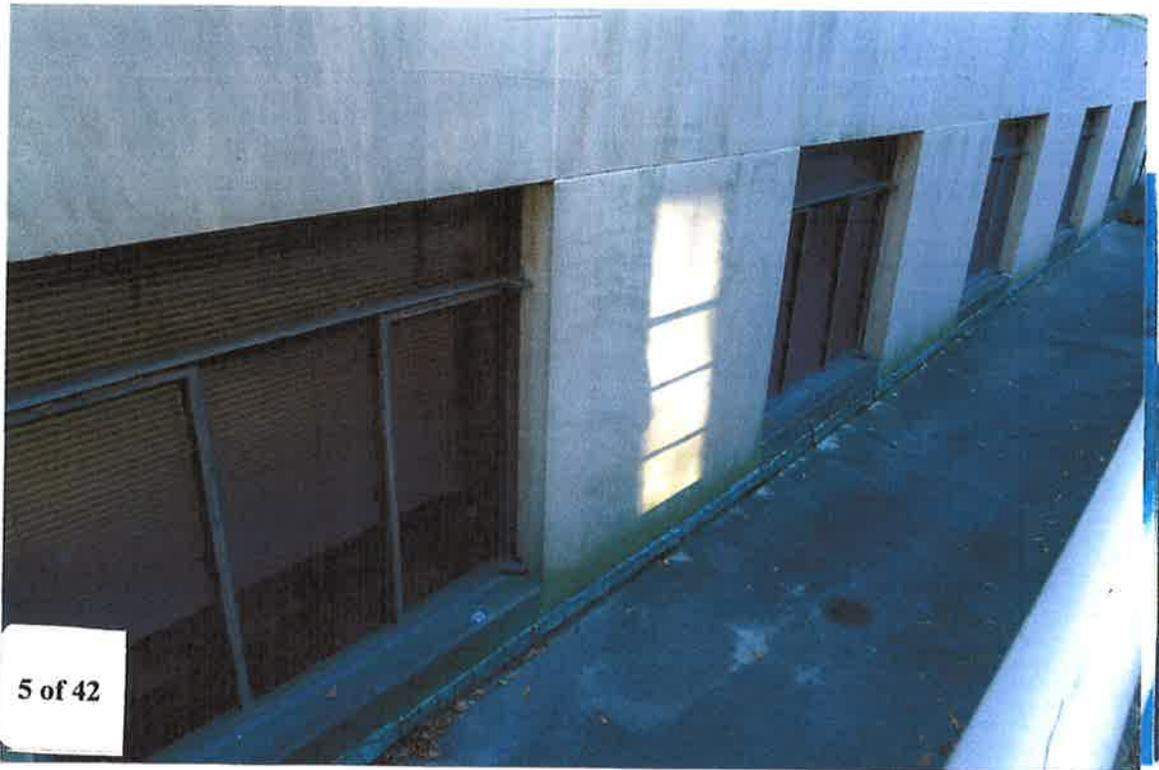
5 of 42-South elevation of south wing, 1949 building basement. Camera facing north.

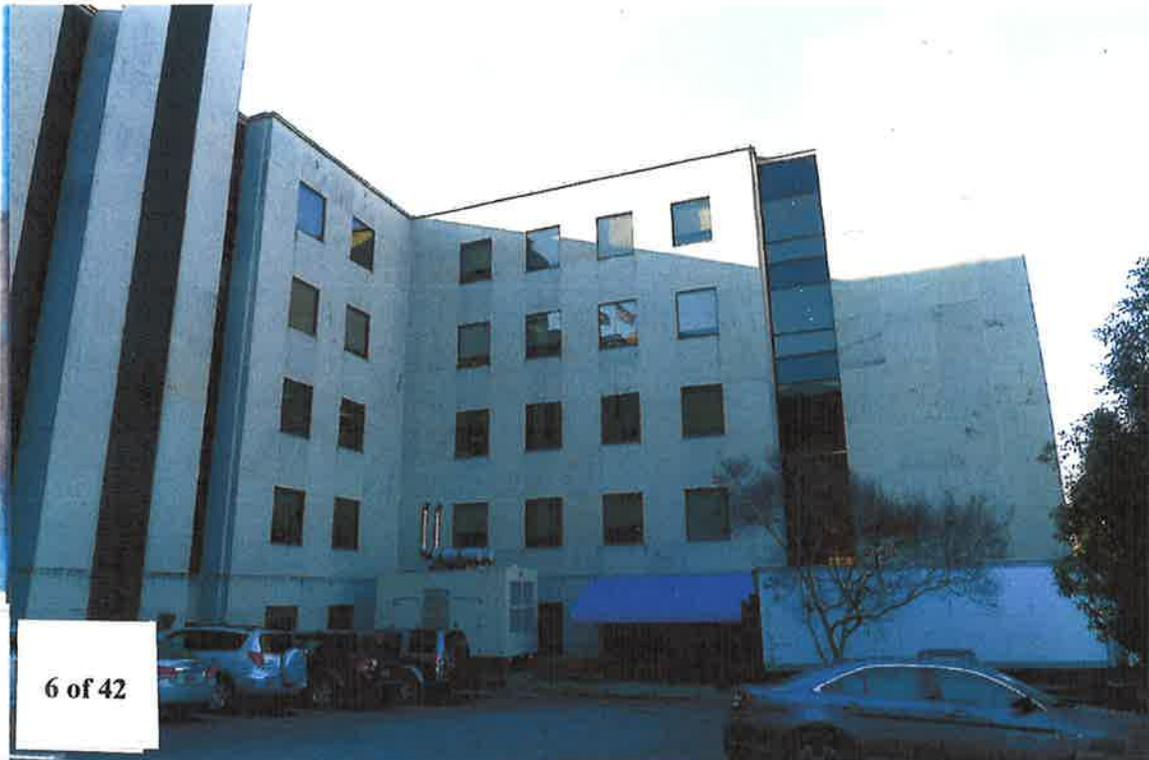
6 of 42-South elevation of north wing, 1977 addition. Camera facing north

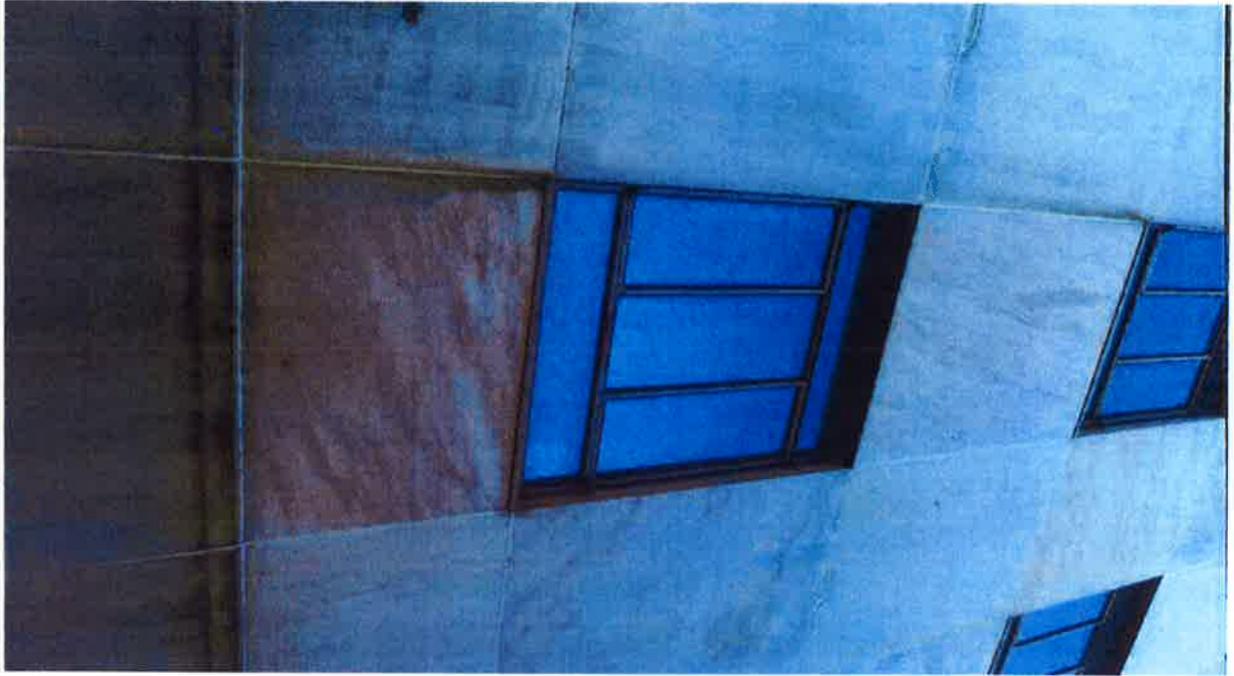
7 of 42-Exterior detail, windows in 1949 building

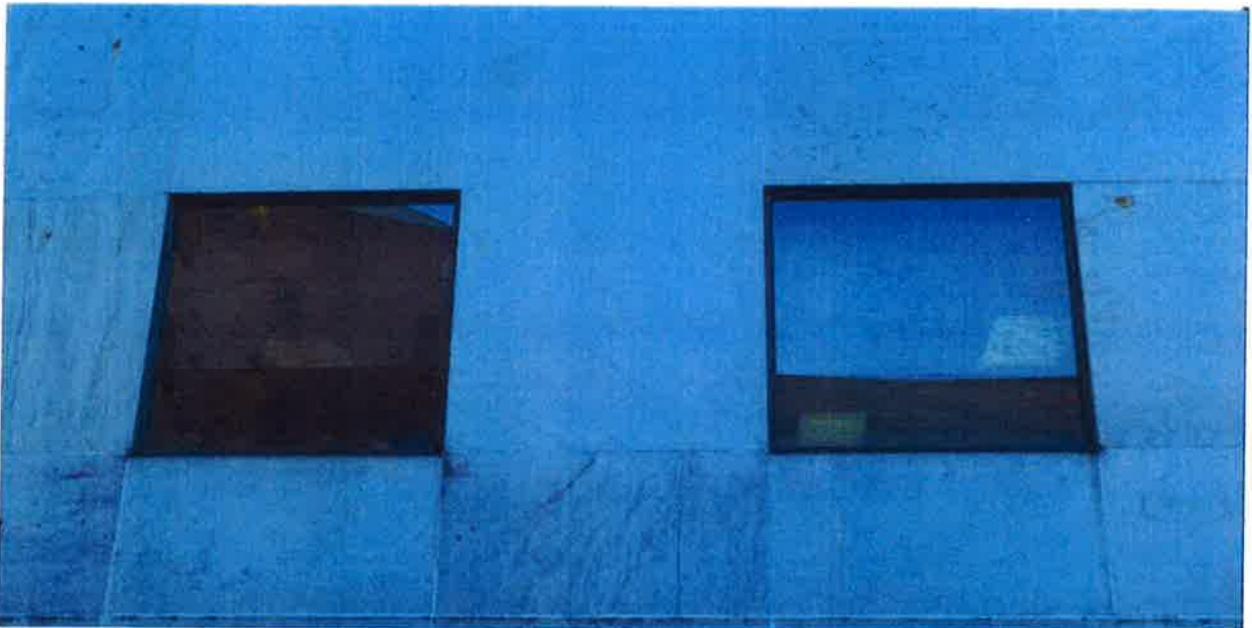
8 of 42-Exterior detail, windows in 1977 addition.

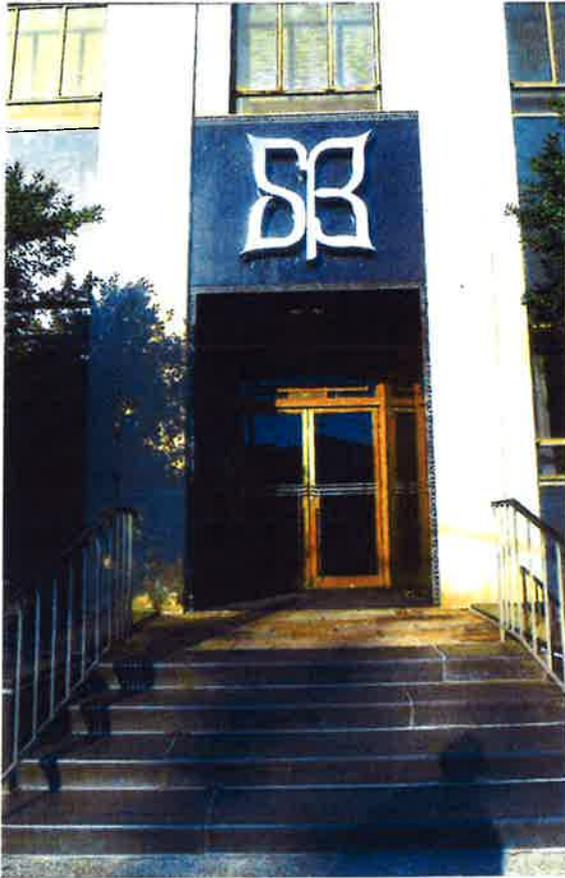
9 of 42-Exterior detail, main entryway, southwest façade. Camera facing northeast

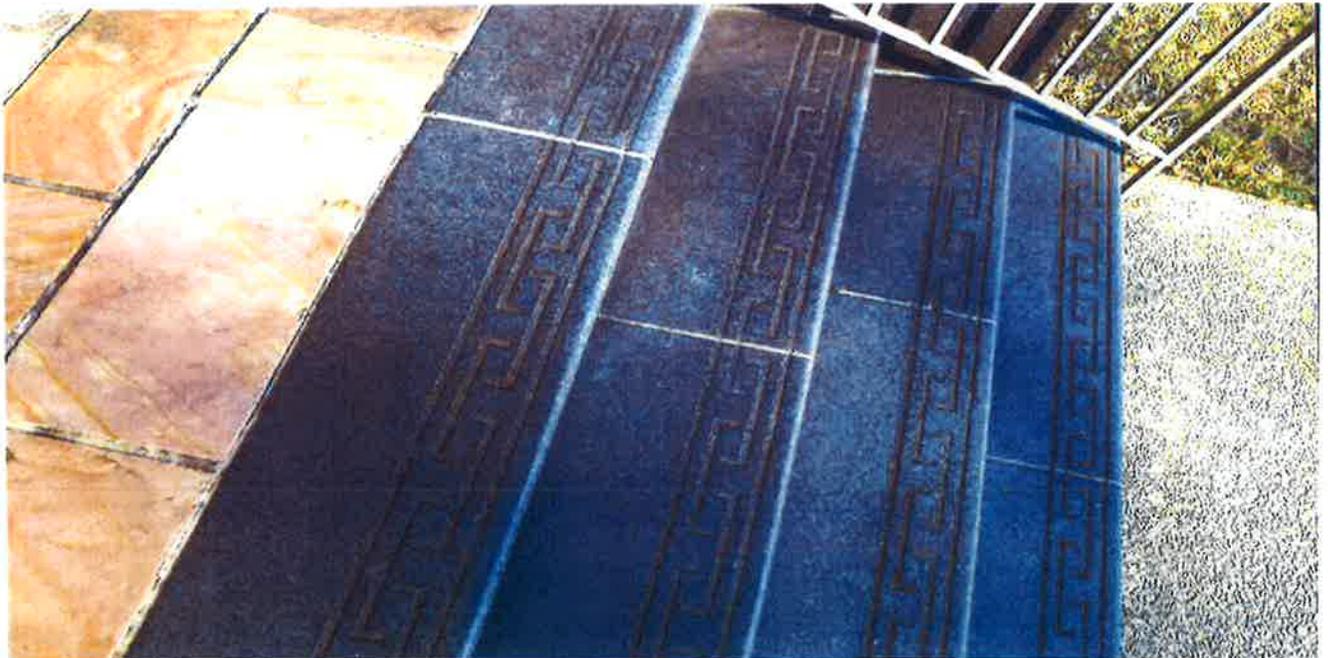
10 of 42 -Exterior detail, main entryway, stairs along southwest façade.

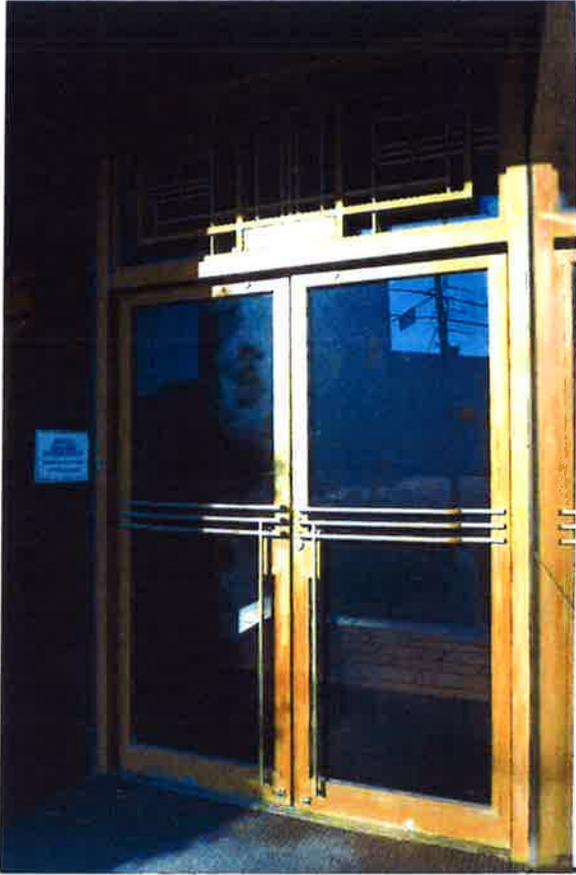
11 of 42 - Exterior detail, main entry door in southwest façade. Camera facing northeast.

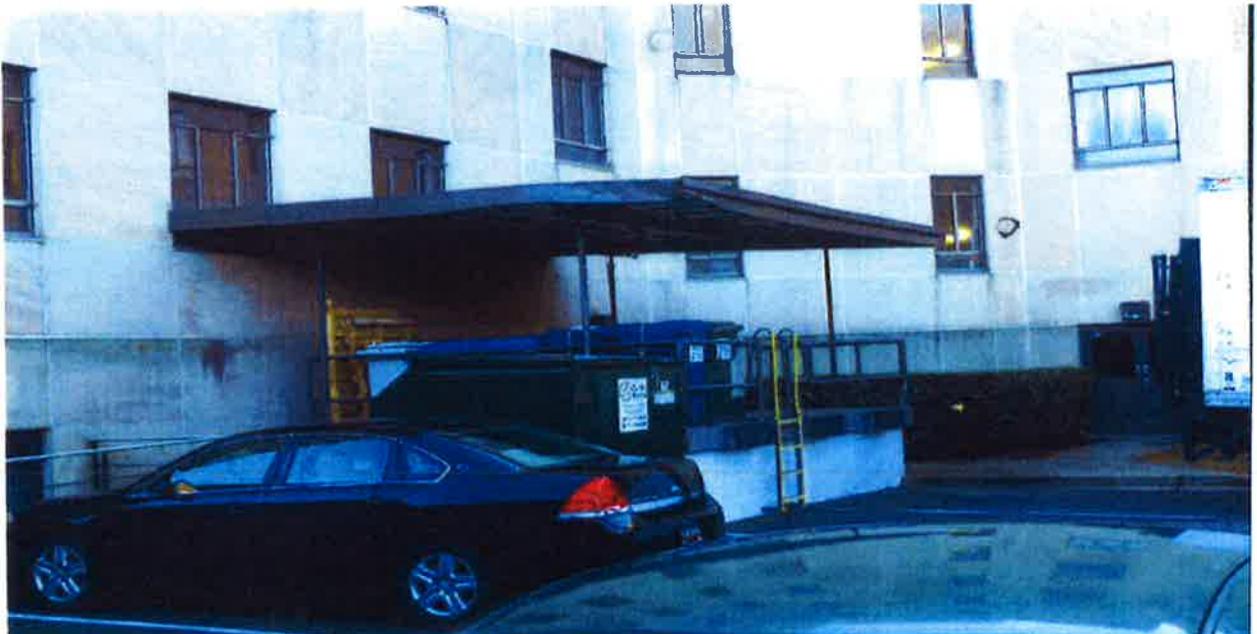
12 of 42-Exterior detail, loading bay along north elevation of south wing. Camera facing southwest.

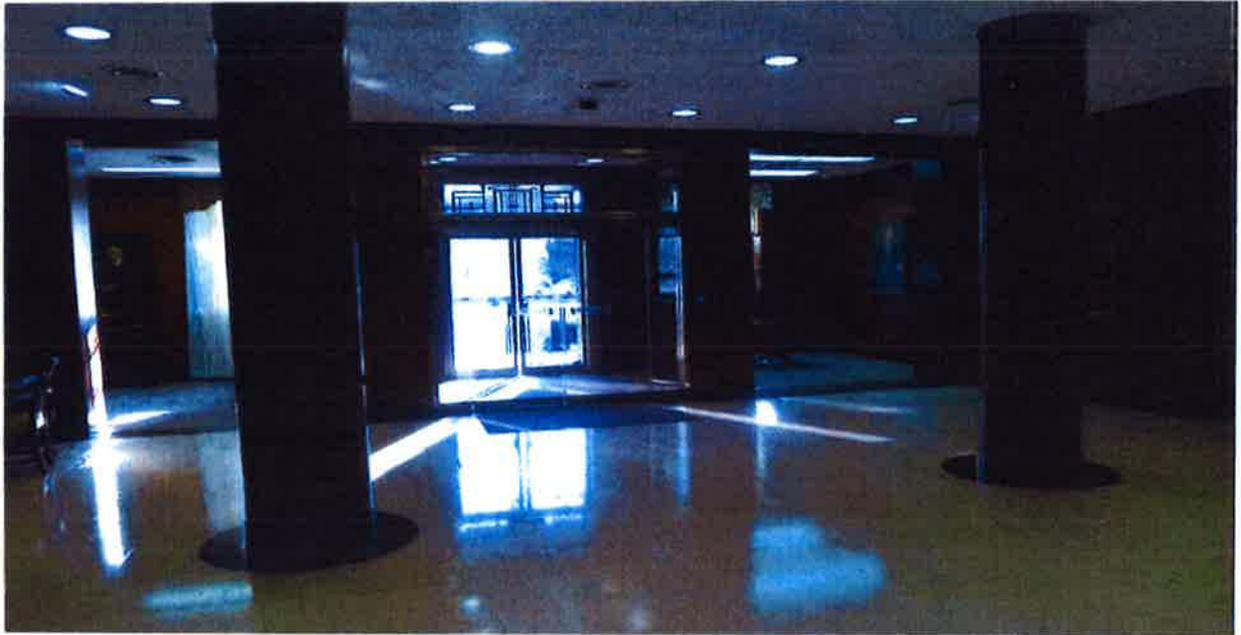
13 of 42-Interior, lobby of original 1949 bldg. Camera facing southwest.

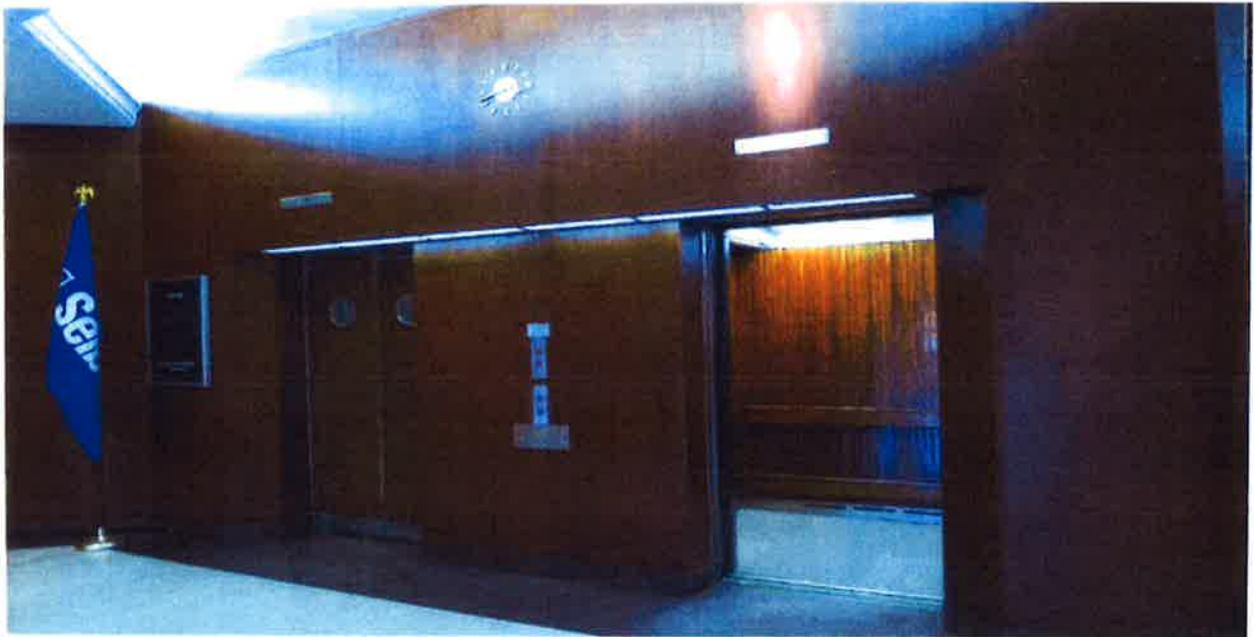
14 of 42-Interior, elevators in lobby of original 1949 building. Camera facing northeast.

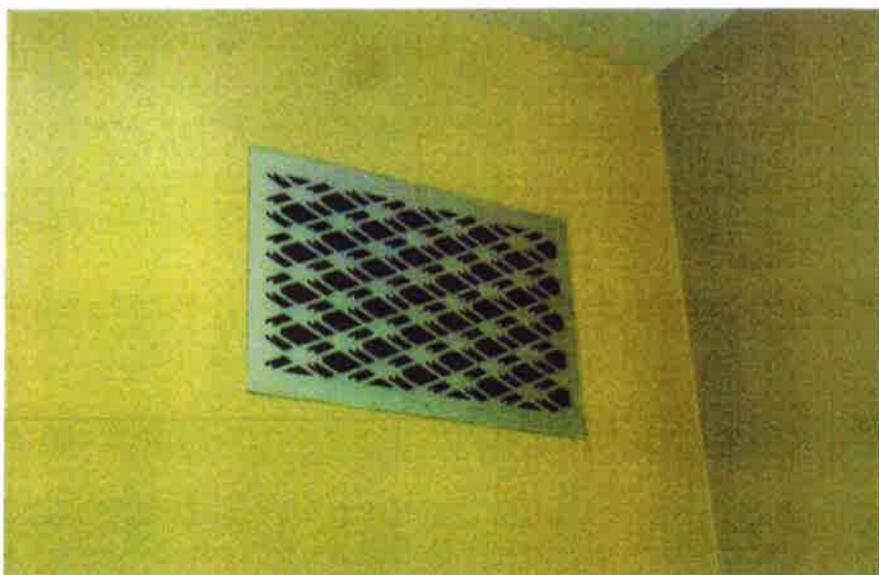
23 of 42-Interior detail, first level of 1949 building, men's restroom iron grate over ductwork.

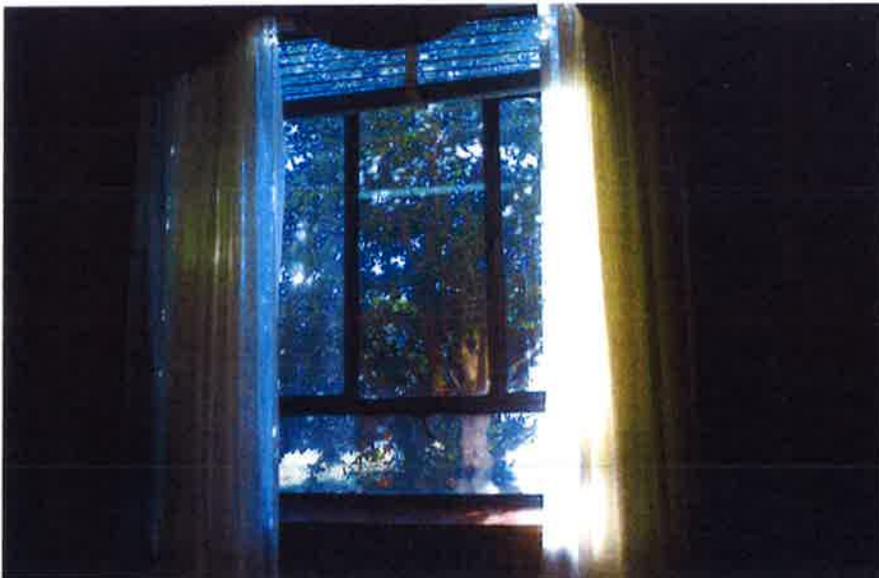
25 of 42 -Interior detail, first level windows in 1949 building.

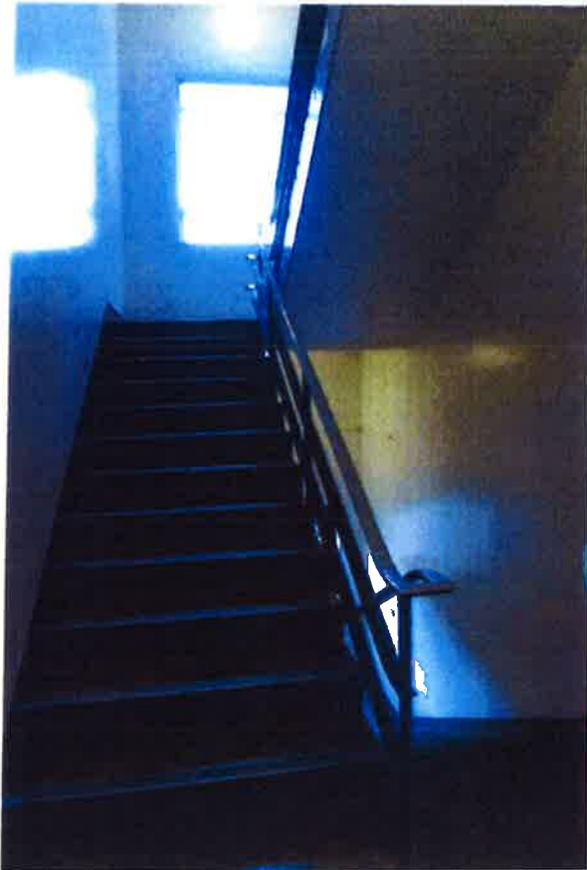
28 of 42-Interior detail, stairwell in 1949 building. Camera facing east.
