# D/DRC Case

1030 Gregg Street

University Hill Architectural Conservation District

**DESIGN/DEVELOPMENT REVIEW COMMISSION**  
**DESIGN REVIEW DISTRICT**  
**HISTORIC AGENDA**  
**EVALUATION SHEET**  
**Case # 3**

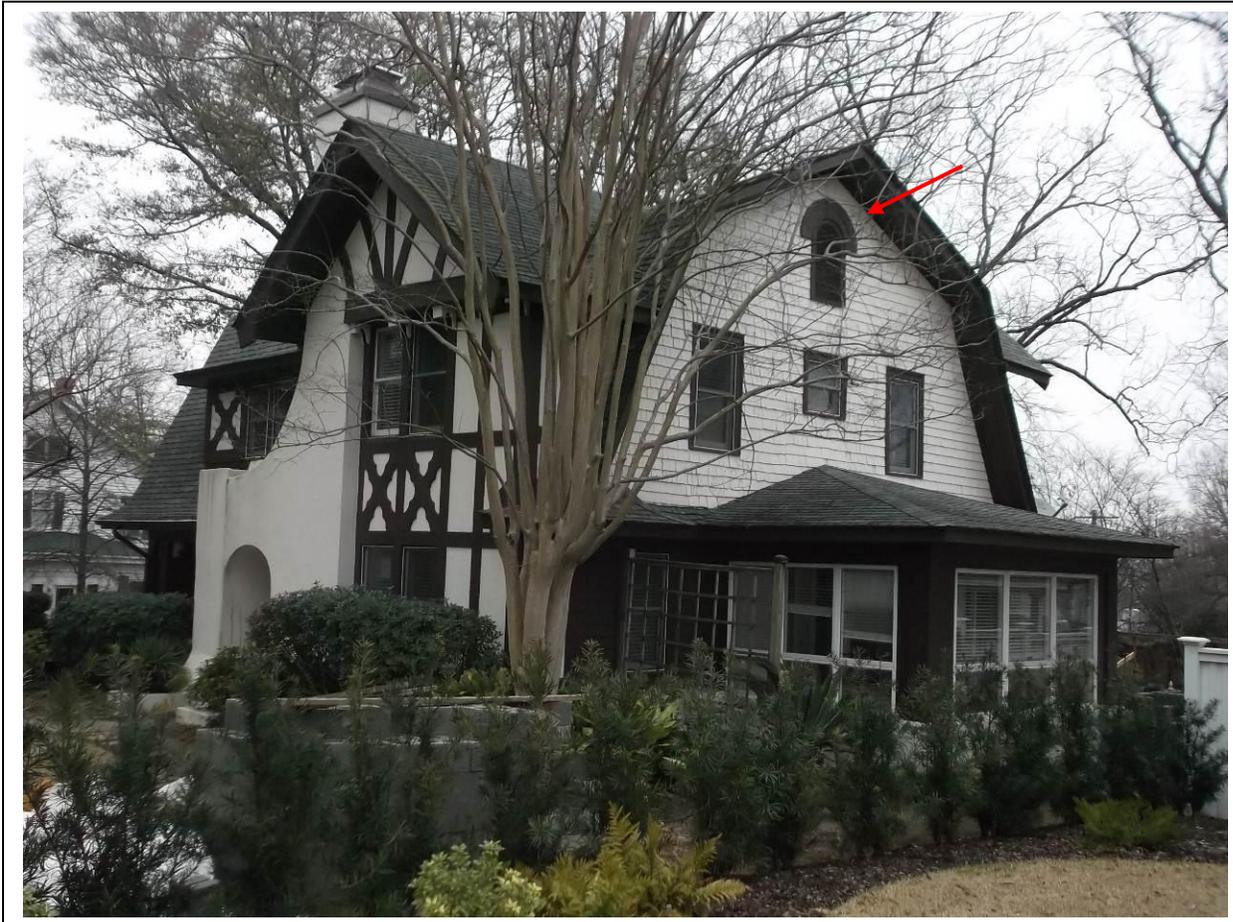
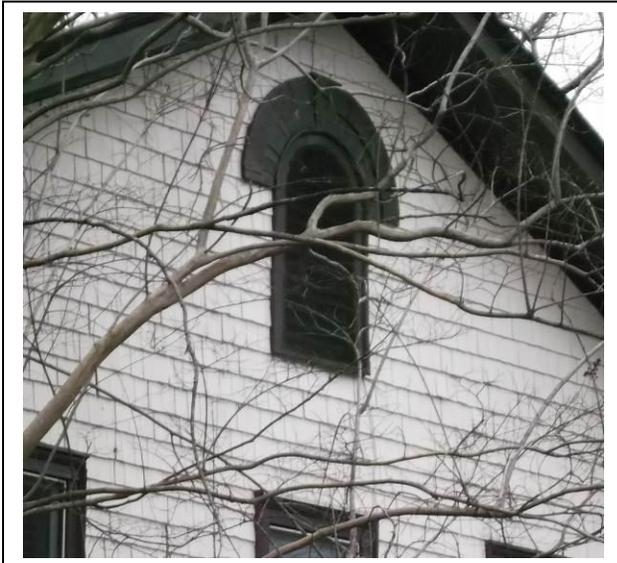
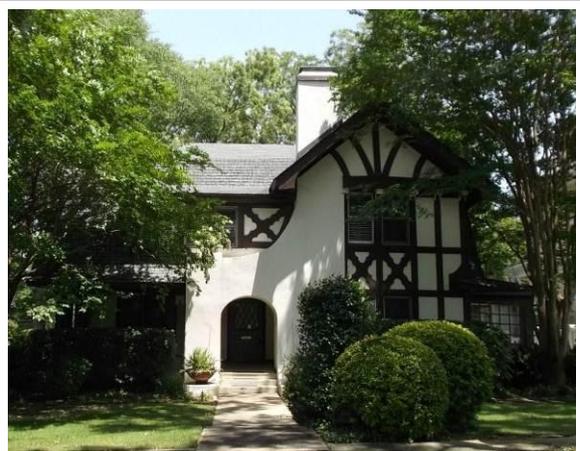
Staff photos

Red arrow indicates vent and trim that are proposed to be removed.

This building has a variety of decorative wood elements. Each component is integral to the overall design of a very complex exterior. Square and rectangular shapes contrast with sloping features and the focal point of the entrance, an arch. This arch motif is only replicated in the south and east attic vents, and is exaggerated by a heavy shroud of trim made up of wood shingle, matching the exterior siding, with a decorative keystone. One of the most detailed adornments for any openings on the building, these are essential components of the building's appearance. The proposal is to remove the trim and enlarge the vent opening to accommodate a new single lite window and install new trim as shown in the attached drawings. Removal of this original trim would not meet the guideline, which states that such features are to be retained.

Staff finds that the proposal to remove original vents and trim, enlarge openings and install visible windows does not meet Section 6 of the guidelines and recommends that the request be denied.

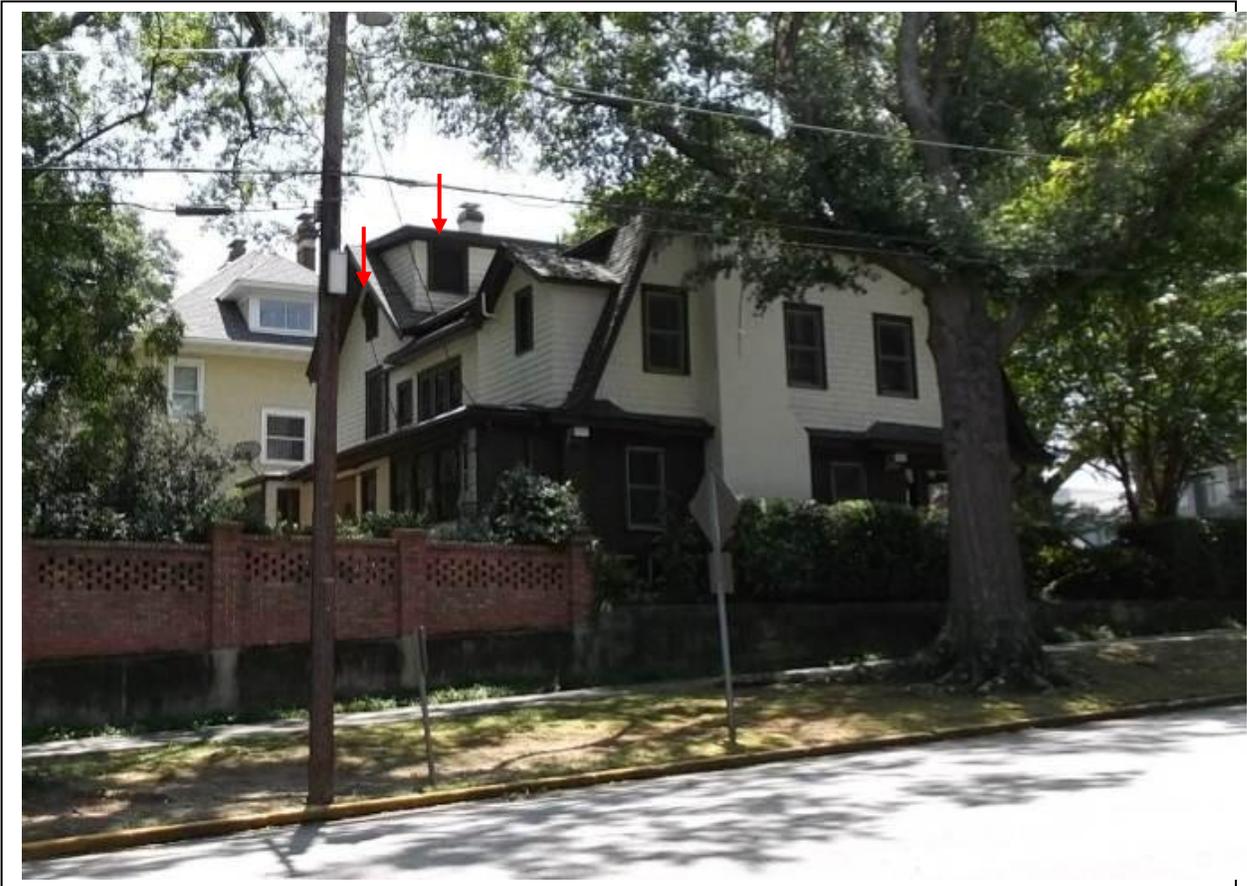
Red arrows point to vents proposed to be converted to windows, Staff photo

The horizontal wood slats of the three attic vents are also components of the exterior wood materials that should be retained. Historic wood vents help to show the observer how the building's interior space was originally configured and how its utilitarian elements such as venting were incorporated into the architectural design, which is done particularly well on this building. Often overlooked, historic vents are also elements that can help date a building, as they changed shape and location as styles evolved over time. According to the guideline, these elements should be retained. The proposal for single lite windows with no grids in these openings is in stark contrast to the existing historic vents and does not meet this guideline.

Should the City's plans examiner conclude that the attic space can be converted to bedroom space and therefore require a means of egress, then only one is required, meaning not all three vents would need to be converted. The most logical location for a conversion would

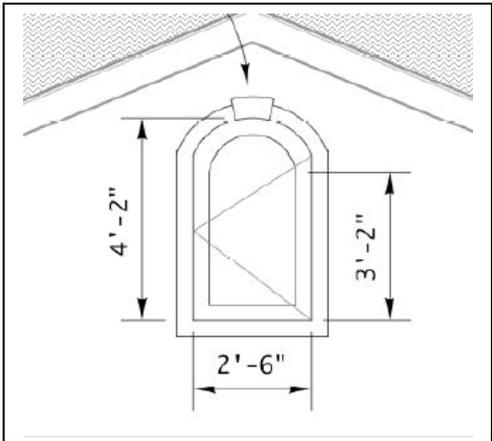
Proposed replacement trim and new window in arched vents, drawing by applicant

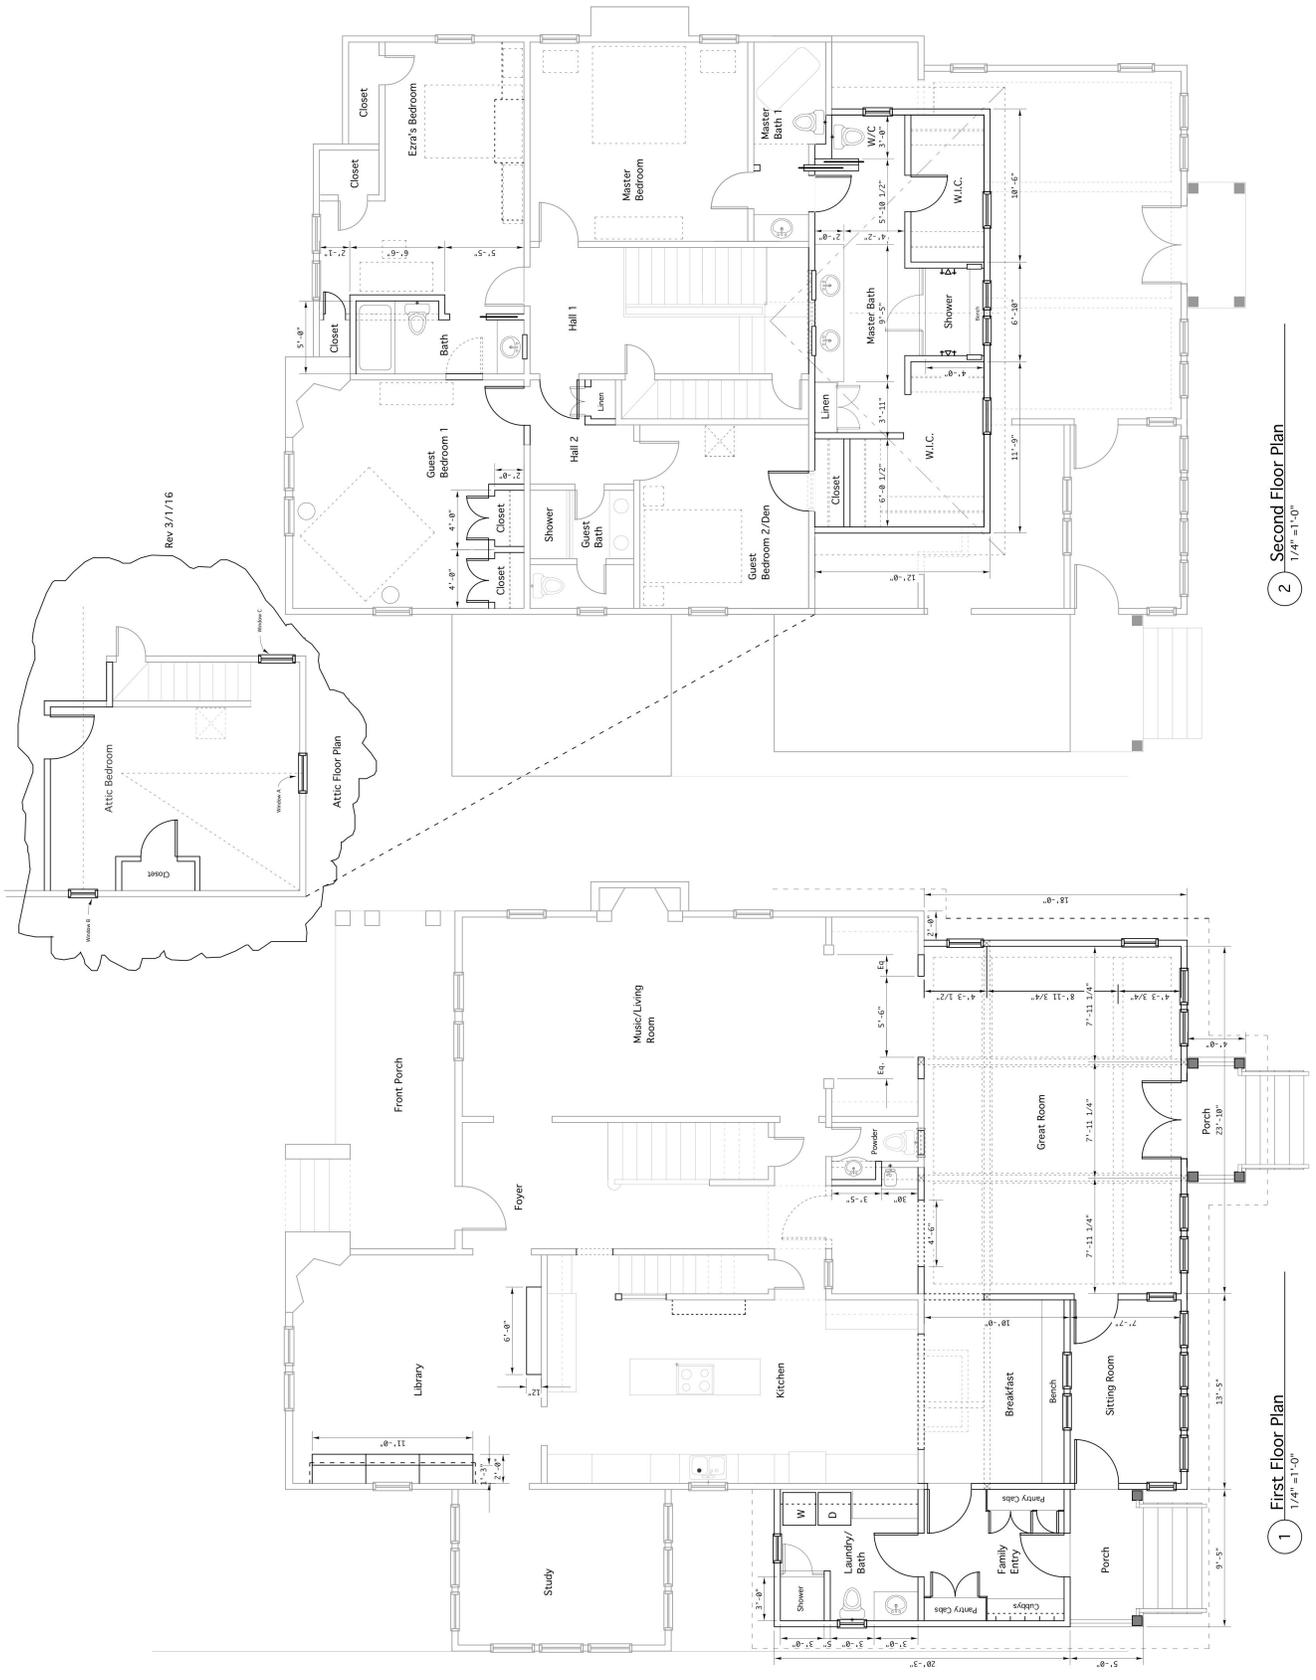
2 Second Floor Plan  
 1/4" = 1'-0"

Rev 3/7/16

The applicant previously indicated that this area was to be a playroom in plans submitted to the City. The new request is to use this area as a bedroom. At present, the City's plans examiner has not reviewed this request to ensure that the space can be used as a bedroom, since it would need to meet certain building codes in order to qualify as such. This distinction is important, as a playroom does not have egress requirements. A bedroom does need one source of egress, typically a window, which has a required amount of space for exiting in case of an emergency.
