DESIGN/DEVELOPMENT REVIEW COMMISSION
DESIGN REVIEW DISTRICT
HISTORIC AGENDA
EVALUATION SHEET
Case # 2

ADDRESS: 1519 Sumter Street

NATURE OF REQUEST: Request Certificate of Design Approval for Preliminary Certification for the Bailey Bill

This is the Delco Light Building, completed in 1921 with a brick and terra cotta façade. It was used by a variety of tenants and owners over the years and by December of 1921 began a multi-decade career housing auto sales and service businesses. It also featured a convention hall on the second floor. It was home to the Powell Furniture Company for many years starting in 1960. It is listed as a contributing building to the Main Street district in the National Register of Historic Places and is therefore eligible for the Bailey Bill.

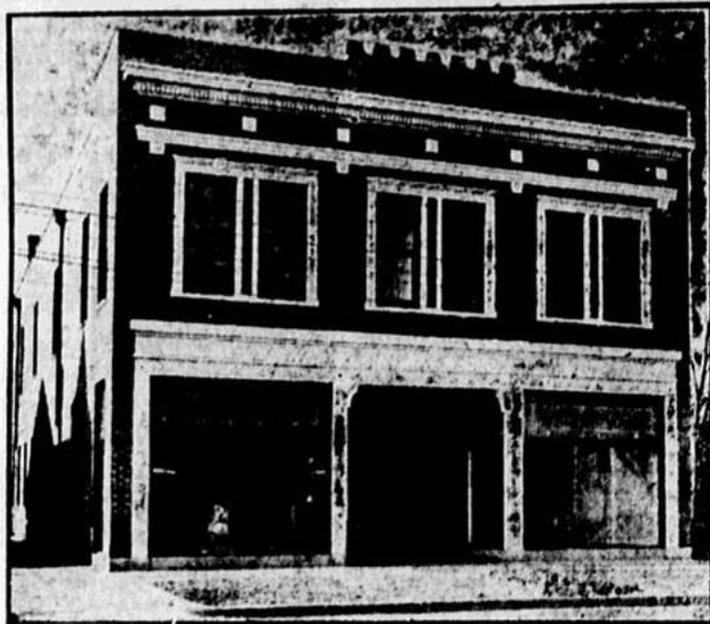
Left: 1921 image from The State

Photo by Blanchard.
Delco Light building, just erected by the Home Light & Power company of South Carolina, distributors for Delco Light products in the states of North and South Carolina. The building is on Sumter street.
Delco Light products are manufactured by the Delco Light company of Dayton, Ohio.
The building is modern in every respect and among other things includes a convention hall.

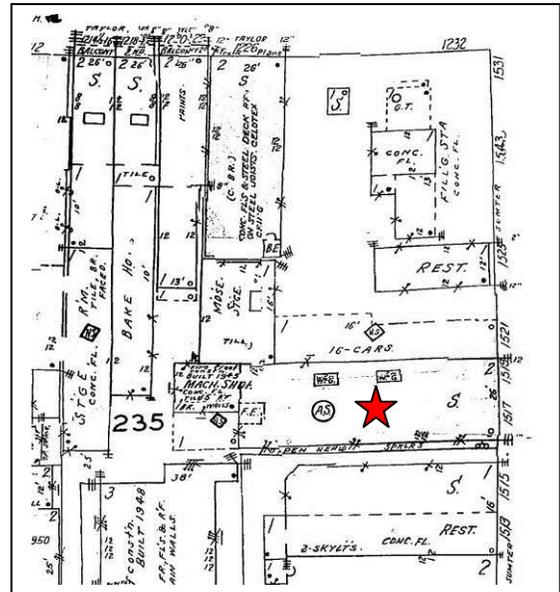
1950 Sanborn map, showing carport on north side of building

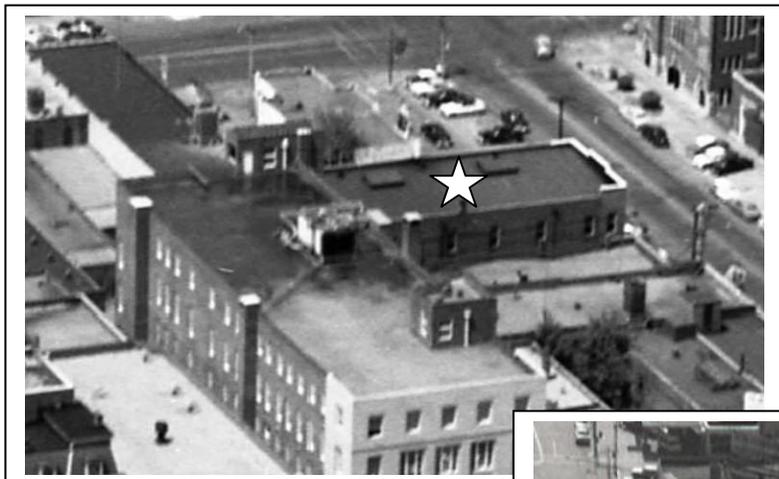
Left: 1955 image of south side of building (Russell Maxey, Richland Library)

Below: 1966 image of north side of building (Russell Maxey, Richland Library)

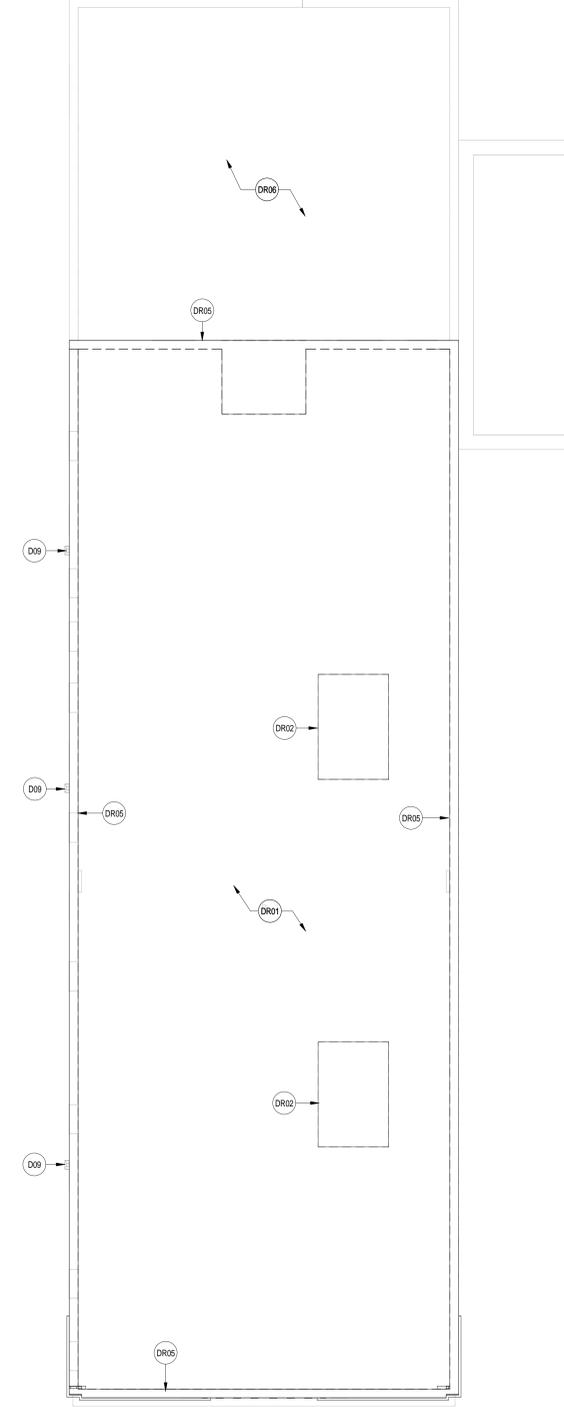
1 ROOF DEMOLITION PLAN
DA1.3 1/8" = 1'-0"

DA1.3 DEMOLITION LEGEND - ROOF PLAN	
Key Value	Keynote Text
D09	REMOVE AND DISPOSE OF EXISTING CONDUCTOR BOX, DOWNSPOUT AND BRACKETS. INFILL CUT BRICK WITH NEW BRICK ENTIRE DOWNSPOUT CAVITY.
DR01	REMOVE AND DISPOSE OF EXISTING ROOFING SYSTEM AND DECKING TO EXISTING WOOD RAFTERS.
DR02	REMOVE AND DISPOSE OF EXISTING SKYLIGHT AND FRAMING. SHORE UP ROOF STRUCTURE AND PREPARE EXISTING FRAMING FOR NEW SKYLIGHT FRAMING.
DR05	REMOVE AND DISPOSE EXISTING COPING AND REPAIR EXISTING MASONRY TO RECEIVE NEW BLOCKING AND METAL COPING.
DR06	REMOVE AND DISPOSE OF EXISTING ROOF SYSTEM, REPAIR ROOF DECK AND STEEL JOISTS AS REQUIRED.

Description of work and impact on feature			
<p>Existing skylight and framing will be removed. The roof will be repaired and the existing framing prepared for addition of new skylight framing. New skylights and a restored light well will pen onto the second floor ceiling below.</p>			
Feature number	7		
Architectural feature	Paint on exterior wall, north elevation	Approximate date of feature	c. 1950s
Description of existing feature and its condition			
<p>The existing north elevation exterior wall is painted a medium gray color. The painted portion of the wall runs from its northeast corner to the center of the wall face. White painted lettering in the top left corner of this face of the building spells "POWELL FURNITURE" in block letters.</p>

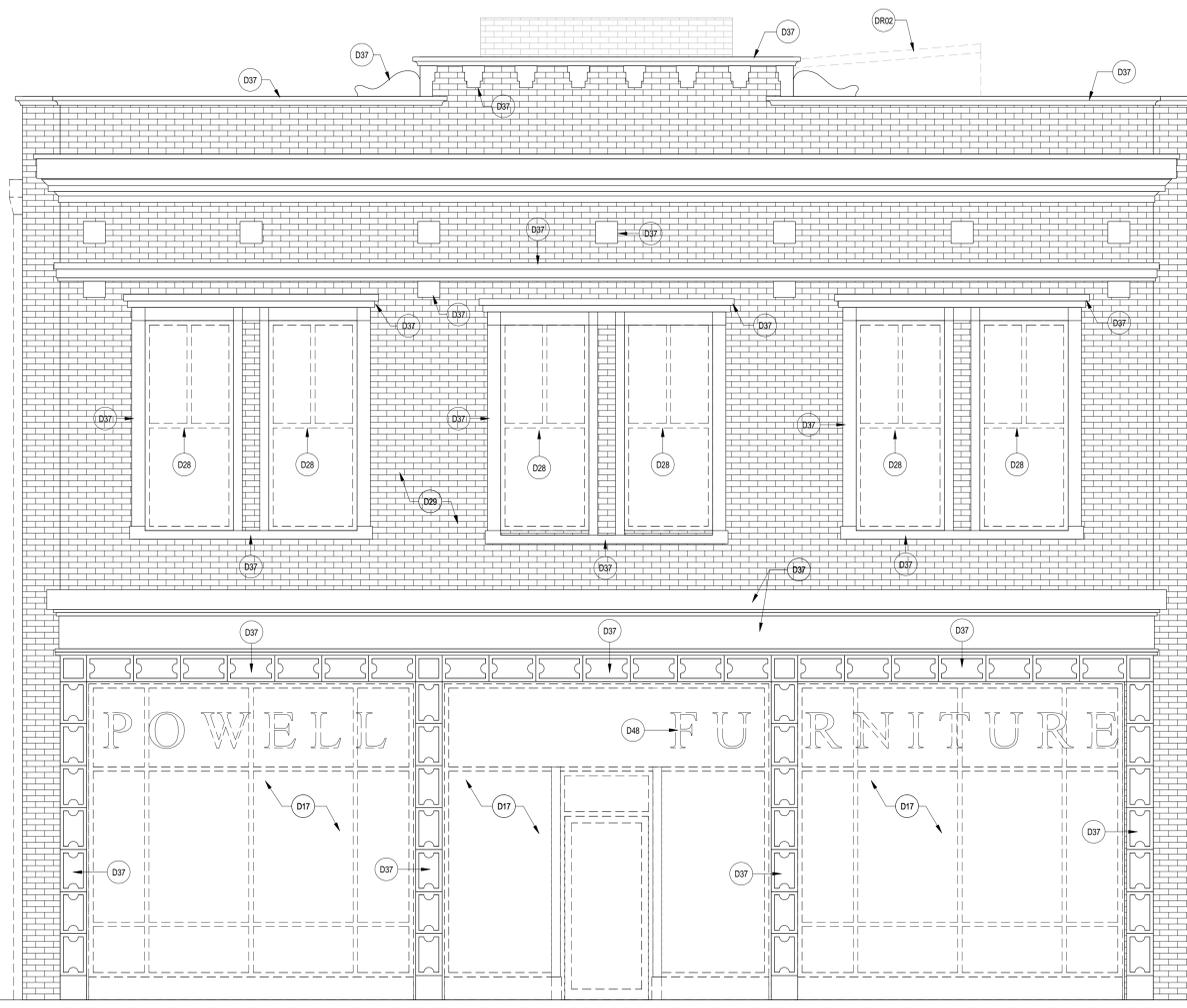
1 DEMOLITION EAST ELEVATION
DA4.1 3/8" = 1'-0"

DA4.1 DEMOLITION LEGEND - ELEVATIONS	
Key Value	Keynote Text
D07	SAW CUT EXISTING MASONRY EXTERIOR WALL FOR NEW EXTERIOR DOOR. SEE STRUCTURAL.
D15	SAW CUT EXISTING MASONRY EXTERIOR WALL FOR NEW EXTERIOR WINDOW. SEE STRUCTURAL.
D17	REMOVE AND DISPOSE OF STOREFRONT, GLAZING, AND TRIM. DEMO SILL FRAMING AND FLASHING TO SLAB. PATCH AND REPAIR ROUGH OPENING EDGES TO RECEIVE NEW STOREFRONT.
D28	REMOVE AND DISPOSE OF EXISTING WINDOW AND REPAIR EDGES OF EXISTING MASONRY ROUGH OPENING.
D29	STRIP AND REMOVE EXISTING PAINT ON MASONRY, CORNICE AND PARAPET WALL PER US DEPARTMENT OF INTERIOR HISTORIC RESTORATION GUIDELINES. TYPICAL ENTIRE FACADE.
D37	IF EXISTING TRIM IS SECURELY FASTENED TO EXISTING WALL, CHEMICALLY STRIP AND CLEAN IN PLACE. TYP. OTHERWISE, CAREFULLY REMOVE, CHEMICALLY STRIP AND CLEAN EXISTING PAINT FROM TERRACOTTA TRIM AND STORE FOR RE-USE. TYP. STORE BROKEN TRIM PEICES FOR USE IN CREATING REPLICAS.

Photo numbers	3, 4	Drawing numbers	DA4.1, A4.2
Description of work and impact on feature			
<p>Proposed work will test the strength of the terra cotta trim's adherence to the building. If the terra cotta trim is securely fastened to the wall surface, it will be chemically stripped and cleaned in place. If it is not strongly adhered to the wall surface, it will be carefully removed and cleaned of existing paint by chemically stripping. Pieces of terra cotta trim removed from the building will be stored for reuse. Broken trim pieces will be used to create replicas of the original.</p>			
Feature number	3

Photo numbers	7	Drawing numbers	DA4.1, A4.2
Description of work and impact on feature			
<p>All existing windows in the building's east elevation will be removed. Edges of the resultant rough masonry openings will be repaired. New windows will be aluminum clad wood double hung sash windows with pane configuration 2 over 1. Magnetic sensors in these windows will be wired to the building's security system. These same windows will be used in window openings on the building's north and south elevations as well. Replacement window style, material, profiles and details are to be historically appropriate subject to further research and staff approval.</p>			
Feature number	6		
Architectural feature	Skylight	Approximate date of feature	
Description of existing feature and its condition			
<p>Skylights are visible from the building's east and south elevations.</p>			
Photo numbers	none	Drawing numbers	DA4.1, DA4.2, A1.3

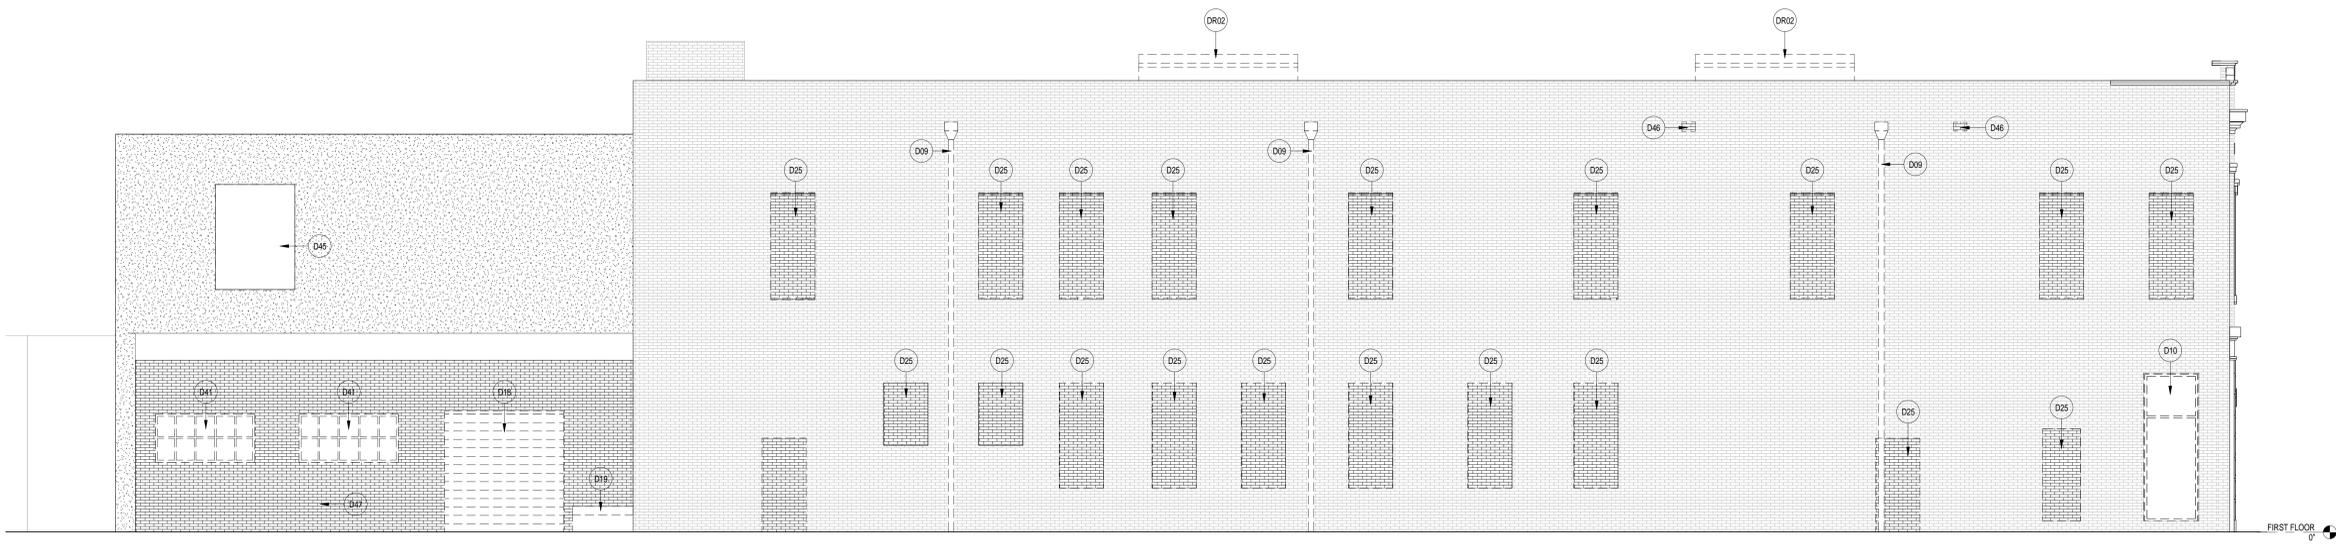
1 DEMOLITION WEST ELEVATION
DA4.2 3/16" = 1'-0"

DA4.2 DEMOLITION LEGEND - ELEVATION	
Key Value	Keynote Text
D09	REMOVE AND DISPOSE OF EXISTING CONDUCTOR BOX, DOWNSPOUT AND BRACKETS. INFILL CUT BRICK WITH NEW BRICK ENTIRE DOWNSPOUT CAVITY.
D10	REMOVE AND DISPOSE OF STOREFRONT, GLAZING, AND TRIM. PATCH AND REPAIR ROUGH OPENING TO RECEIVE NEW STOREFRONT.
D18	REMOVE AND DISPOSE OF EXISTING ROLL UP DOOR, DOOR TRACKS AND SUPPORT FRAMING.
D19	REMOVE AND DISPOSE OF EXISTING CONCRETE LOADING DOCK STRUCTURE AND FOUNDATION.
D25	REMOVE AND SALVAGE EXISTING BRICK INFILL AT ORIGINAL BUILDING WINDOW ROUGH OPENINGS AND PREPARE ROUGH OPENING TO RECEIVE NEW WINDOWS.
D41	REMOVE AND DISPOSE OF WINDOW SYSTEM AND TRIM. PATCH AND REPAIR ROUGH OPENING.
D45	SAW CUT EXISTING CMU WALL FOR NEW ROUGH OPENING.
D46	SAW CUT EXISTING BRICK LEVEL WITH ROOF SURFACE FOR NEW THROUGH WALL SCUPPER AT NEW DOWNSPOUT LOCATION.
D47	REMOVE AND DISPOSE OF EXISTING BRICK WALL. SHORE UP WALL AND PREPARE FOR NEW LOAD BEARING COLUMNS AND BEAM.

DR02	REMOVE AND DISPOSE OF EXISTING SKYLIGHT AND FRAMING. SHORE UP ROOF STRUCTURE AND PREPARE EXISTING FRAMING FOR NEW SKYLIGHT FRAMING.

Photo numbers	14, 15, 16	Drawing numbers	DA4.2, A4.1
Description of work and impact on feature			
<p>Existing brick infill in the center 6 windows will be removed and salvaged. Resultant rough openings will be repaired and prepared to receive new windows. New windows will be aluminum clad wood double hung sash windows with pane configuration 2 over 1. Magnetic sensors in these windows will be wired to the building's security system. Replacement window style, material, profiles and details are to be historically appropriate subject to further research and staff approval.</p> <p>The 2 westernmost windows will remain infilled.</p> <p>The storefront window, glazing, and trim in the southeast corner will be removed. Rough openings will be patched and repaired. This opening will be infilled with new three wythes of brick.</p> <p>The brick infill in the remaining rectangular window near the building's southeast corner will be removed and salvaged. It will be infilled once more with new three wythes of brick.</p>

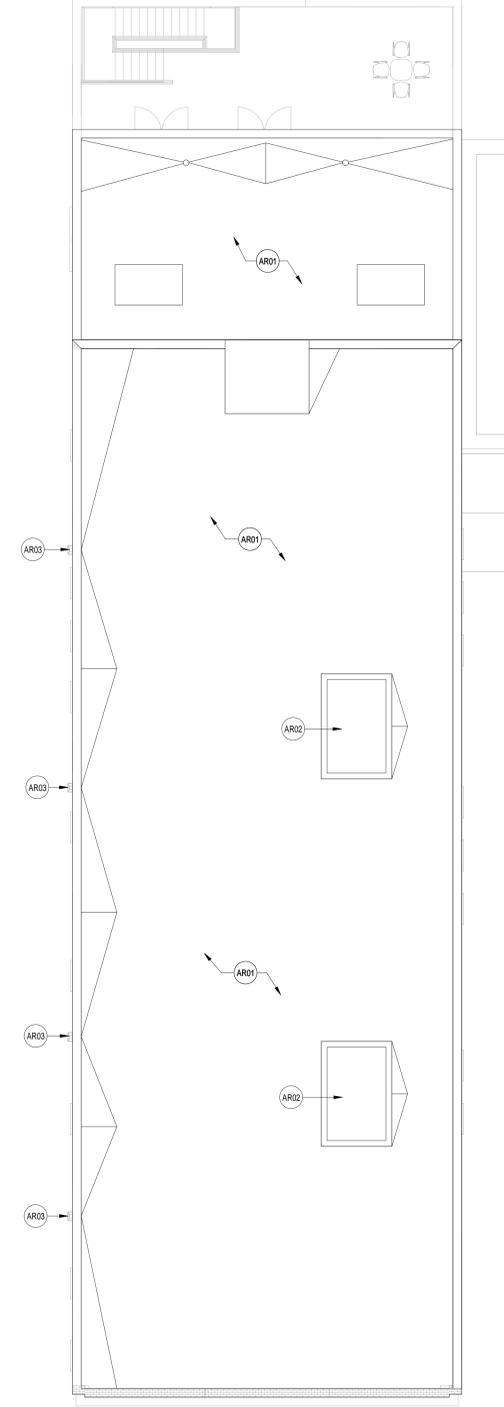
1
A1.3 A1.5 ROOF PLAN
1/8" = 1'-0"

1. SEE A6.0 FOR TYPICAL ROOF CONSTRUCTION.
2. FOR LOW SLOPED ROOF, MINIMUM ROOF SLOPE IS 1/4" PER FOOT.
3. COORDINATE WITH PLAN AND ELEVATION DRAWINGS FOR LOCATION OF DOWNSPOUTS.
4. CONTRACTOR TO SIZE GUTTERS AND DOWNSPOUTS BASED ON ROOF SURFACE.
5. COORDINATE WITH PLUMBING AND MECHANICAL DRAWINGS FOR ROOF PENETRATIONS.

A1.3 NEW WORK LEGEND - ROOF	
Key Value	Keynote Text
AR01	NEW KEE THERMOPLASTIC SINGLE PLY MEMBRANE ROOF OVER 1/2" COVER BOARD FULLY ADHERED TO 6" OF POLYISO FULLY ADHERED TO NEW STRUCTURAL PLYWOOD DECKING. FASTEN DECKING TO EXISTING ROOF RAFTERS.
AR02	NEW SKYLIGHTS AND RESTORED LIGHT WELL TO SECOND FLOOR CEILING BELOW.
AR03	NEW CONDUCTOR BOX, DOWNSPOUT AND BRACKETS. INFILL AND TOOTH IN NEW BRICK TO MATCH EXISTING AT DOWNSPOUT CAVITY.

feature	
Description of existing feature and its condition			
<p>The existing roof is flat and not visible from street level on any side. It is wood framing over wood rafters, and covered in tar and gravel.</p>			
Photo numbers	none	Drawing numbers	DA1.3, A1.3
Description of work and impact on feature			
<p>The existing roofing system and decking will be removed to existing wood rafters. The existing skylight and framing (see item 6) will be removed, and the roof structure shored up to prepare the existing framing for a new skylight. Existing coping along the edges of the roof will be removed and existing masonry will be repaired to receive new blocking and metal coping.</p> <p>The existing roof system in the building's west addition will be removed and the roof deck and steel joints will be repaired as required.</p> <p>The new roof on both the main building and its addition will be kee thermoplastic single ply membrane over ½" cover board fully adhered to 6" of polysio fully adhered to new structural plywood decking. The decking will be fastened to the existing roof rafters.</p>

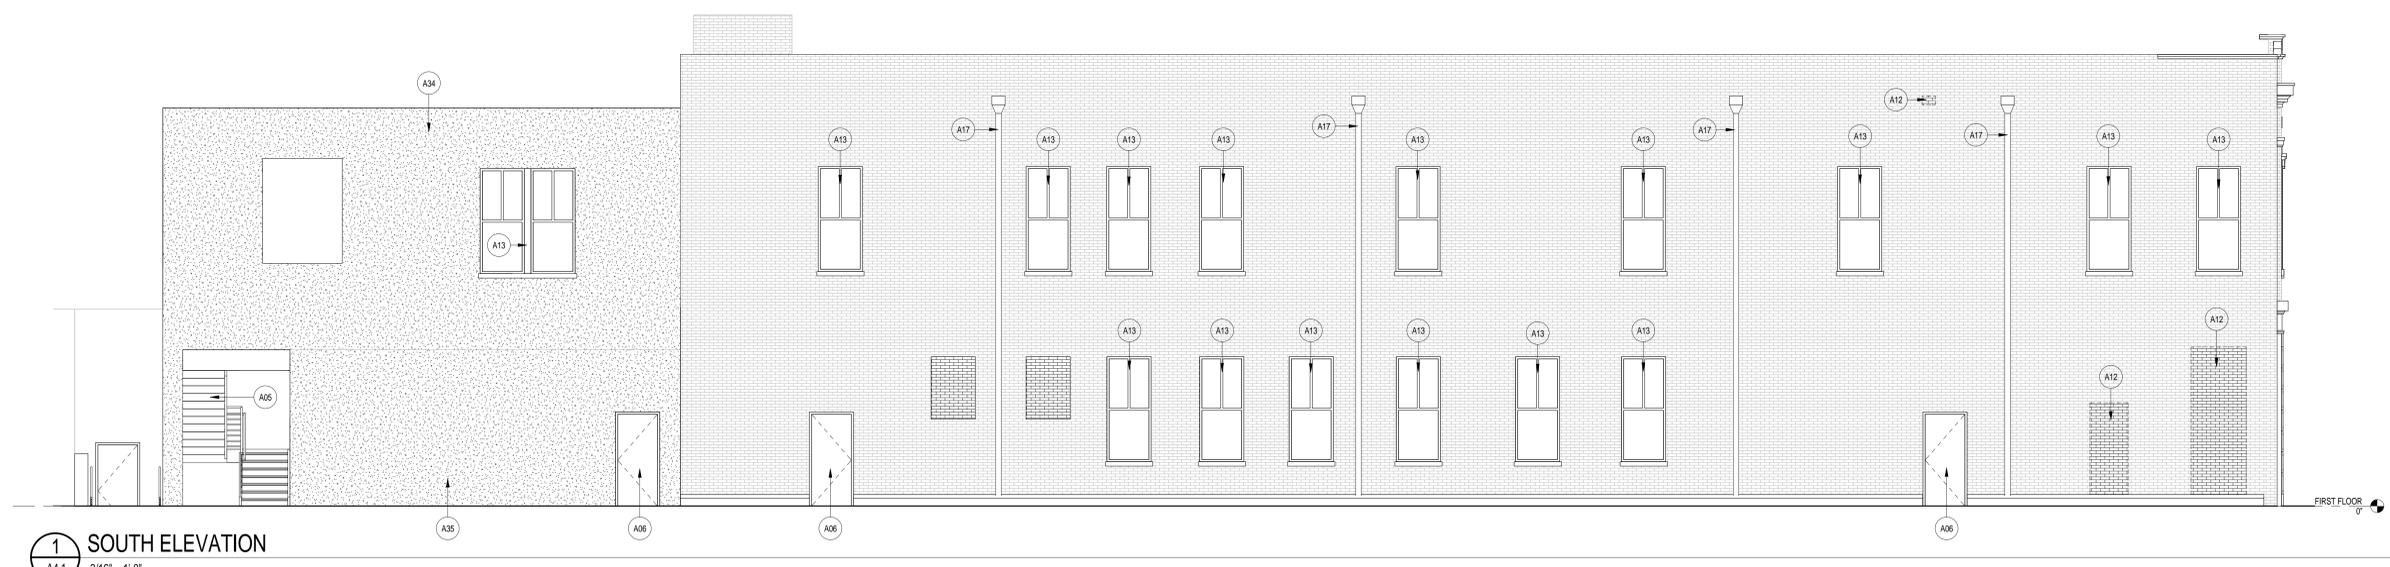
1 SOUTH ELEVATION
A4.1 3/16" = 1'-0"

A4.1 NEW WORK LEGEND - ELEVATIONS	
Key Value	Keynote Text
A05	NEW METAL PAN STAIR WITH SALVAGED WOOD IN TREADS, SANDED, STAINED, AND SEALED. CUSTOM STAINLESS STEEL WALL MOUNTED HANDRAIL AND GAURDRAIL/HANDRAIL SYSTEM THROUGHOUT.
A06	NEW INSULATED EXTERIOR HOLLOW METAL DOOR AND FRAME WITH ACCESS CONTROL: CARD READER AND DOOR POSITION SWITCH. PROVIDE DOOR CONTACTS FOR SECURITY SYSTEM.
A08	NEW INSULATED, LAMINATED, GLASS ENTRANCE STOREFRONT DOOR(S) WITH SIDE LIGHTS. ACCESS CONTROL: CARD READER AND DOOR POSITION SWITCH. PROVIDE DOOR CONTACTS FOR SECURITY SYSTEM.
A12	INFILL NEW THREE WYTHES OF BRICK IN WALL OPENING.
A13	NEW ALUMINUM CLAD WOOD DOUBLE HUNG SASH WINDOWS, BASIS OF DESIGN JELD-WEN. PROVIDE MAGNETIC SENSOR WIRED TO SECURITY SYSTEM.
A17	NEW CONDUCTOR BOX, DOWNSPOUT AND BRACKETS. INFILL AND TOOTH IN NEW BRICK TO MATCH EXISTING AT DOWNSPOUT CAVITY.
A33	NEW PRE-ENGINEERED METAL CANOPY SYSTEM.
A34	NEW STUCCO FINISH OVER EXISTING CMU WALL.

A35	NEW STUCCO FINISH OVER NEW CMU WALL.

South Elevation: There are a few exterior alterations proposed for this elevation, some are located near the rear in the concrete block addition and will not be highly visible to the public right of way. Closer to the front of the building a new door opening with a flat metal door is proposed. This will necessitate the loss of a minor amount of exterior brick; this brick should be salvaged for repairs to other parts of the building. The minor size of this pedestrian door is compatible with the building. A nearby pedestrian door that is closer to the façade will be bricked in; this is not an original opening and its infill will be an improvement for the historic appearance.

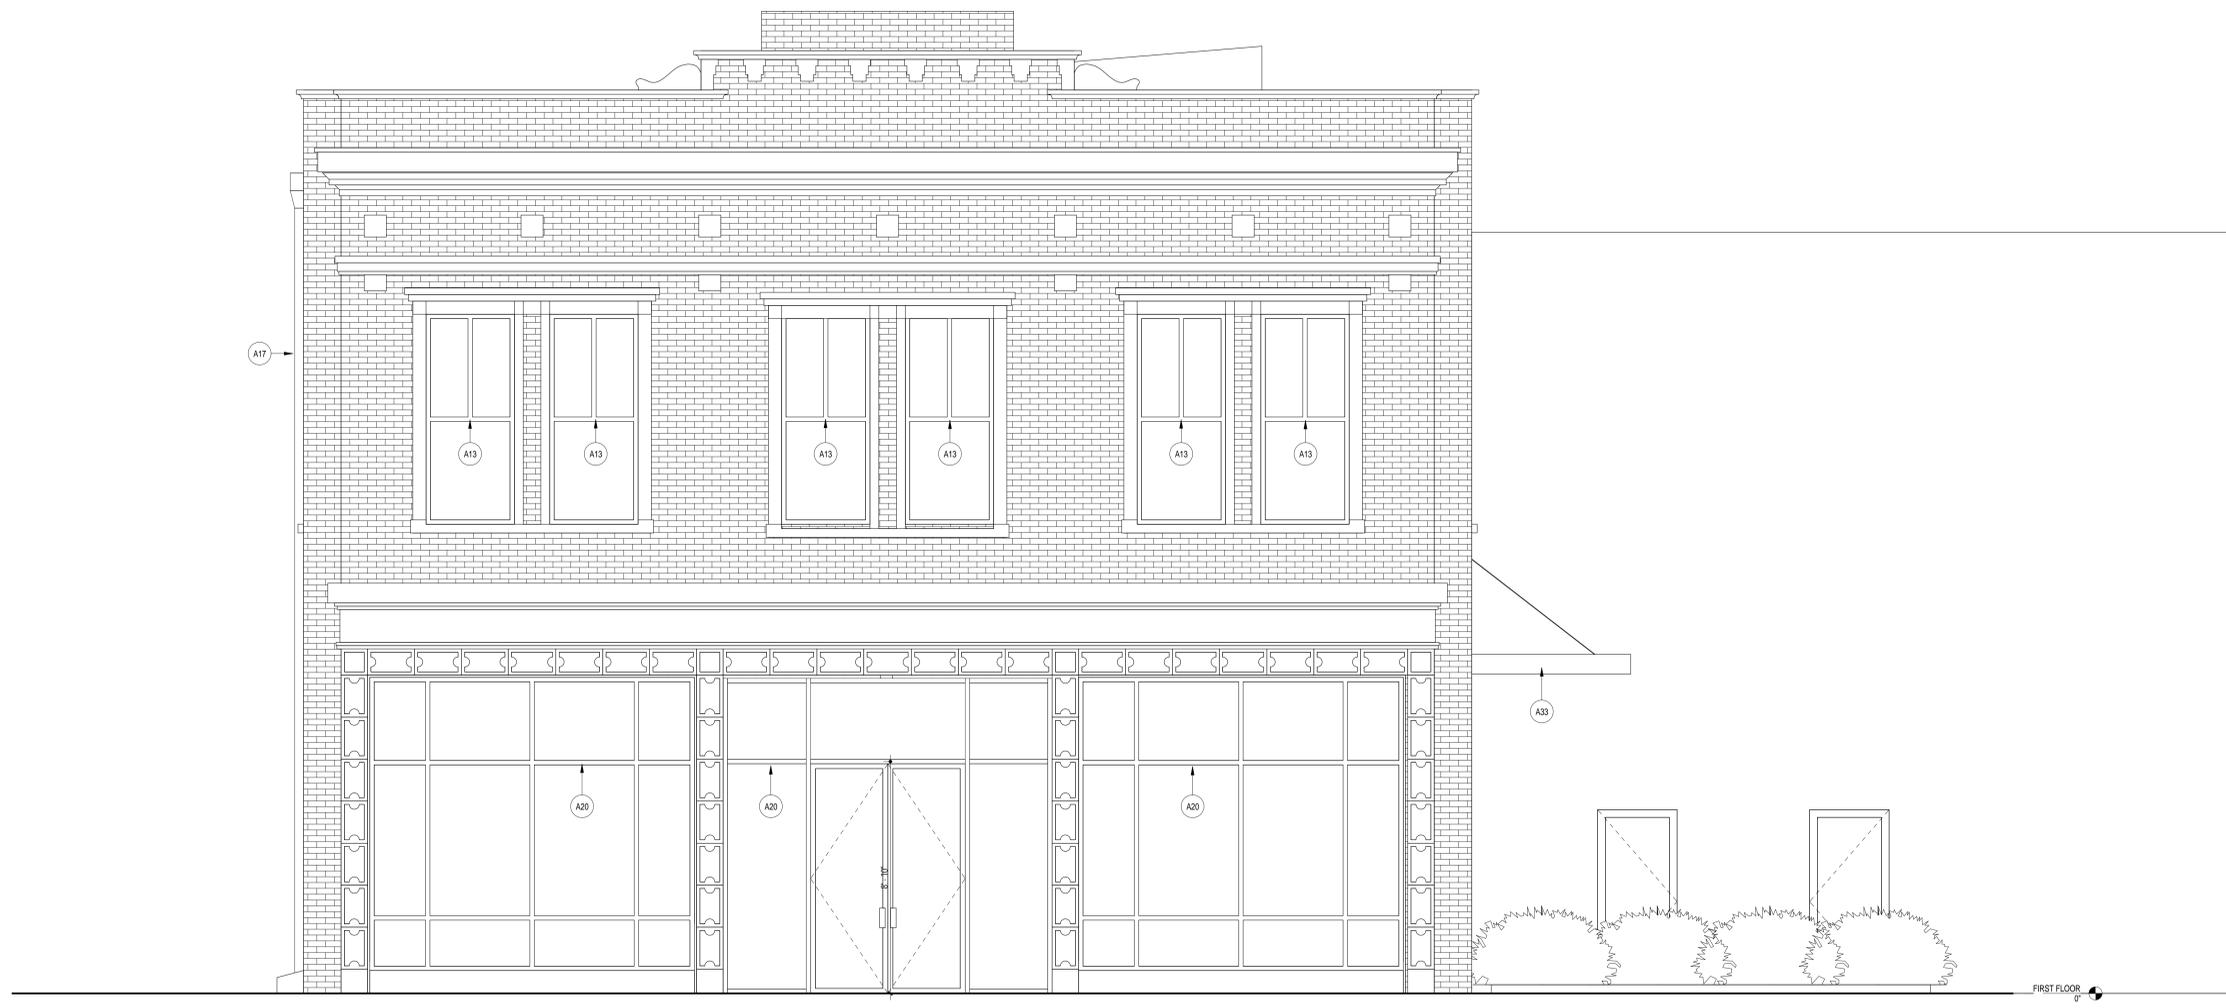
1 EAST ELEVATION
A4.2 3/8" = 1'-0"

A4.1 NEW WORK LEGEND - ELEVATIONS	
Key Value	Keynote Text
A13	NEW ALUMINUM CLAD WOOD DOUBLE HUNG SASH WINDOWS, BASIS OF DESIGN JELD-WEN. PROVIDE MAGNETIC SENSOR WIRED TO SECURITY SYSTEM.
A17	NEW CONDUCTOR BOX, DOWNSPOUT AND BRACKETS. INFILL AND TOOTH IN NEW BRICK TO MATCH EXISTING AT DOWNSPOUT CAVITY.
A20	NEW STOREFRONT, GLAZING, AND TRIM. NEW SILL FRAMING AND FLASHING TO SLAB.
A33	NEW PRE-ENGINEERED METAL CANOPY SYSTEM.

If no historic windows are found in the original openings that have been bricked in, and which could be repaired (determination by staff), then new aluminum-clad windows are proposed. The proposed pattern of 2/1 is not consistent with the historic windows and does not meet this ordinance. A 6/1 pattern would be consistent.

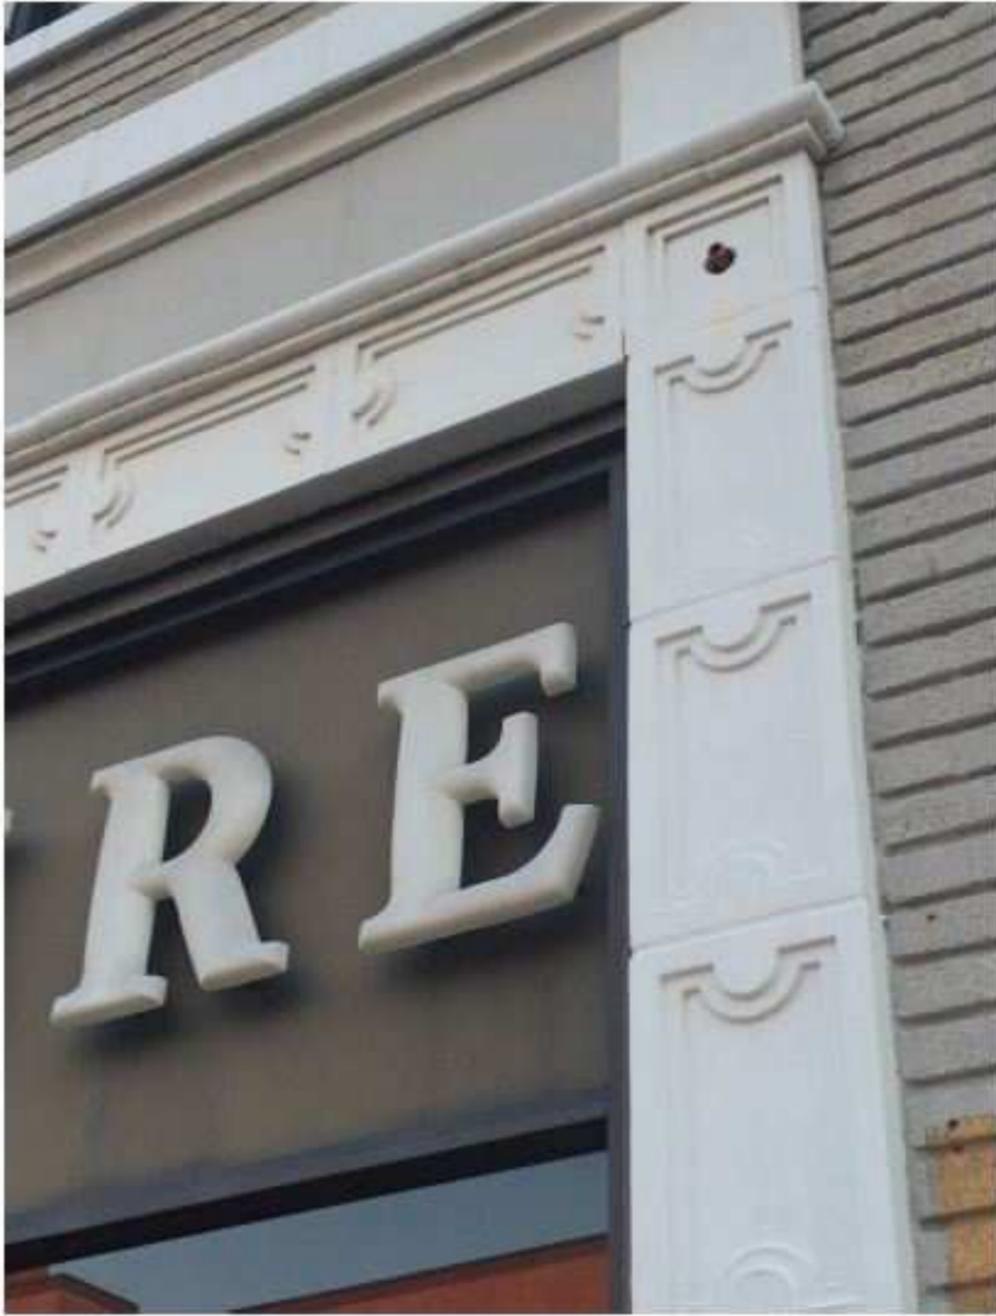
Photo 3

Item 2: Terra cotta trim (east elevation)

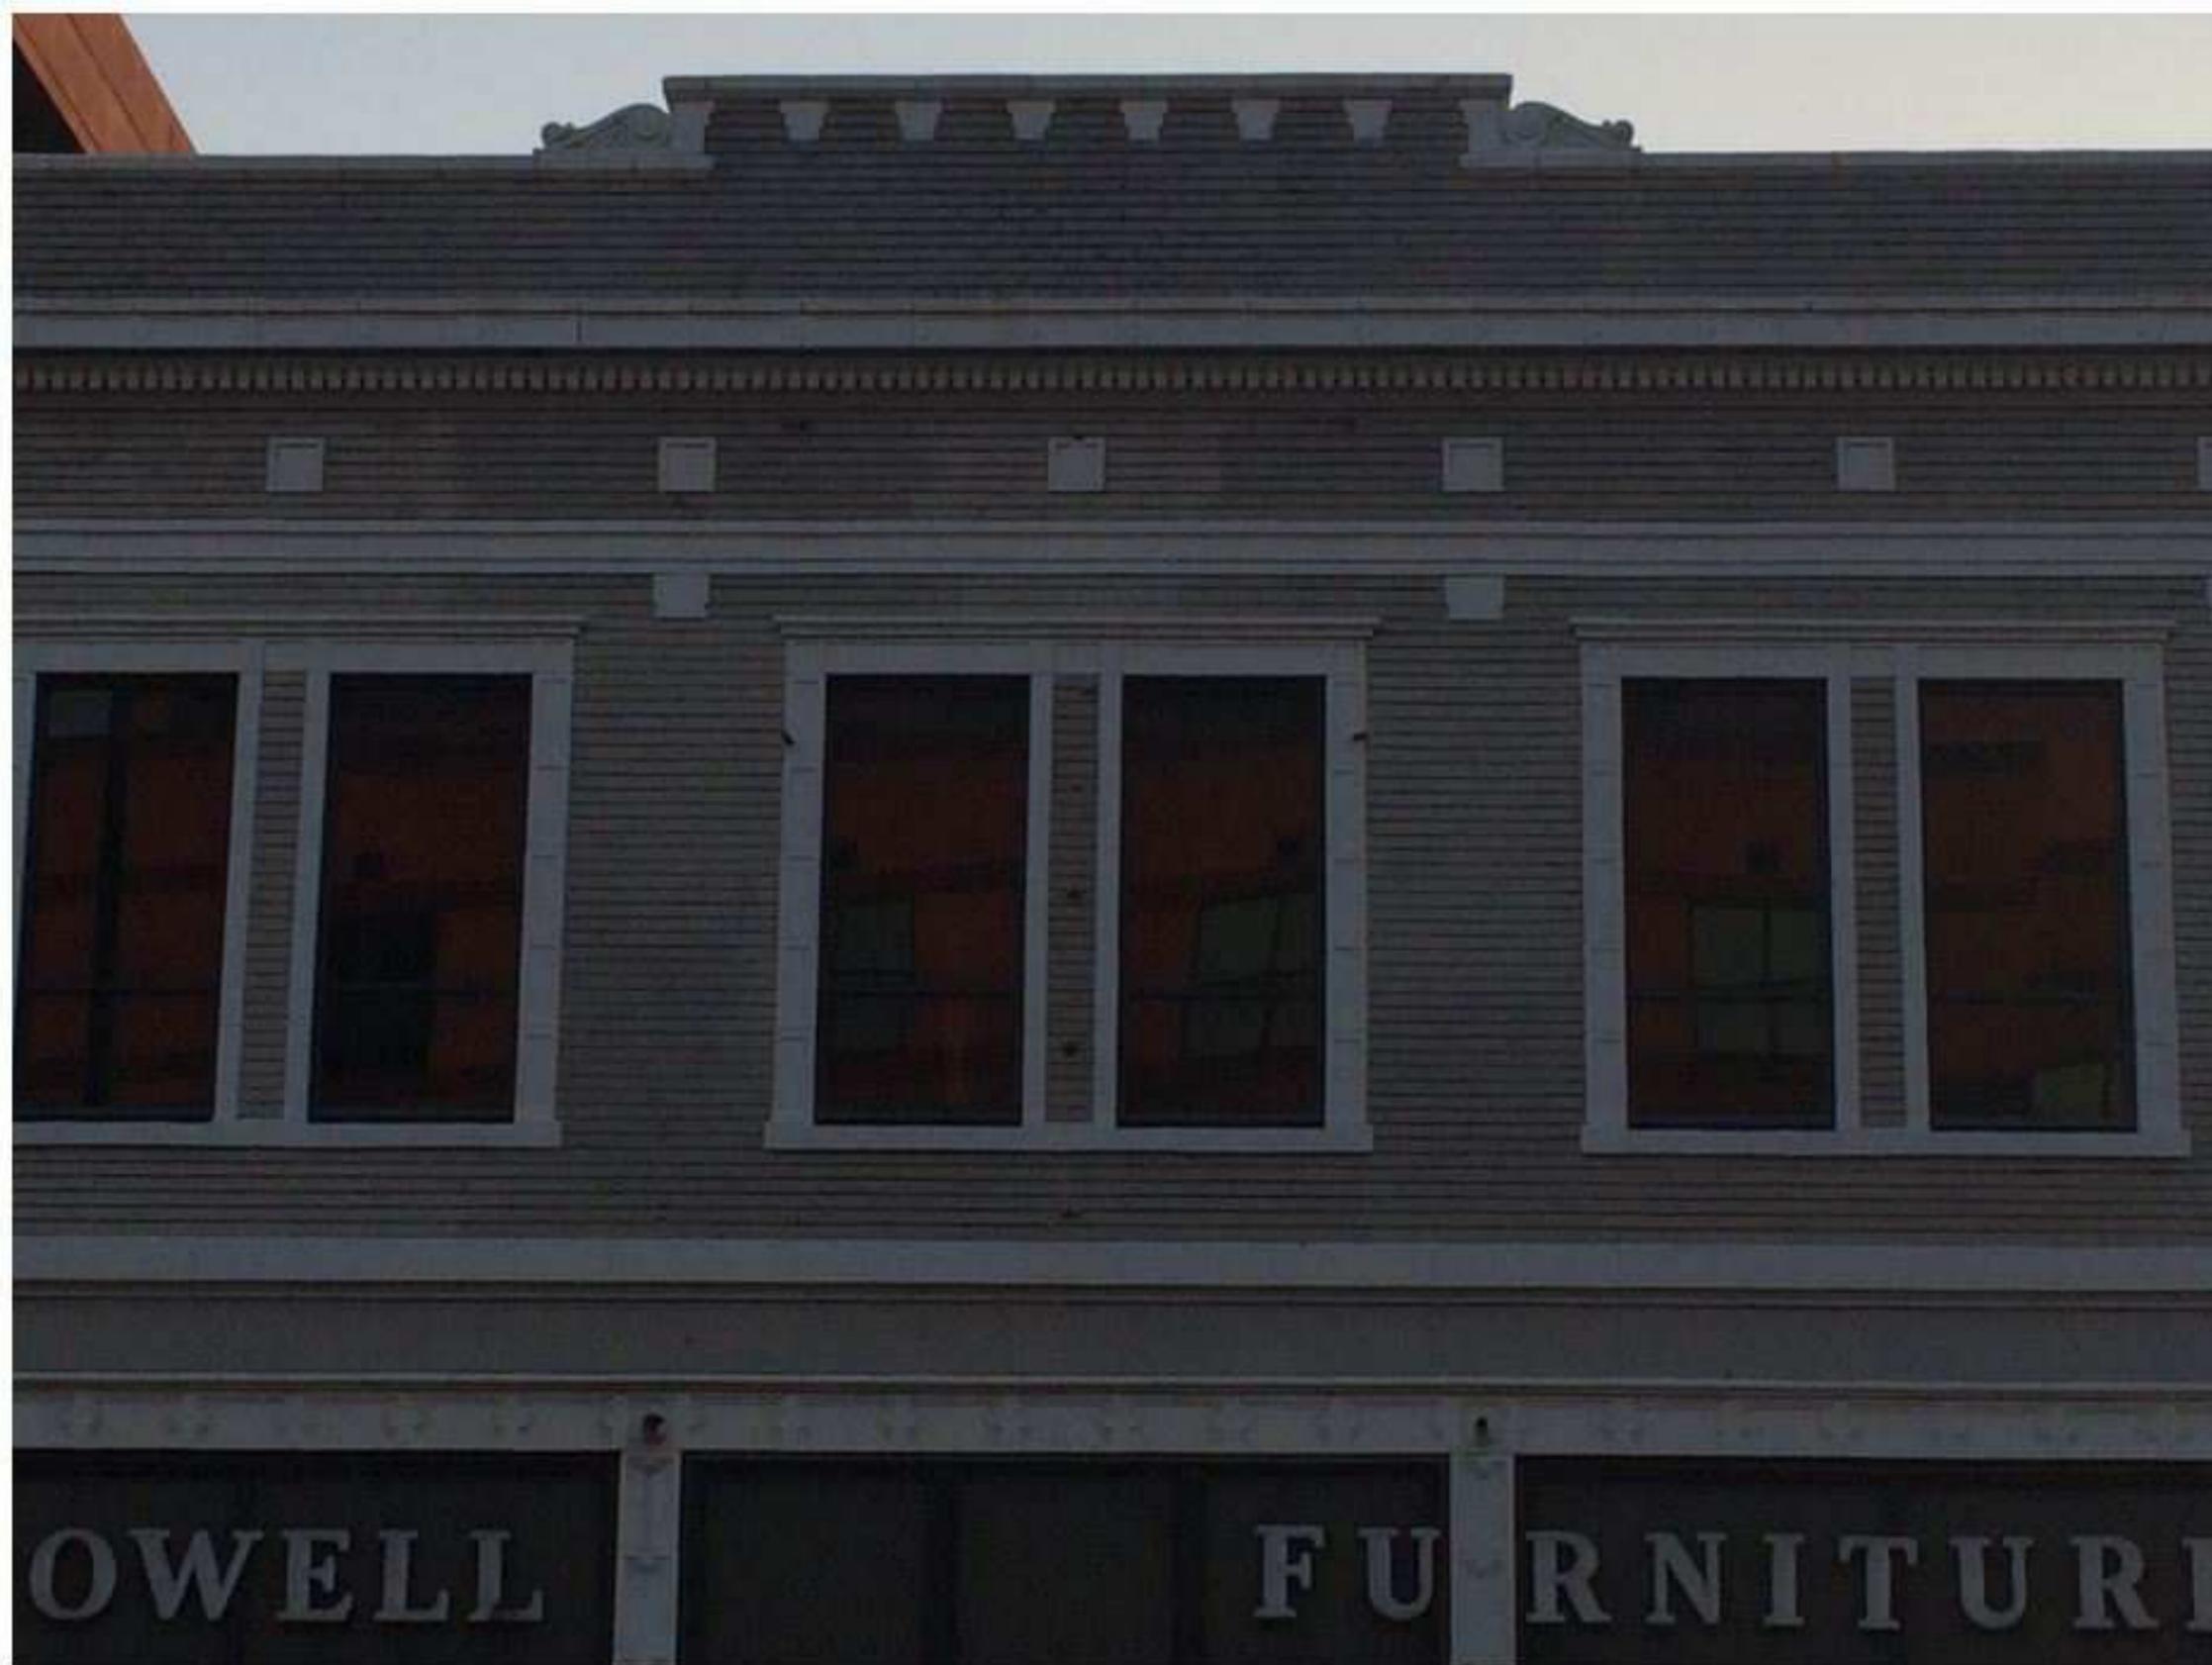
Photo 7

Item 5: Second level windows in east elevation

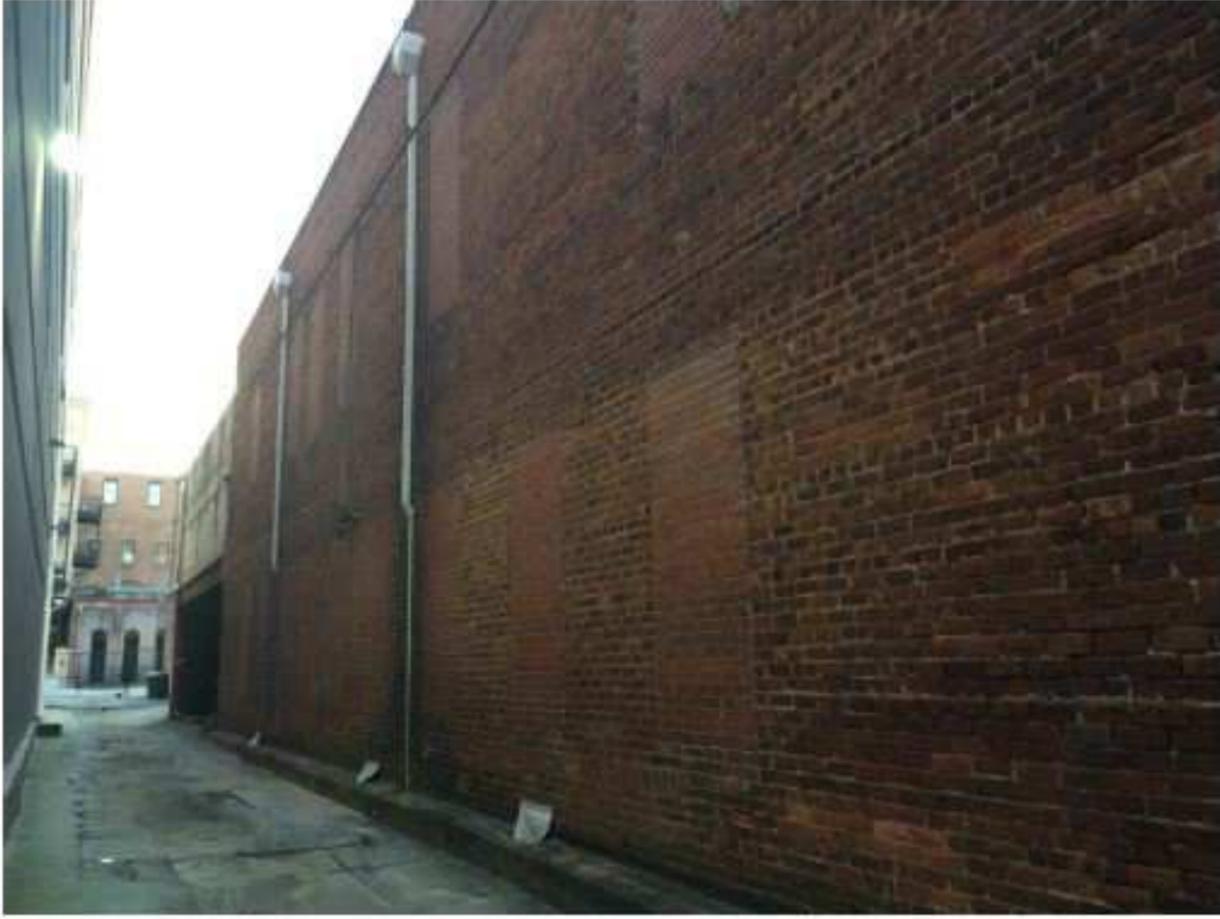
Photo 14

Item 10: First level windows in south elevation

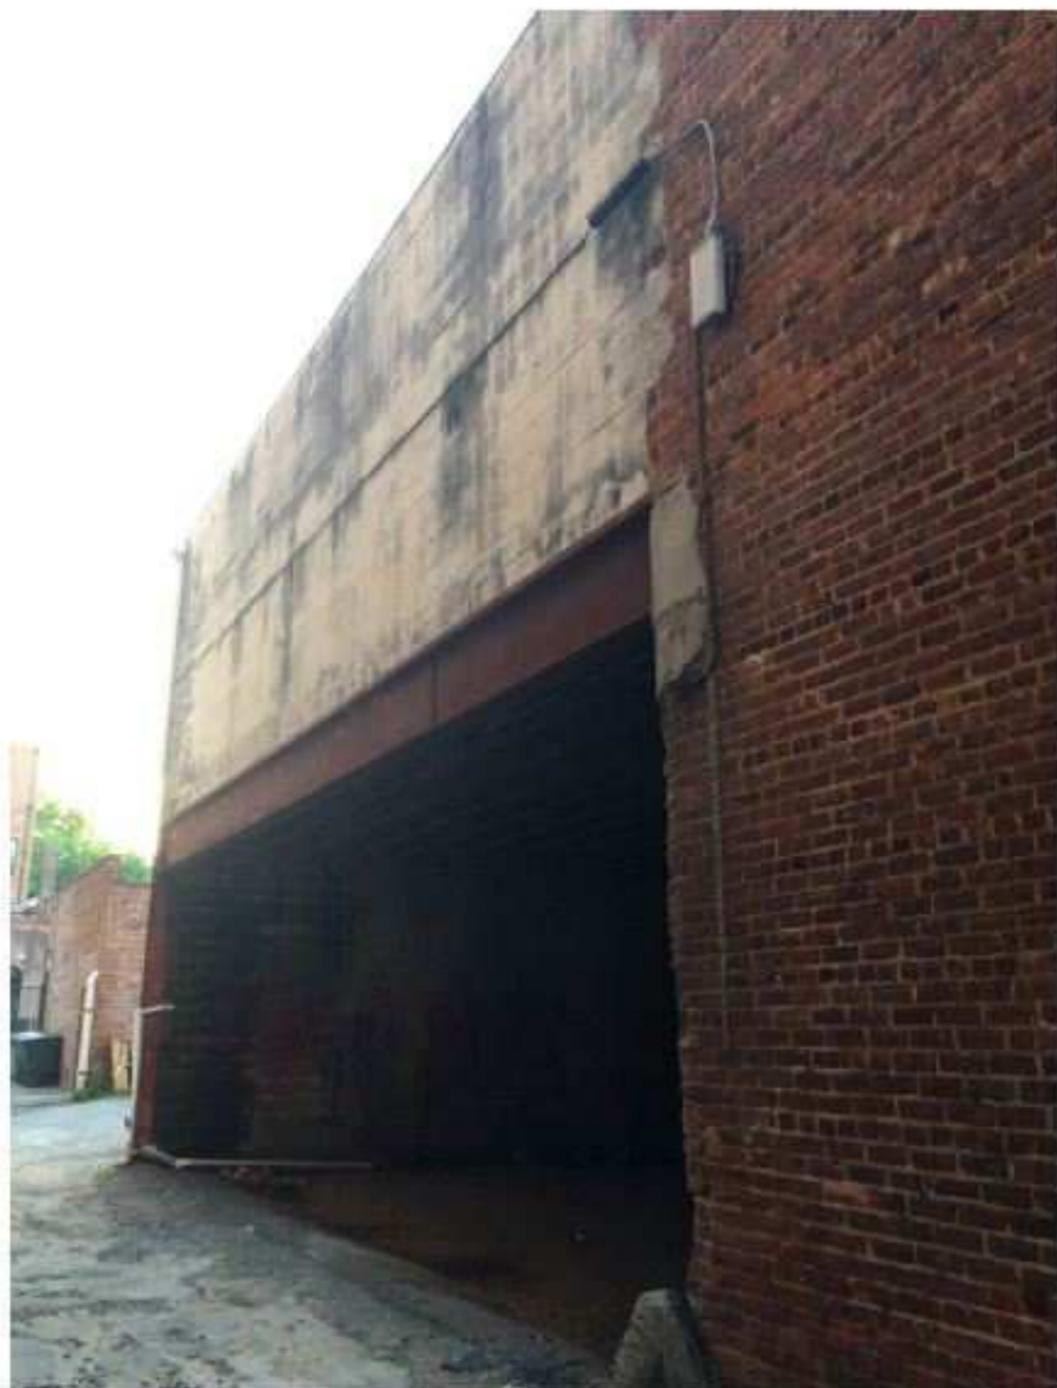
Photo 24

Item 14: Rear addition south elevation

Description of existing feature and its condition			
A two-story addition abuts the building's west elevation. This addition contains openings only in its south elevation. The first level of this addition is brick. It contains three bays, with high rectangular windows in the first two bays and a wide roll-up loading door in the last. The windows contain panes 5 over 5 with aluminum casing and mullions. A low loading dock stands at the addition's southeast corner.			
The second level of this addition is constructed of CMU. It contains a singular, square window in the southwest corner.			
Photo numbers	24, 25	Drawing numbers	DA4.2, A4.1
Description of work and impact on feature			
The roll up loading door, its tracks and support framing will be removed. The existing concrete loading dock will be removed. The existing window system and its trim will be removed and the resultant rough openings patched and repaired. The CMU second level will be saw cut for a new rough opening. The existing brick wall in the first level will be removed. The CMU wall above will be shored up and prepared for new load bearing columns and beams.
