D/DRC Case

1222-1224 Taylor Street

DESIGN/DEVELOPMENT REVIEW COMMISSION
DESIGN REVIEW DISTRICT
EVALUATION SHEET
Case # 2

NATURE OF REQUEST: Request for Certificates of Design Approval for renovations to an existing structure.

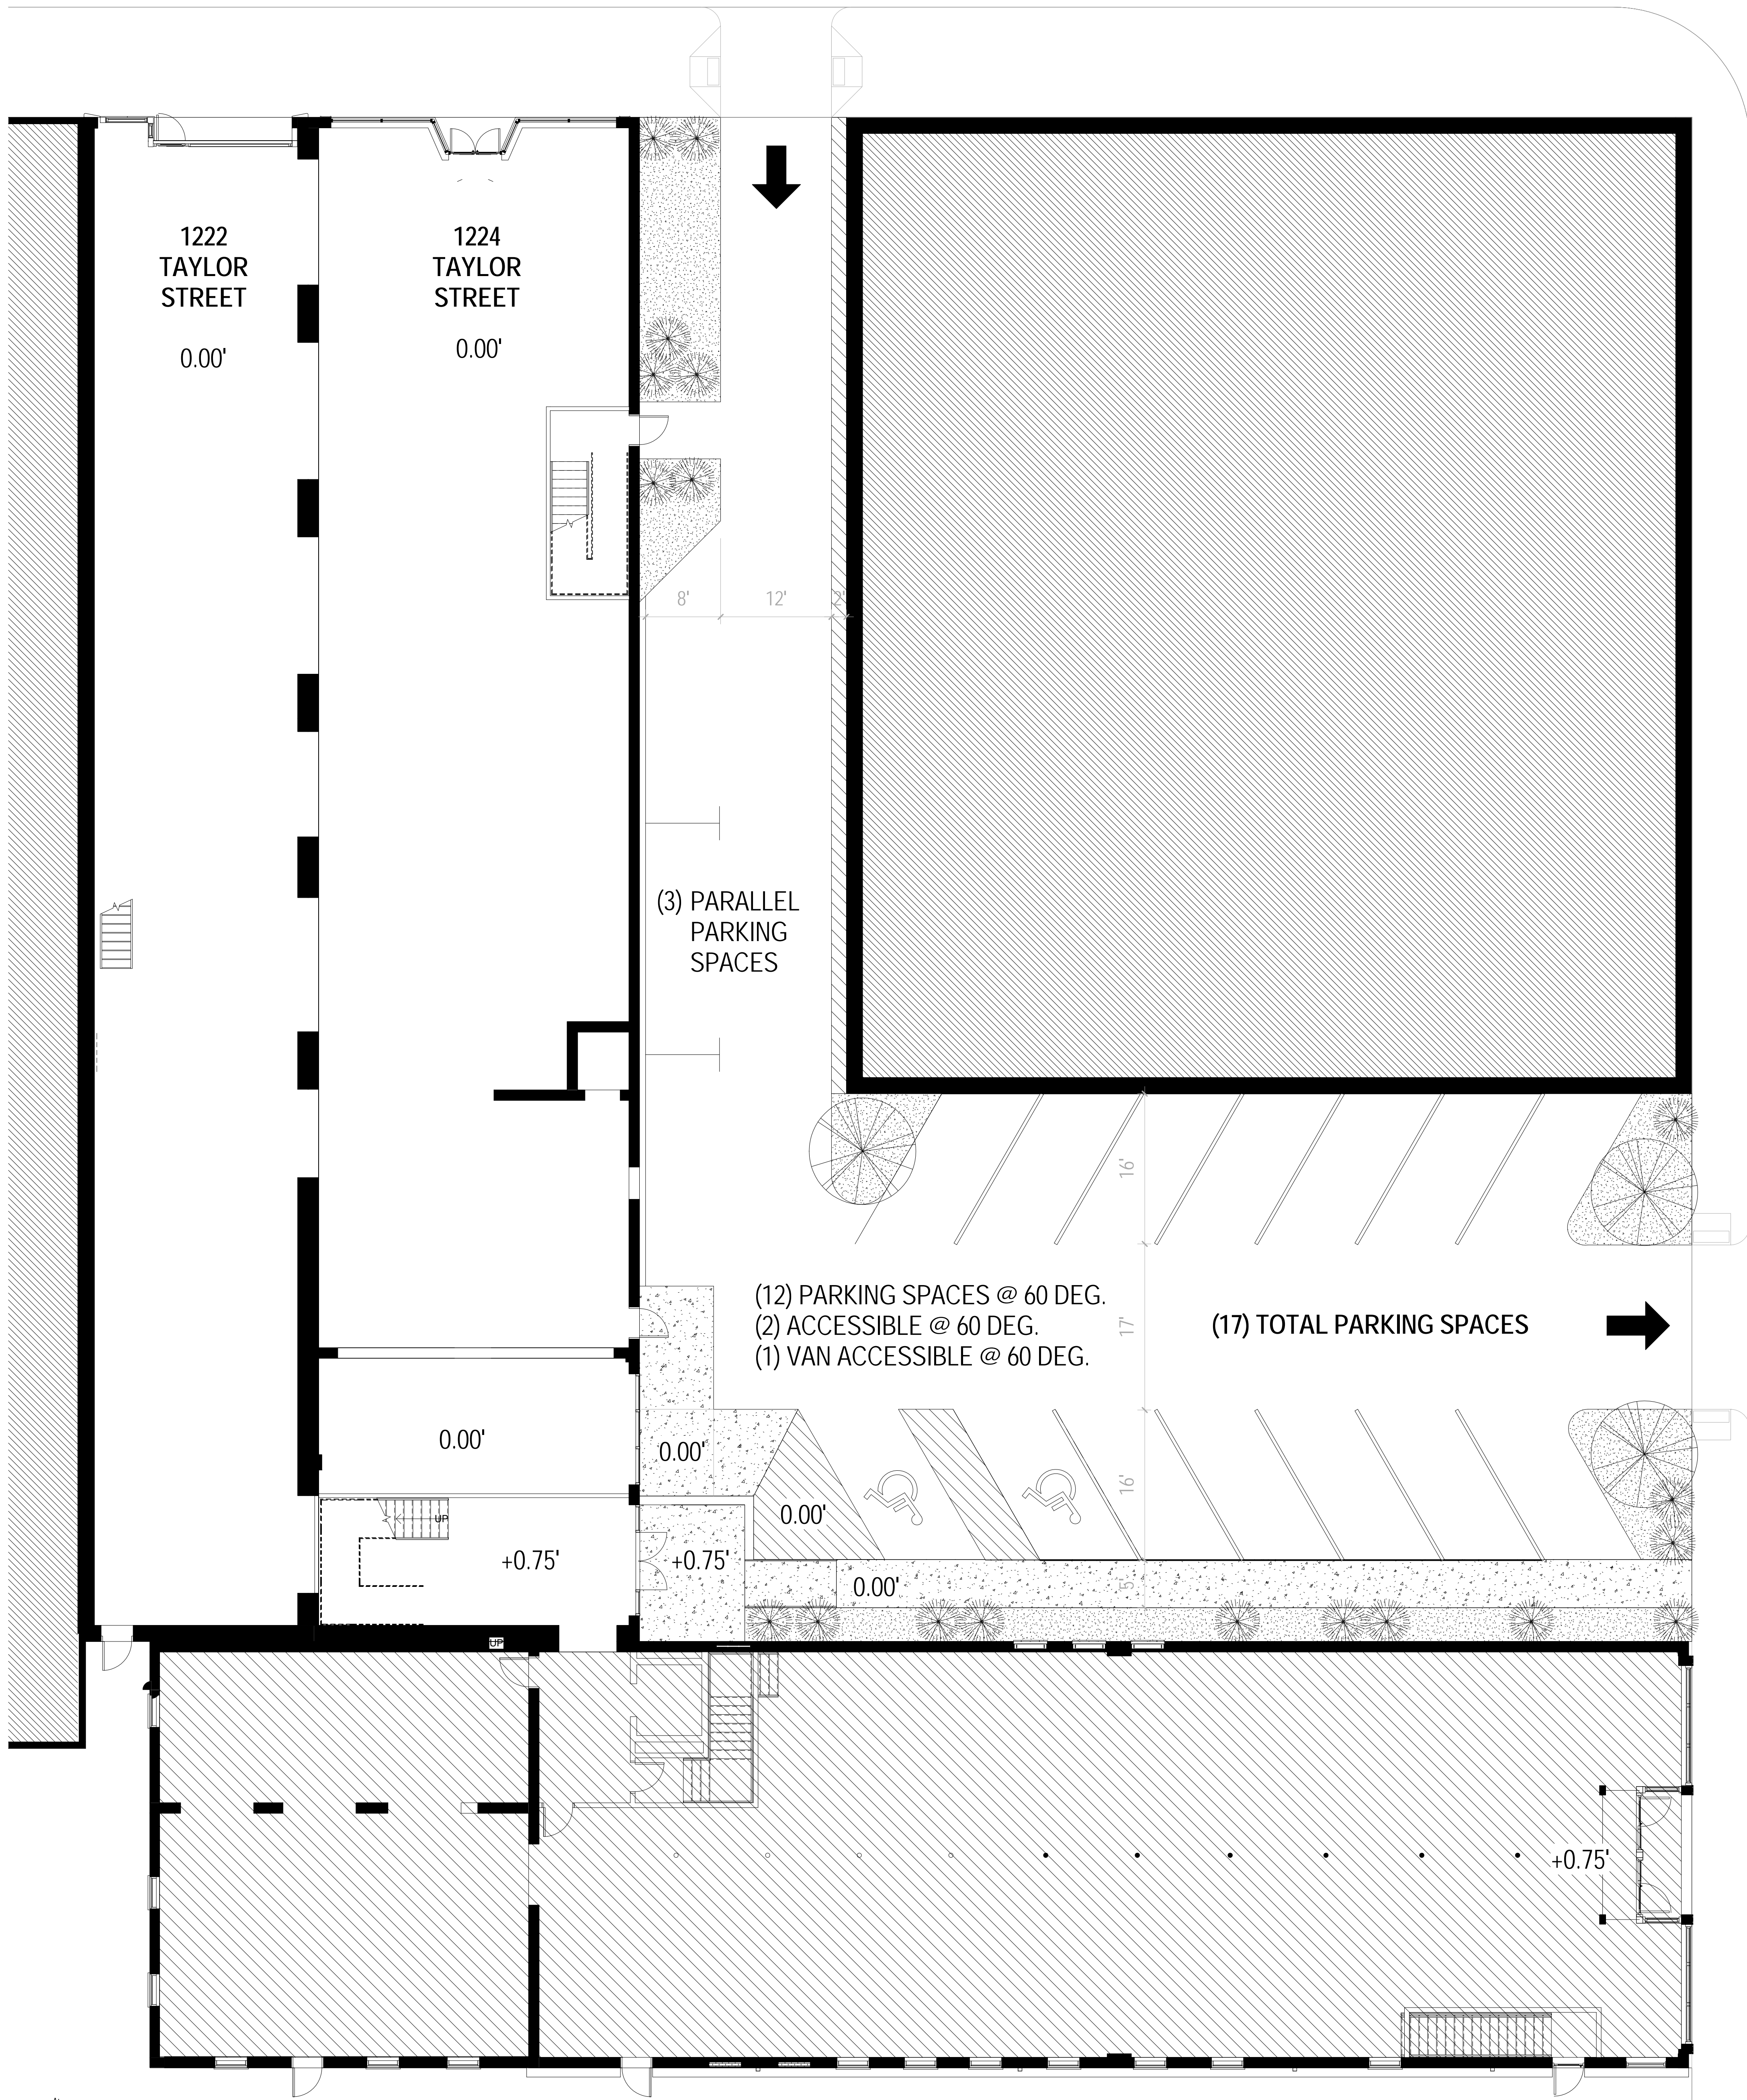
1
AS1.1

SITE PLAN
1/8" = 1'-0"

RESTORE AND/OR REPLACE FRITTED METAL EDGE BANDING SURROUNDING STOREFRONT, THREE SIDES

REPLACE DAMAGED EXISTING STOREFRONT, TYP., WITH NEW ALUMINUM STOREFRONT TO MATCH IN FINISH, MULLION SIZE, AND CONFIGURATION. SET ON EXISTING BRICK BASE.

REMOVE RUST AND SCALE, STRIP AND REPLACE GLAZING SEALANT AND GLAZING WHERE DAMAGED, TYPICAL ALL WINDOWS.

REPAIR DAMAGED AREAS OF STUCCO FACADE AND PAINT. TYP.

- REMOVE WINDOW AND INFILL WITH MATCHING SALVAGED BRICK
- REMOVE RUST AND SCALE, STRIP AND REPLACE GLAZING SEALANT AND GLAZING WHERE DAMAGED, TYPICAL ALL WINDOWS.

- REMOVE AND DISPOSE OF EXTERIOR STAIR ADDITION (ADDED AFTER PERIOD OF SIGNIFICANCE)
- REPAIR AND RE-SEAL TERRACOTTA TILE COPING
- REMOVE WALL PACK AND PATCH WALL, TYP.

Storefront is being added to the southern end of the eastern façade, facing Sumter Street. As this is an existing building, the storefront ends up far back from the street. To provide pedestrian access, a sidewalk has been provided between the parking and the adjacent building. This pedestrian connection is important to keep pedestrians from walking through the parking lot.

Original windows are being restored and glazing replaced as necessary. 2 new windows are being added to the upper floor on the eastern elevation where an exterior stair addition will be removed. The new windows continue the pattern of openings on the second floor. Windows are being added to the first floor also on this eastern elevation, to align with the upper floor openings.

The garage doors on the eastern façade, which are visible from Sumter Street, are being replaced with storefront and a new canopy is being added. The original openings will remain.

The stucco on the Rose Talbert façade will be repaired and painted.
