Melrose Heights / Oak Lawn Architectural Conservation District

DESIGN/DEVELOPMENT REVIEW COMMISSION
DESIGN REVIEW DISTRICT
HISTORIC AGENDA
EVALUATION SHEET
Case # 11

ADDRESS: 1420 Hagood Avenue

NATURE OF REQUEST: Request Certificate of Design Approval for new construction

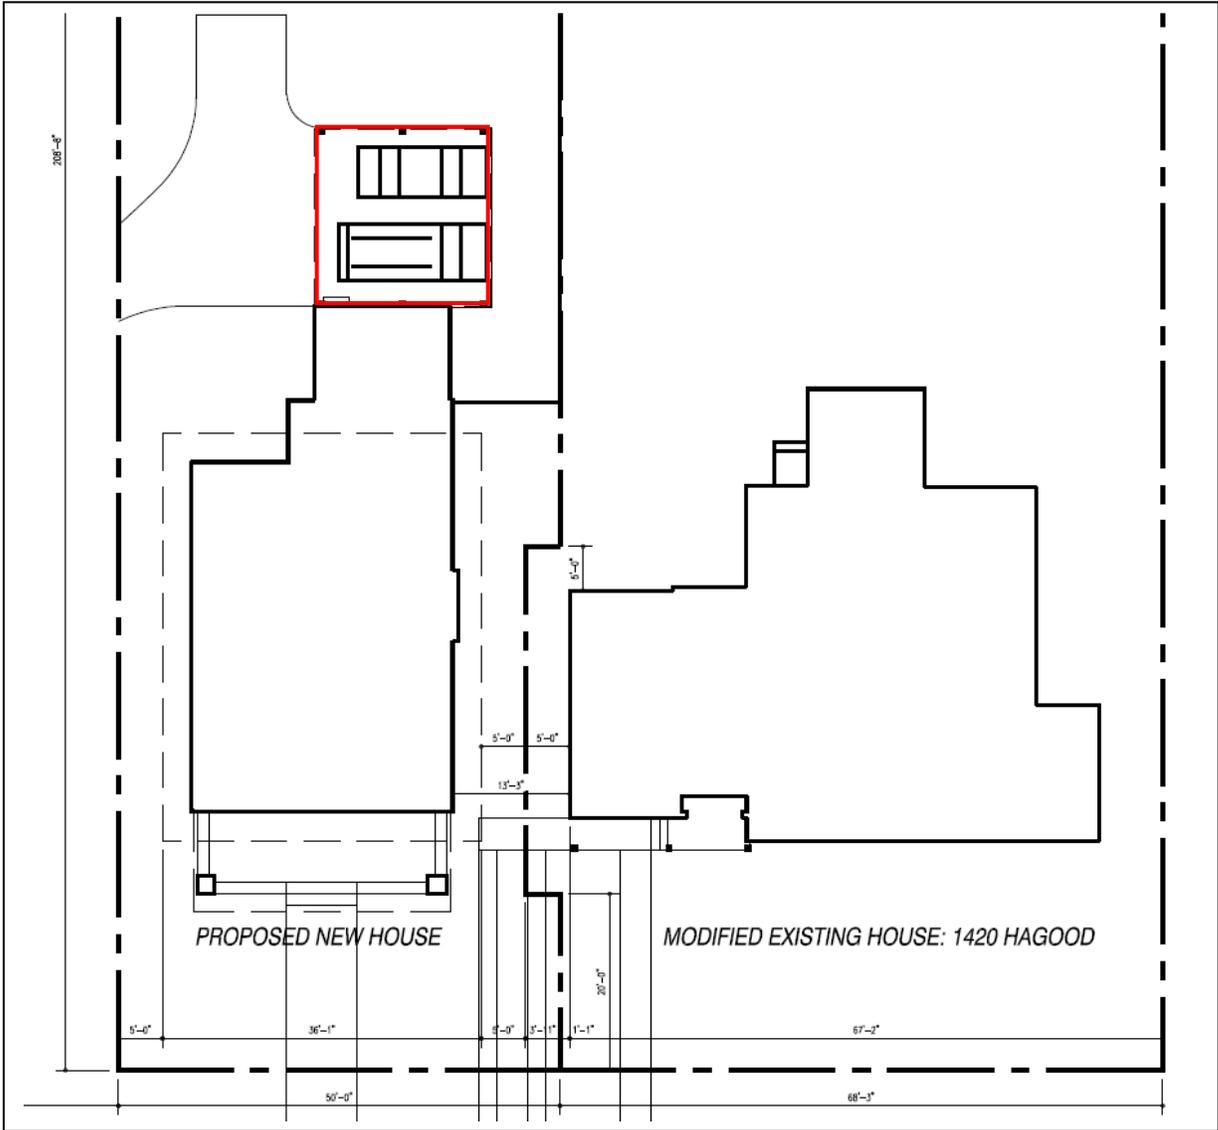
Red outline of carport is shown

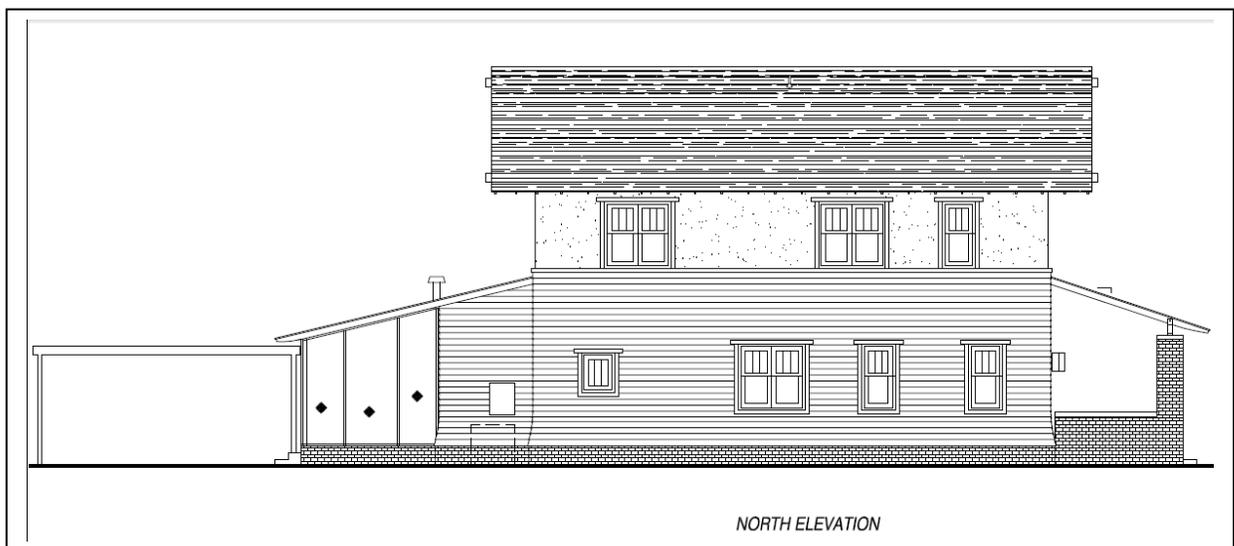
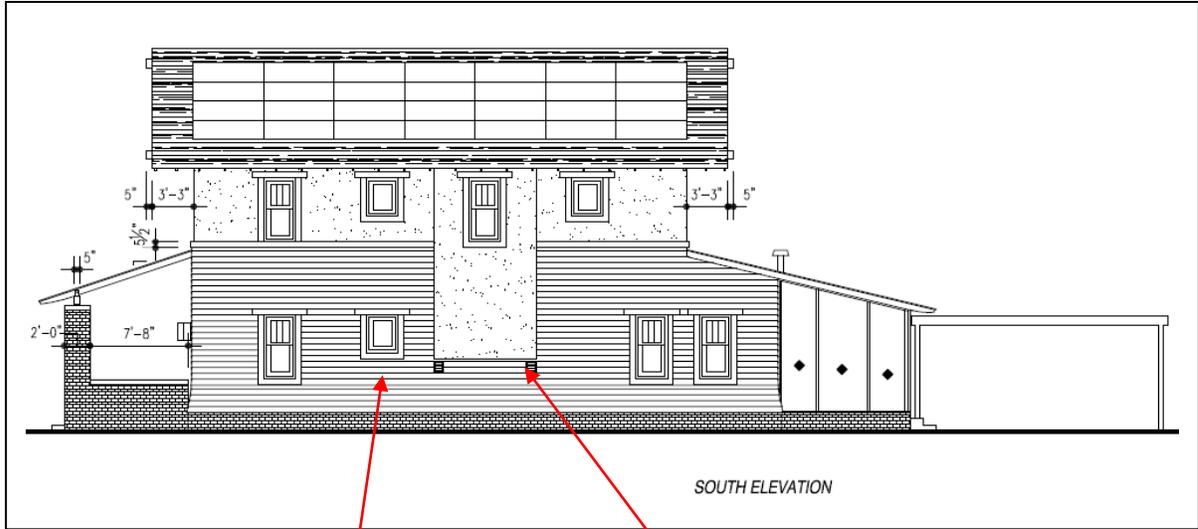
Curve at base of wall is not consistent with area; paired windows should have a muntin; the proposed front door is overly wide

Small windows are too numerous

Projecting bay on south elevation is unlike anything found on the block or street.

Projecting Bay: The south wall features a projecting 2-story bay that is approximately a foot deep and a single bay wide. This is not a feature found on the block or street, and therefore does not

Doors: The only visible door will be the front door, which is proposed to be a Craftsman-influenced blind panel over two vertical panels and a width of 4 feet. This width is not visually compatible with historic door openings found on the street. Given the rather narrow façade of this building, which will be the narrowest among its neighbors, an oversized door would seem that much more out of proportion with historic front door widths nearby, which are probably around three feet wide.

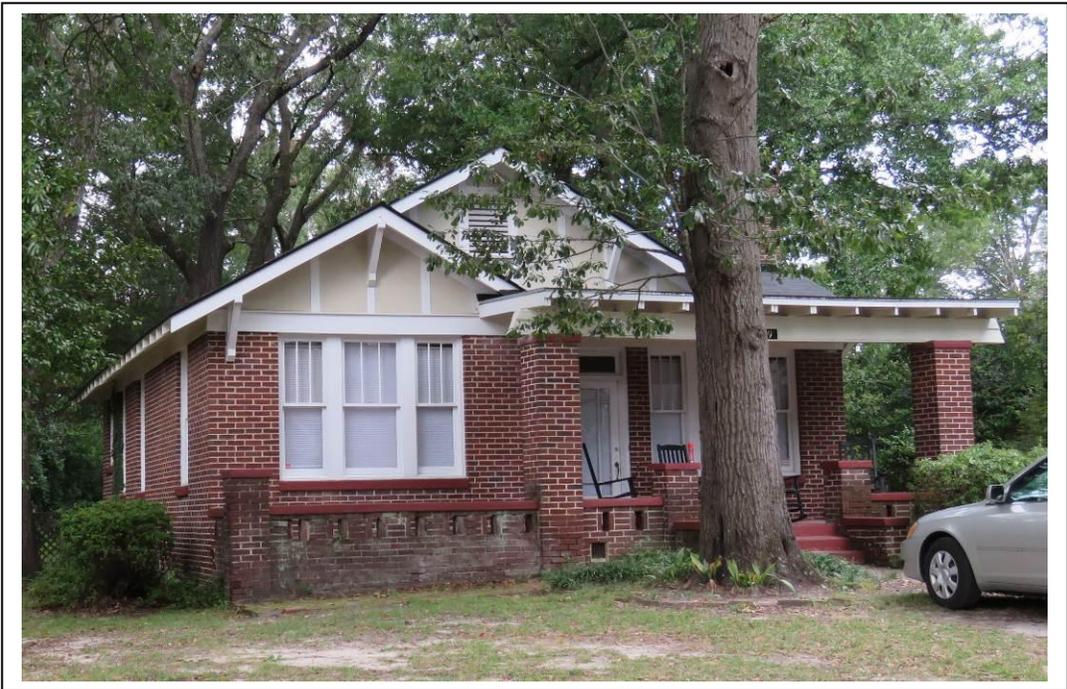
House across the street on Hagood Avenue with some of the elements proposed: open framing on porch roof, grouped windows, brick wall and column. Note that the faux half timbering is limited to small gables, with a rectangular vent.

Porch Roof: The proposed shed roof has open, or visible, framing; this is found on a few examples on historic porch roofs on Hagood Avenue, including one almost directly across the street.

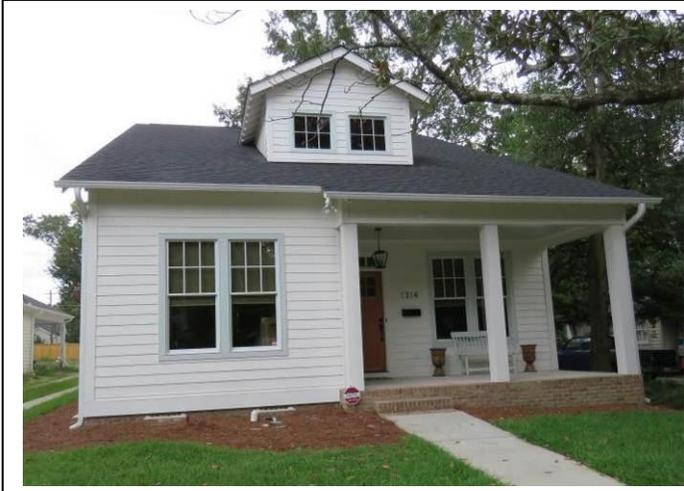
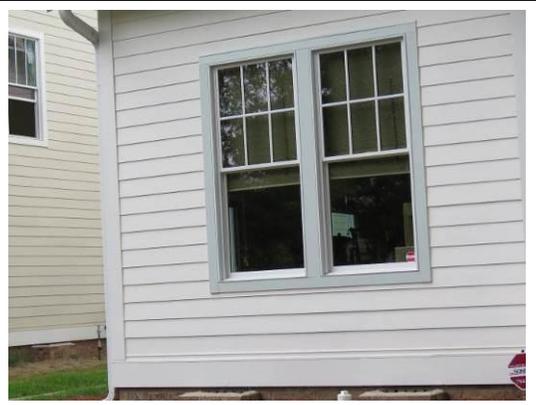
Historic wood windows

Note thickness of sash, inset of bottom sash, lack of extra framing or gaskets around edges of sashes, and simple bottom rail

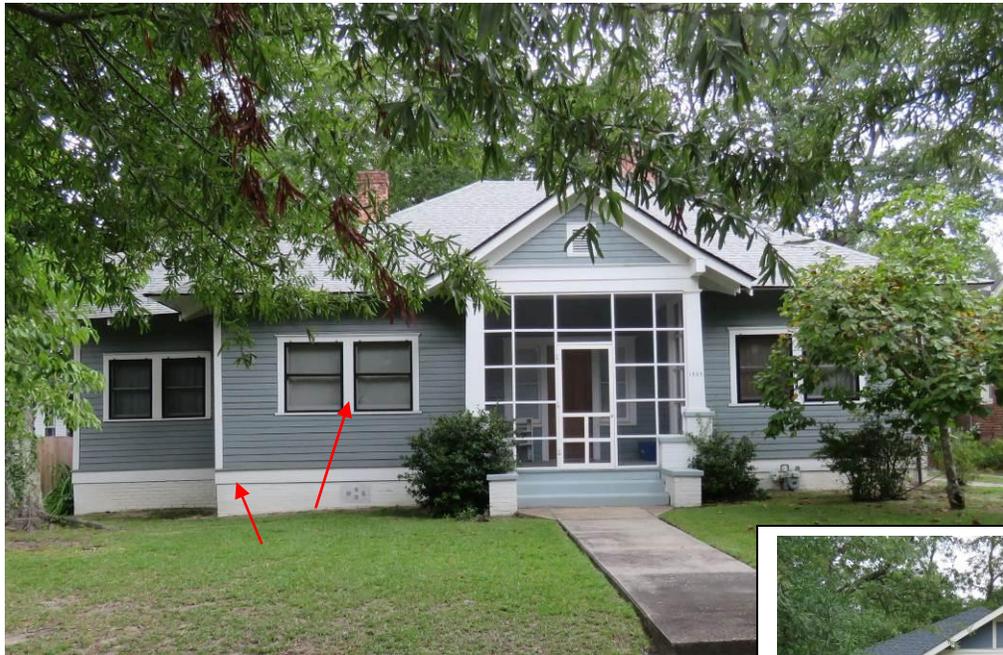
New construction in the district, note mullion between windows

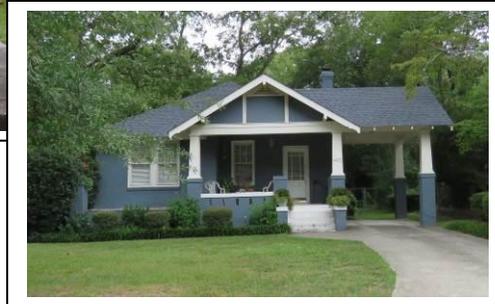
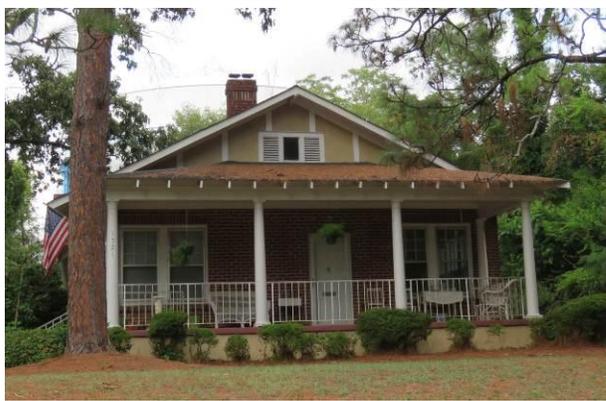
House on Hagood

Note mullions between windows and skirt board proud of brick foundation

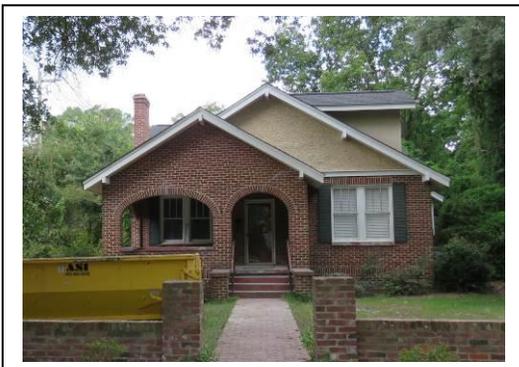
Other houses on Hagood with faux half timbering or stucco, note they are one story and brick

Gable: The guideline indicates that "*When selecting architectural details, consider the scale, placement, profile, and relief of details on surrounding structures for the basis of design decisions.*" The proposed faux half-timbering does not appear to meet this guideline as it has been expanded to such a degree that it is out of proportion with the scale and placement of historic examples in surrounding structures. This is an item found repeatedly in the area, but only on one and one and a half story houses. It is also only found in small front gables that intersect with a main roof or a side gable; in other words, it is not stretched across an entire façade of a building as proposed. This overly large faux half timbering is not visually compatible with the street.

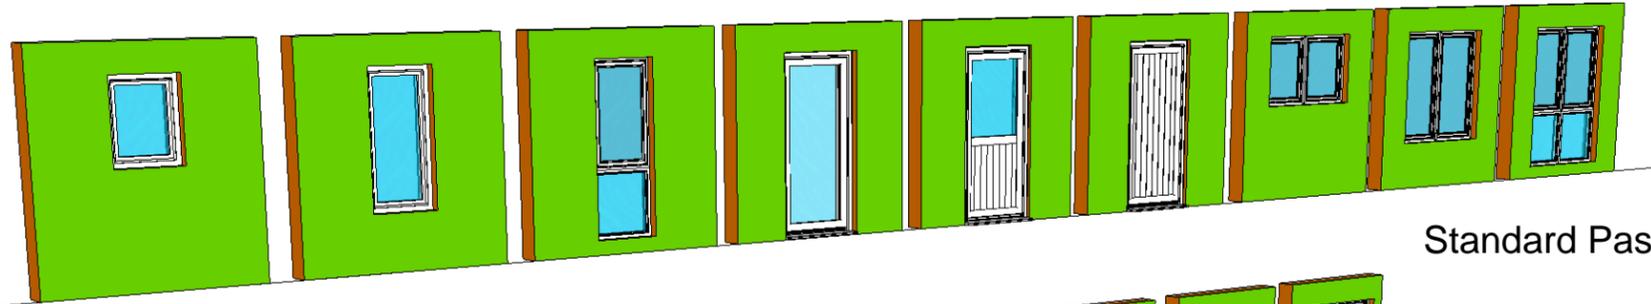
Standard Passivhaus Certified Single & Twin Windows and Doors in 8' Panel

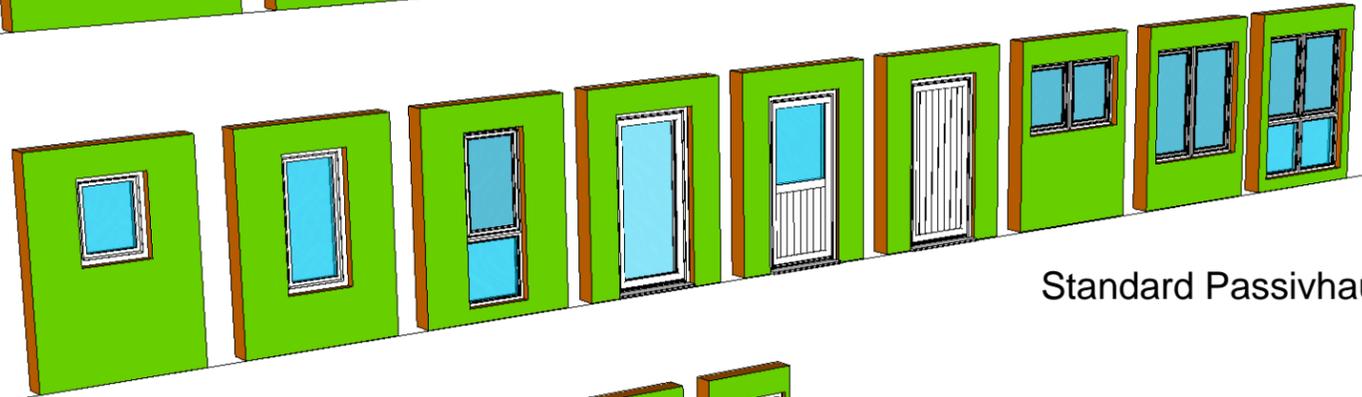
Standard Passivhaus Certified Single & Twin Windows and Doors in 6' Panel

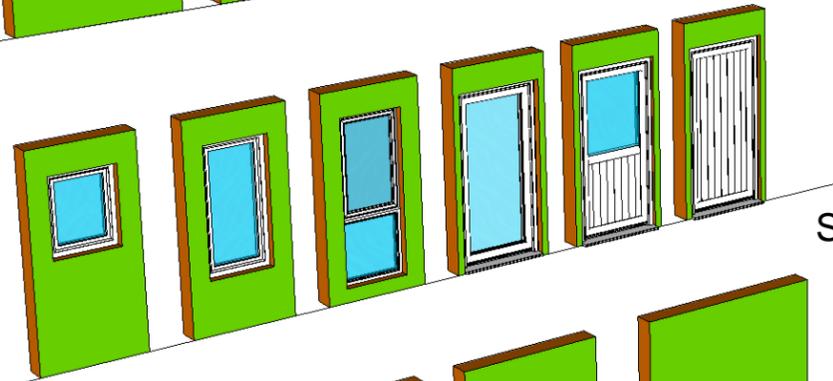
Standard Passivhaus Certified Single Windows and Doors in 4' Panel

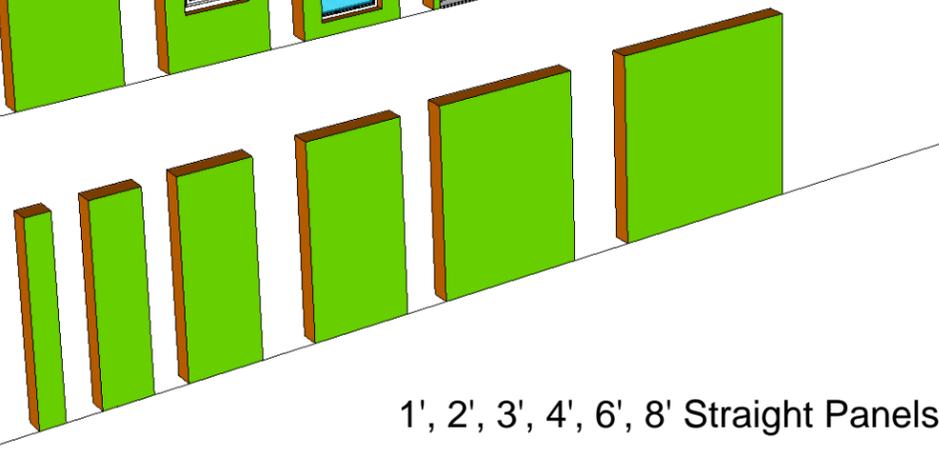
1', 2', 3', 4', 6', 8' Straight Panels

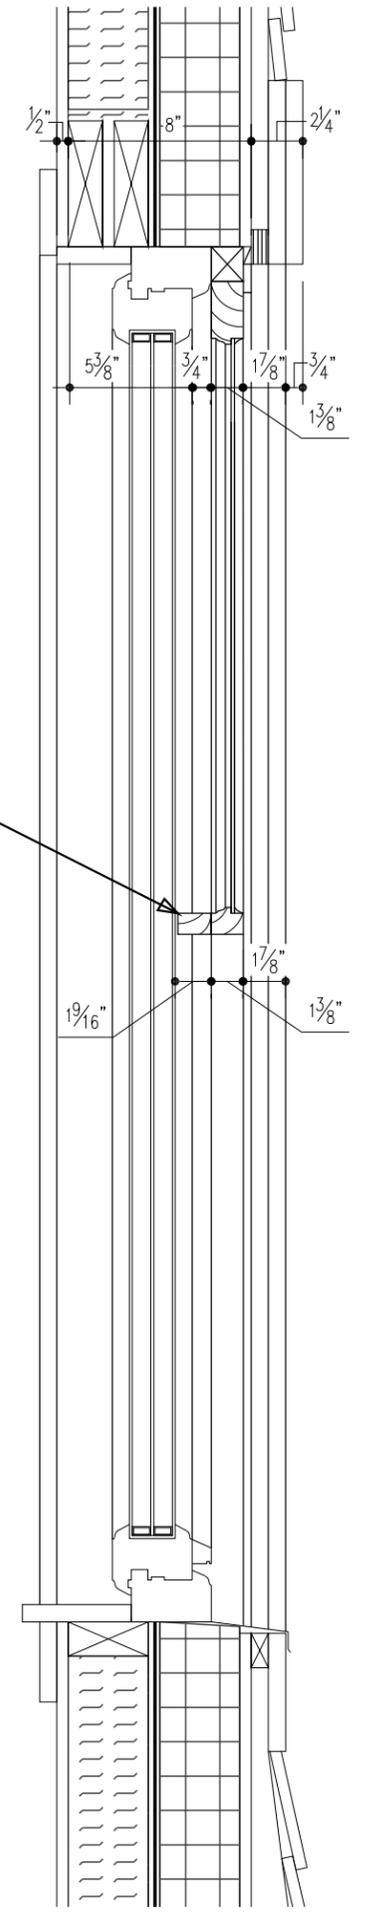
*PAINTED WOOD TRIM PIECE SCREWED TO BOTTOM
RAIL OF FIXED UPPER SASH AND SCRIBED TO
PROFILE OF INNER WINDOW TO CLOSE GAP*

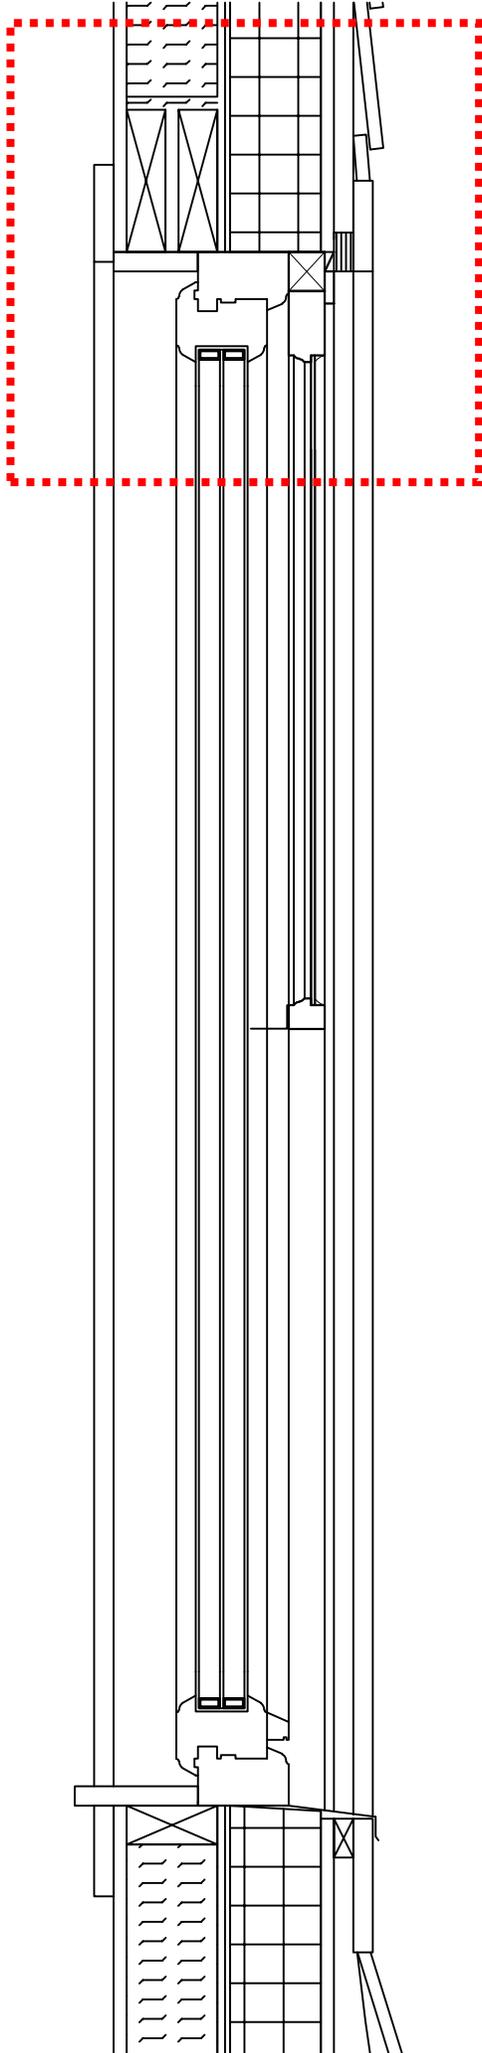
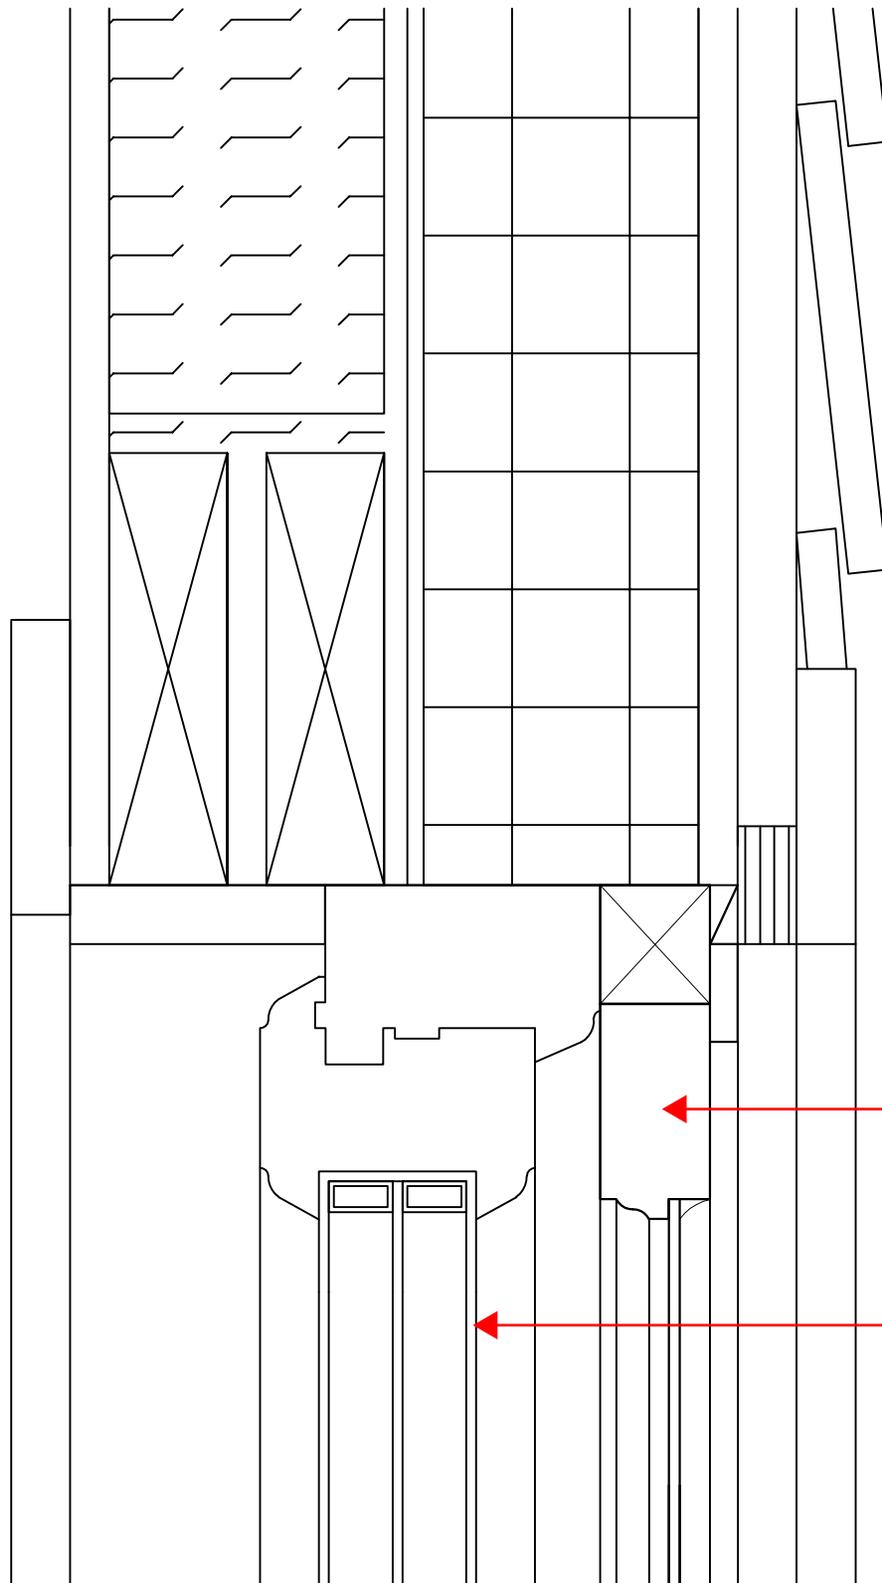
SEE HEAD DETAIL
NEXT SHEET

Fixed Wood Top Sash

The windows are sized at 30" wide and 50" tall for the rough opening. There are a variety of window sizes found on the street, and these do not seem out of character in their size.
