D/DRC Case

1121 Daly Street

Melrose Heights / Oak Lawn Architectural Conservation District

NATURE OF REQUEST: Request Certificate of Design Approval for exterior change (porch enclosure)

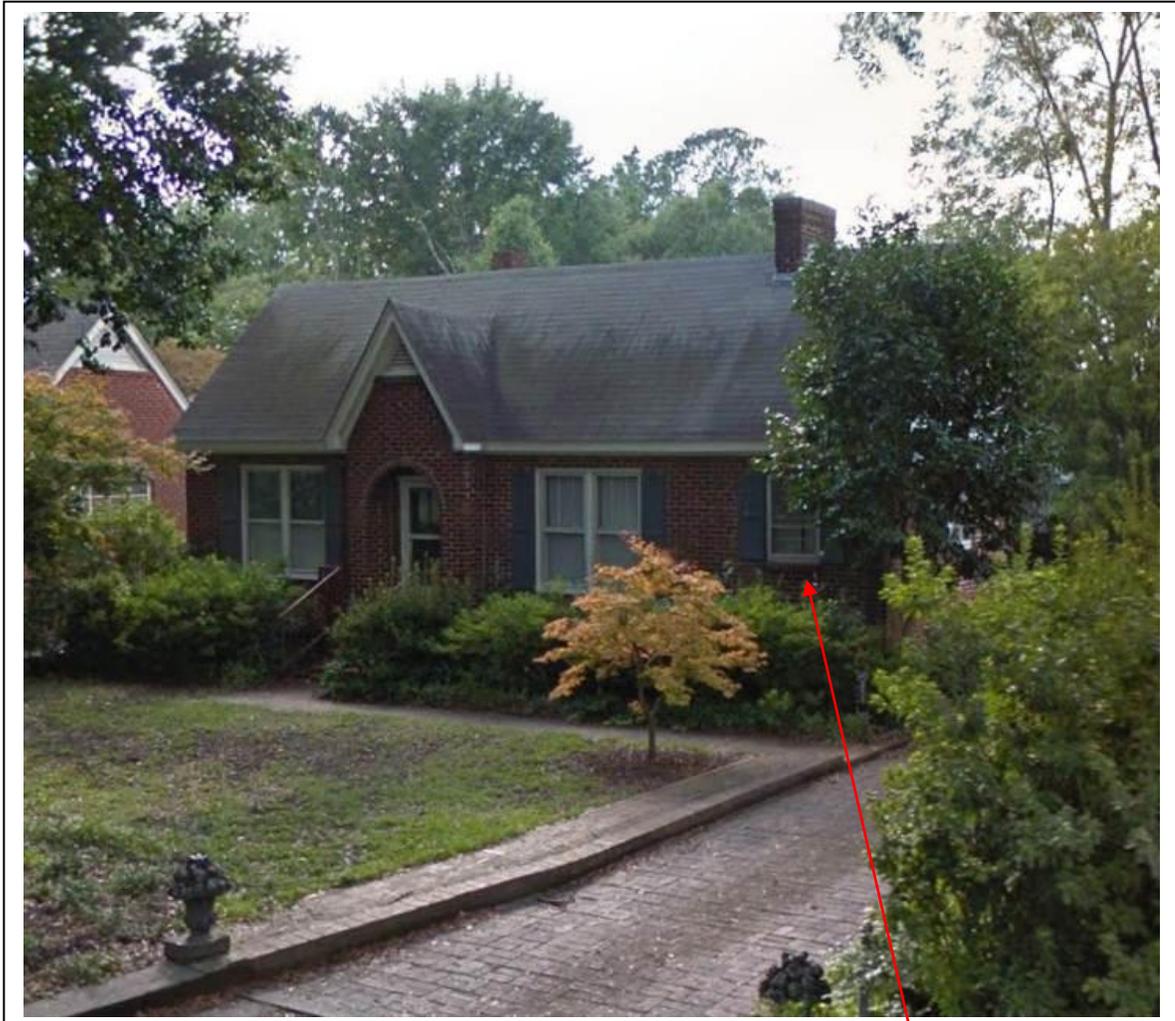
Google image, location of proposed porch re-opening and enclosure

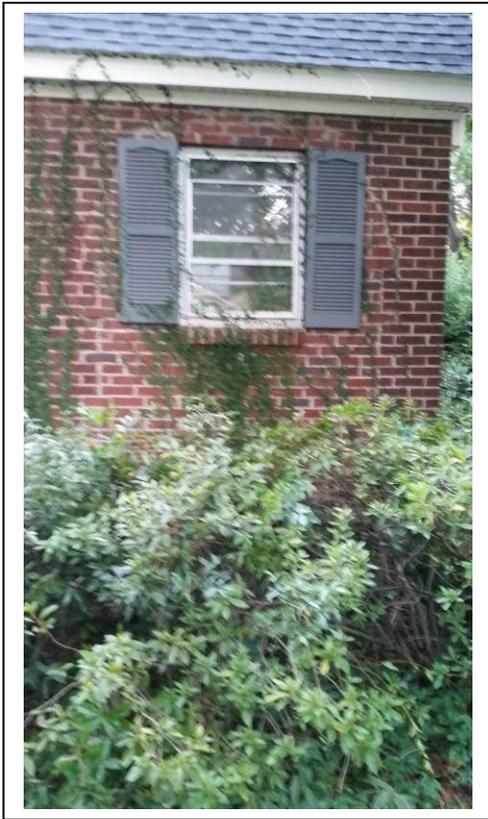
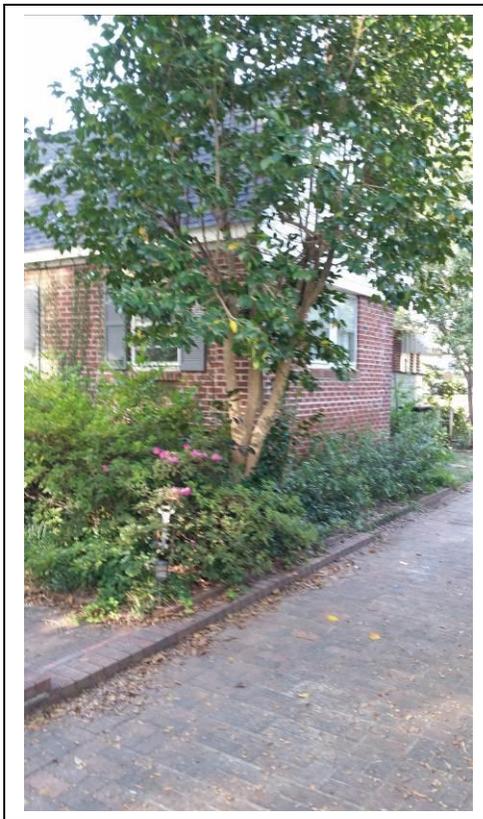
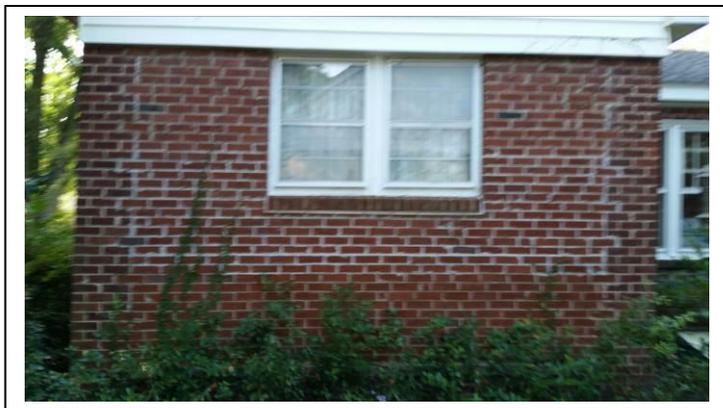
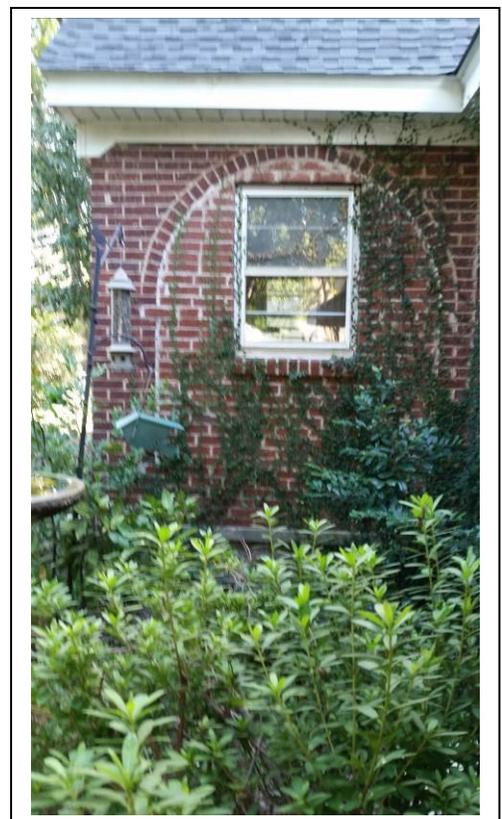
Photos provided by applicant show front of house, oblique view, side of porch and rear of porch, which has the best evidence of the brick detailing that will be restored on the front

The front arch in the porch has been altered by the removal of the header course of bricks that delineated the arch; this detail is still evident on the back wall of the porch and will be recreated on the front, restoring a feature that was originally on the building.

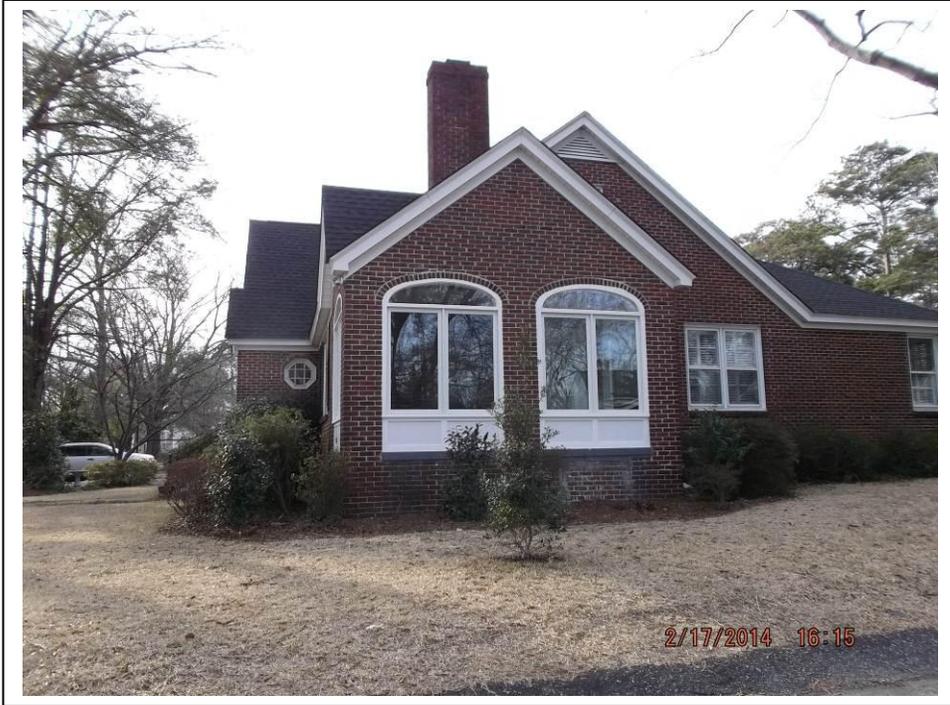
Staff photo of enclosed side porch in the same neighborhood
