D/DRC Case

DESIGN/DEVELOPMENT REVIEW COMMISSION
DESIGN REVIEW DISTRICT
HISTORIC AGENDA
EVALUATION SHEET
Case # 2

ADDRESS: 1420 Hagood Avenue

NATURE OF REQUEST: Request Certificate of Design Approval for new construction

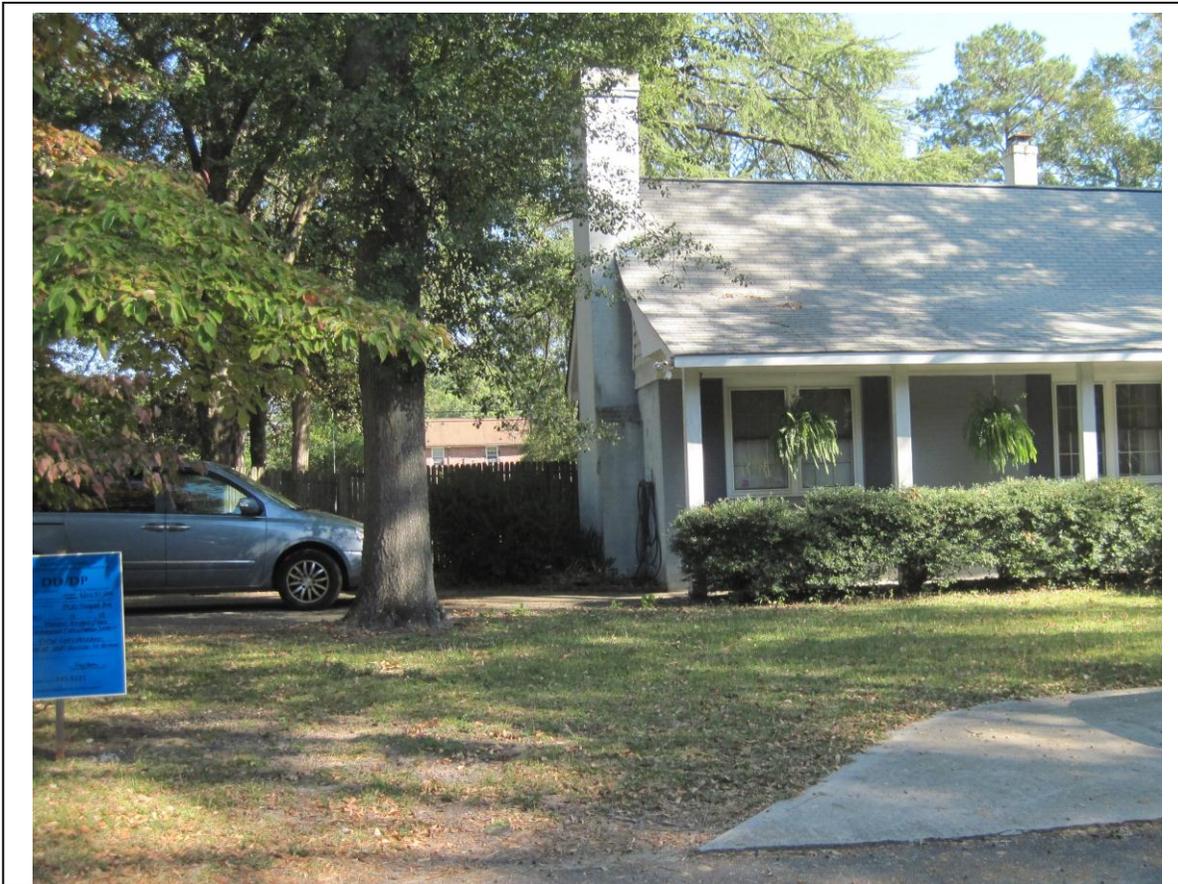
Photos of project site, note visibility of windows on existing house, which is at about the same setback as the proposed house. Existing house will have portion of visible addition removed. Staff photos.

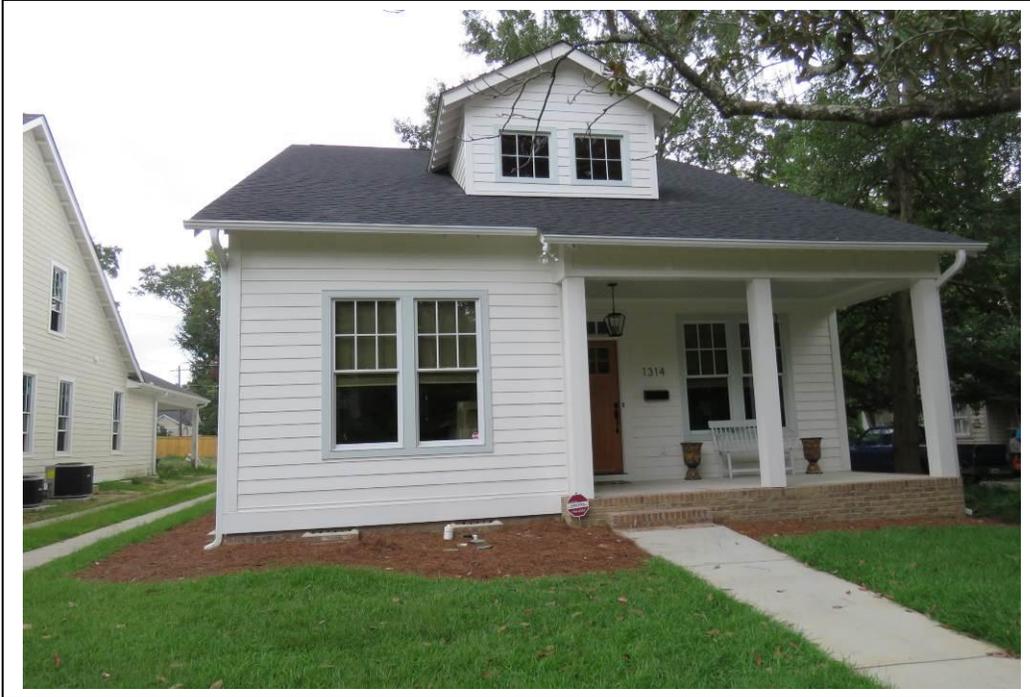
New construction in the district with aluminum-clad wood windows

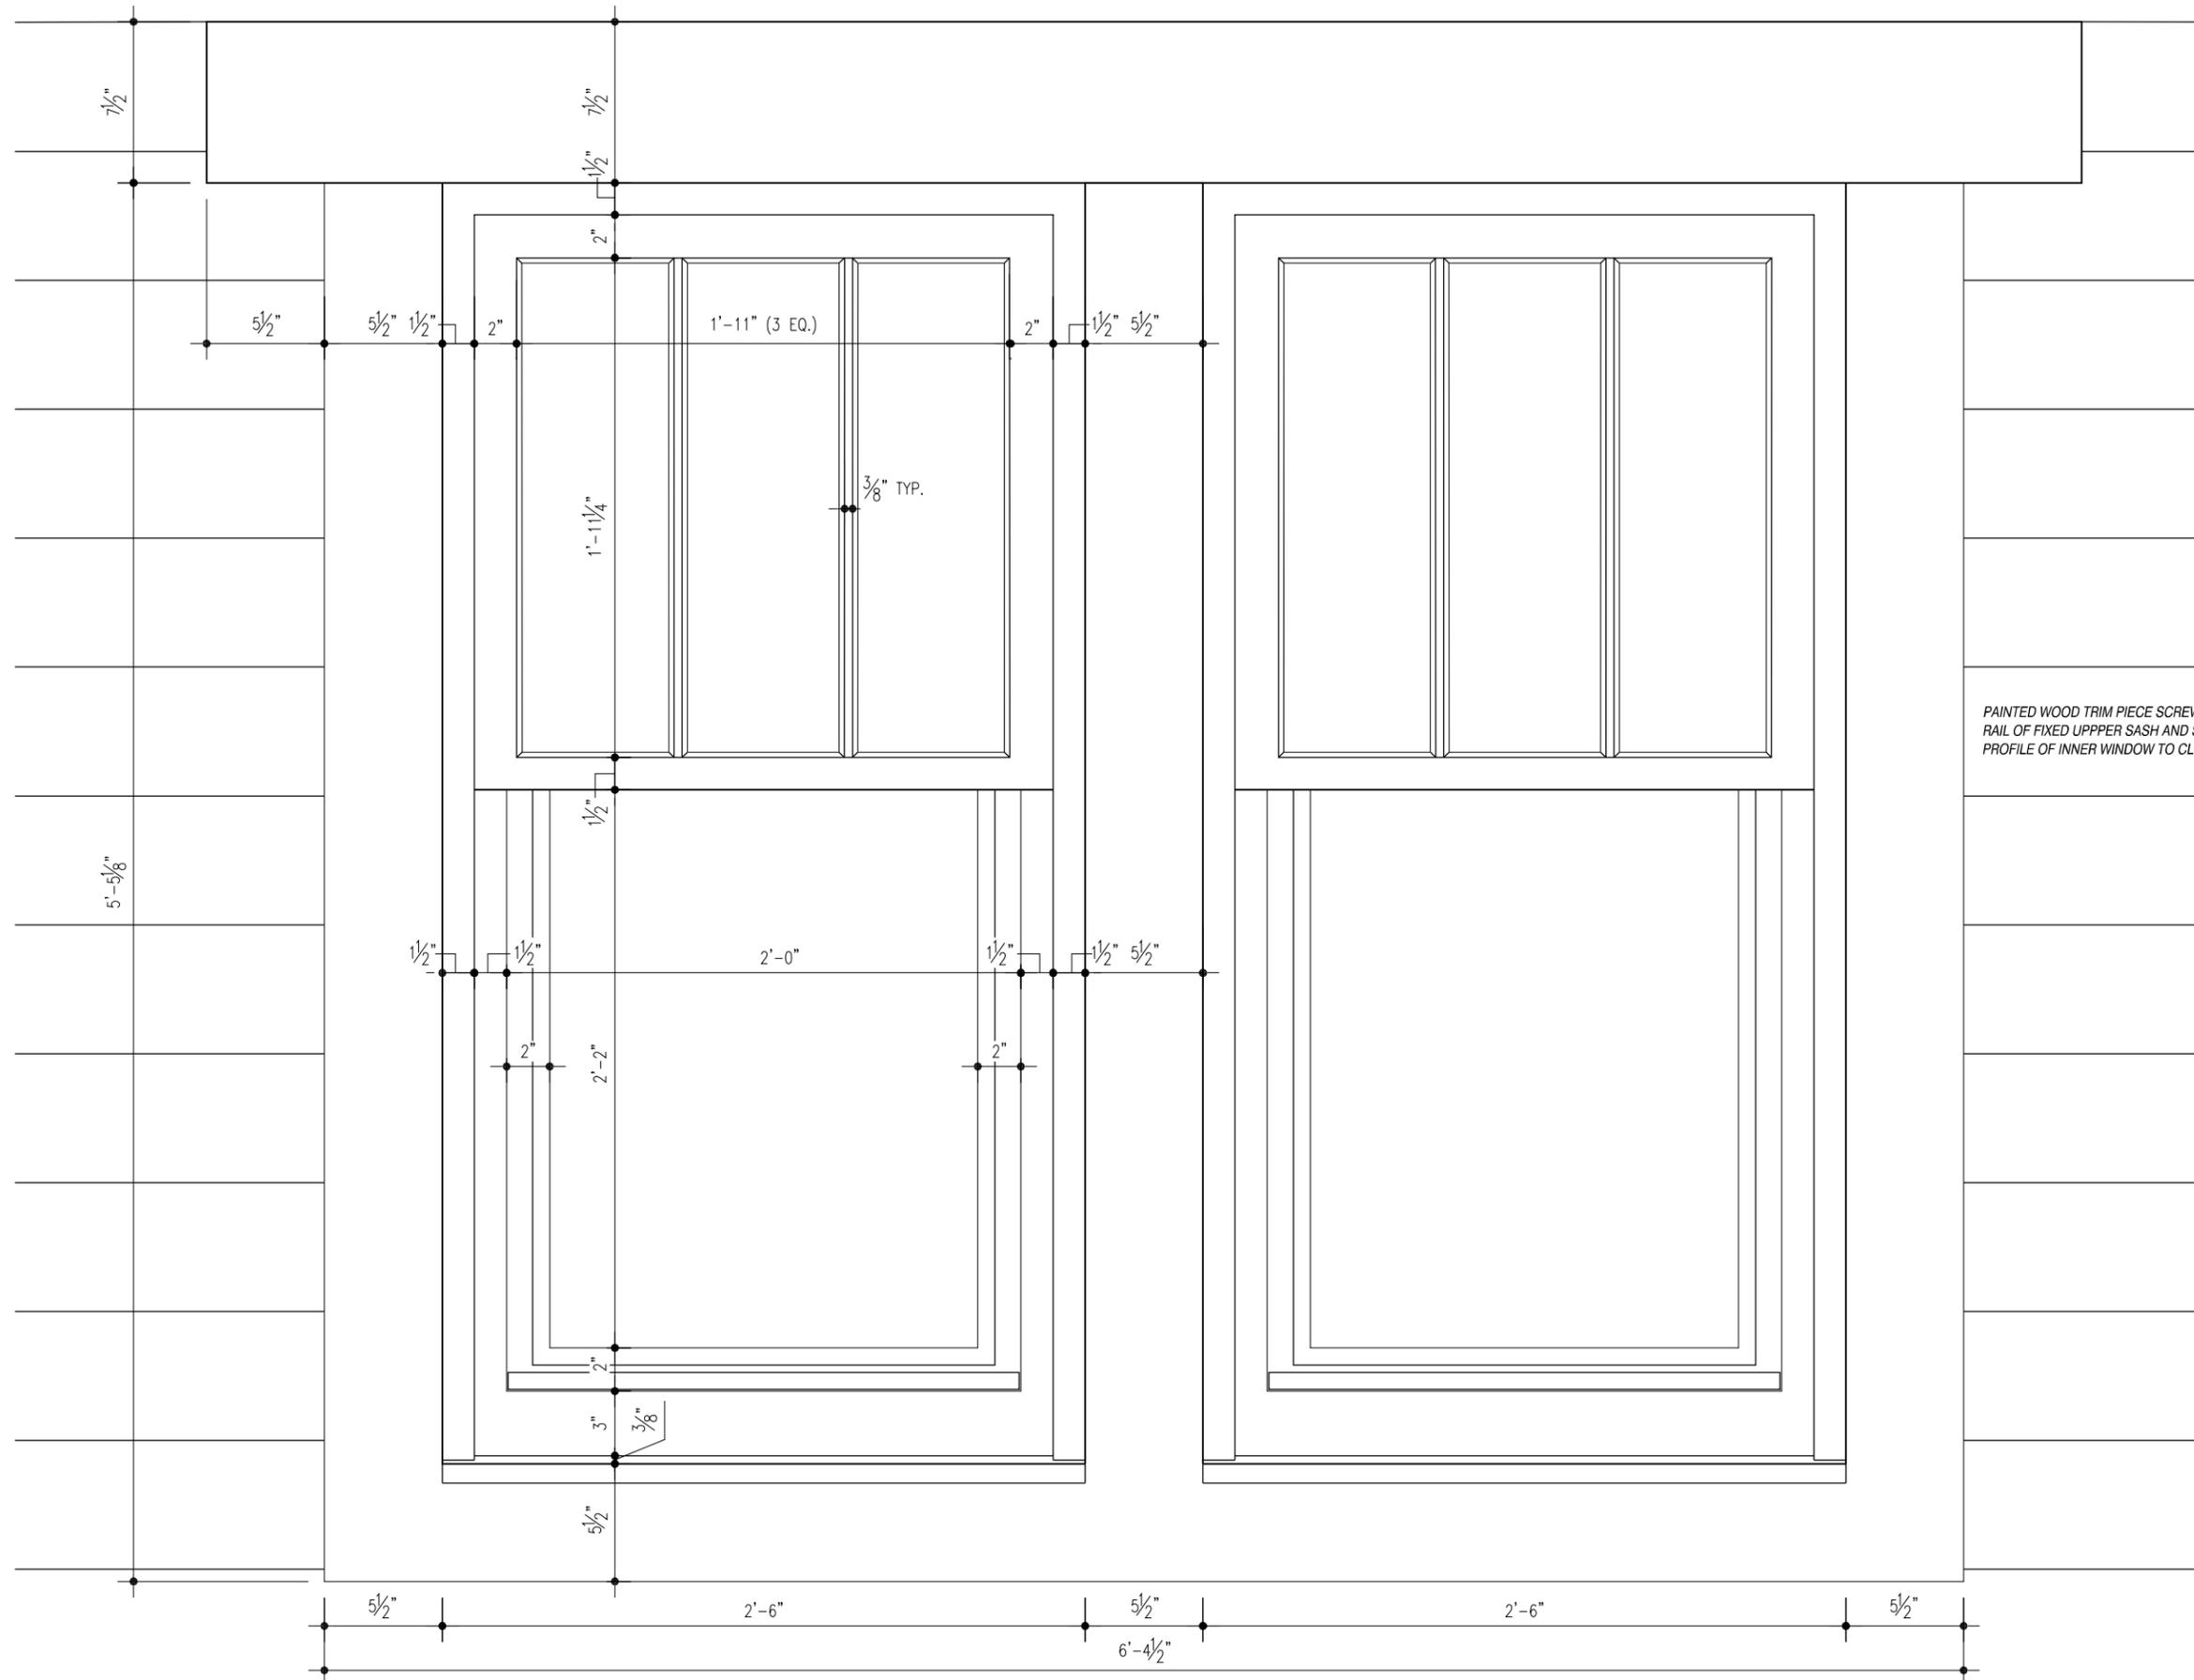
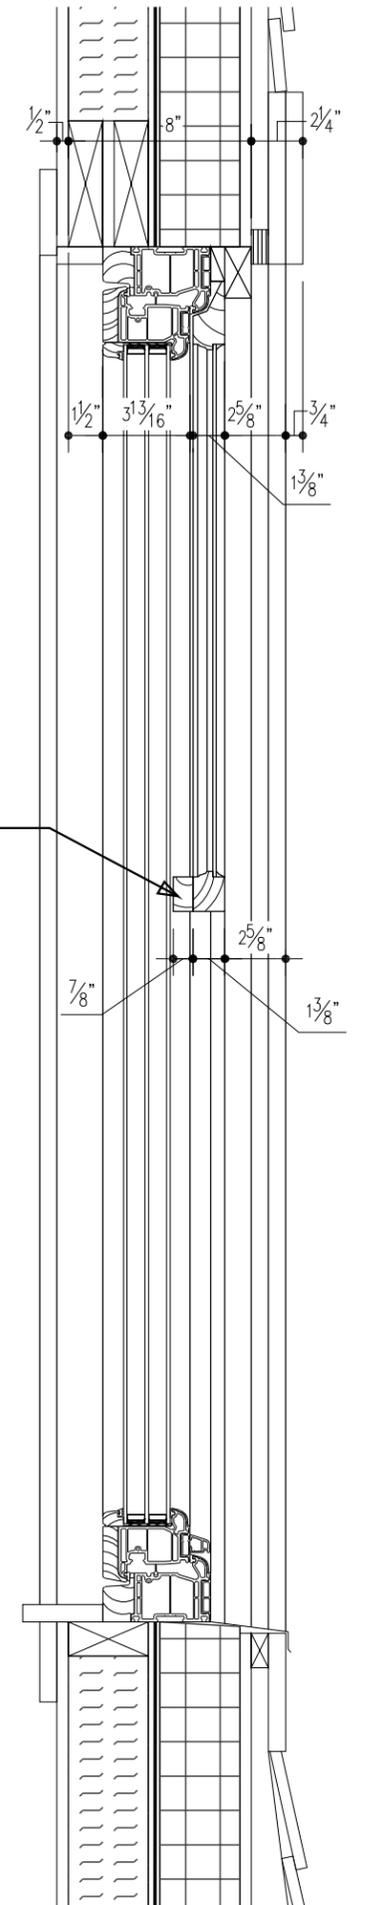
1424 HAGOOD AVE WINDOW DETAILS 1 1/2"=1'-0"

The applicant has provided drawings of this arrangement as well as photographs of the proposed window. The side view drawing shows that the gap between the proposed wood sash and the aluminum-clad casement window has been reduced to 7/8" -or a difference of a half inch- from the previous proposal. This makes the bottom rail of the top sash appear to 2 1/4" deep, still thicker than the average historic window thickness of 1 and 3/8 inches, but not double the thickness as was previously proposed. This could be further reduced with a wood sash only 1 and 1/8 inch thick.
