DESIGN/DEVELOPMENT REVIEW COMMISSION
DESIGN REVIEW DISTRICT
CONSENT AGENDA
EVALUATION SHEET
Case # 4

ADDRESS: 1544 Main Street

NATURE OF REQUEST: Request for Certificate of Design Approval for exterior changes and preliminary certification for the Bailey Bill

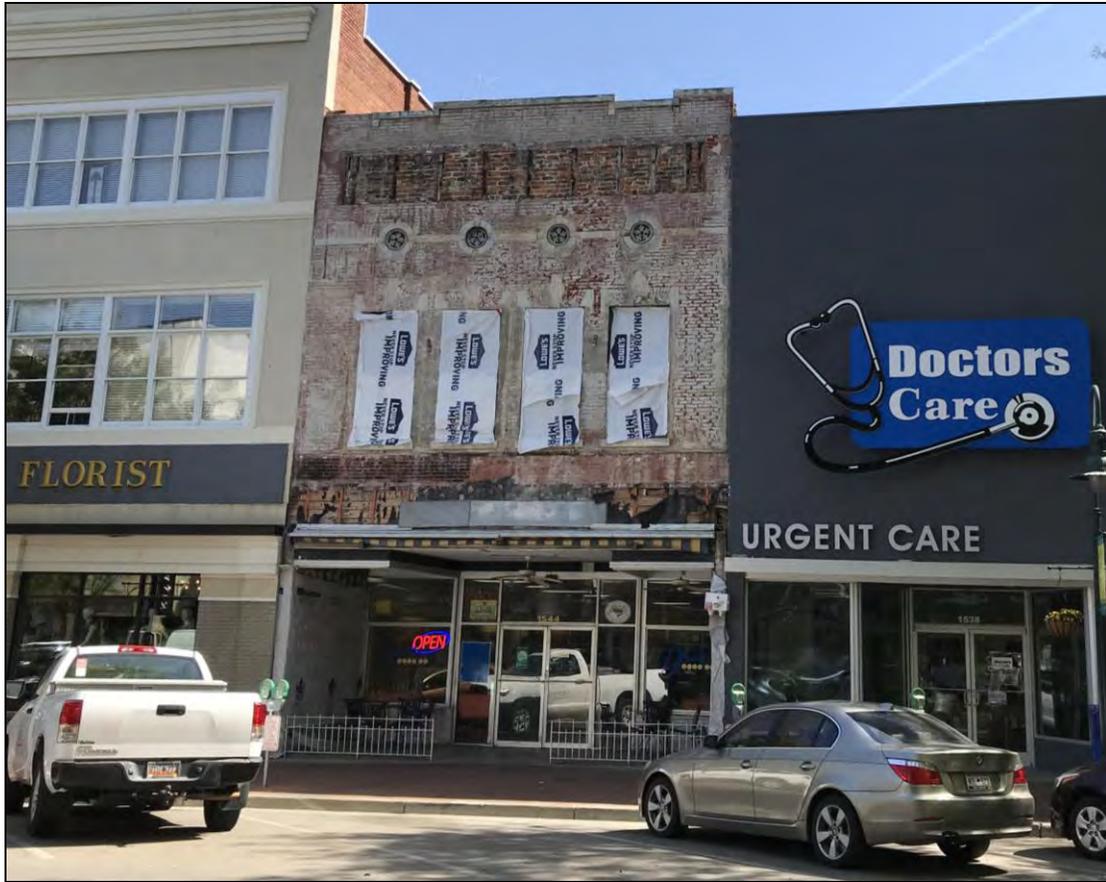
1544 Main Street, photo by staff

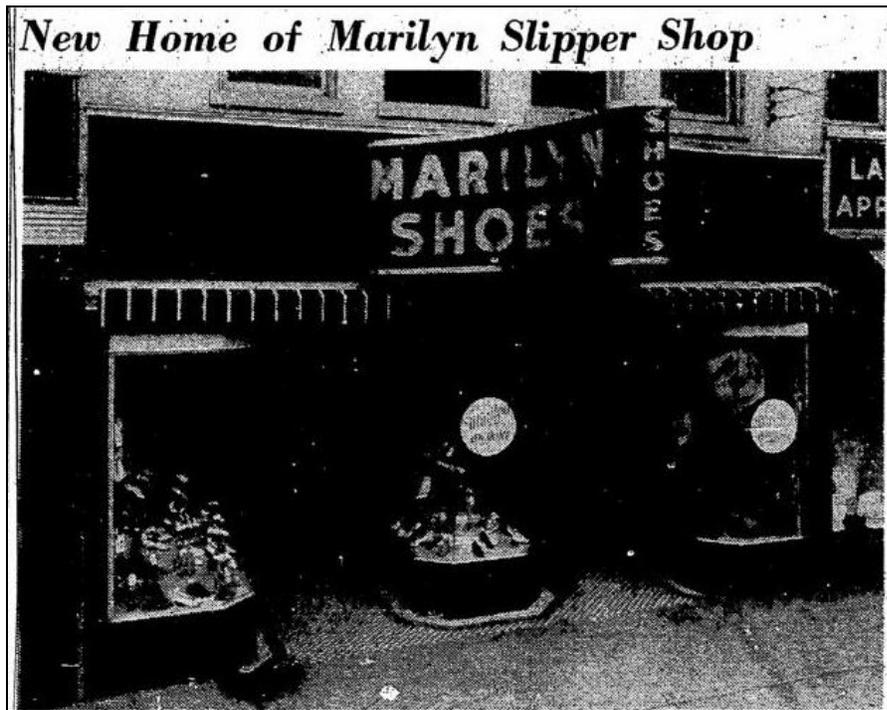
1941 storefront renovation, display cases with Vitrolite and metal details and new signage

seen in historic photos. The storefront will also be redesigned to reference the 1940s storefront but with a contemporary use. As seen in historic photos, the 1940s storefront used metal and pigmented glass (possibly Vitrolite or similar material) display cases with chamfered corners but eliminated the staircase to the second floor. The new design will reference this design in materials and the use of chamfered corners and recessed entry but restore the staircase to the second floor. All windows will use non-tinted glass to be reviewed by staff. Current drawings for the storefront list the material at the bulkheads as a metal panel; since this material was likely Vitrolite or something similar, staff recommends using a material that approximates the appearance of pigmented structural glass.

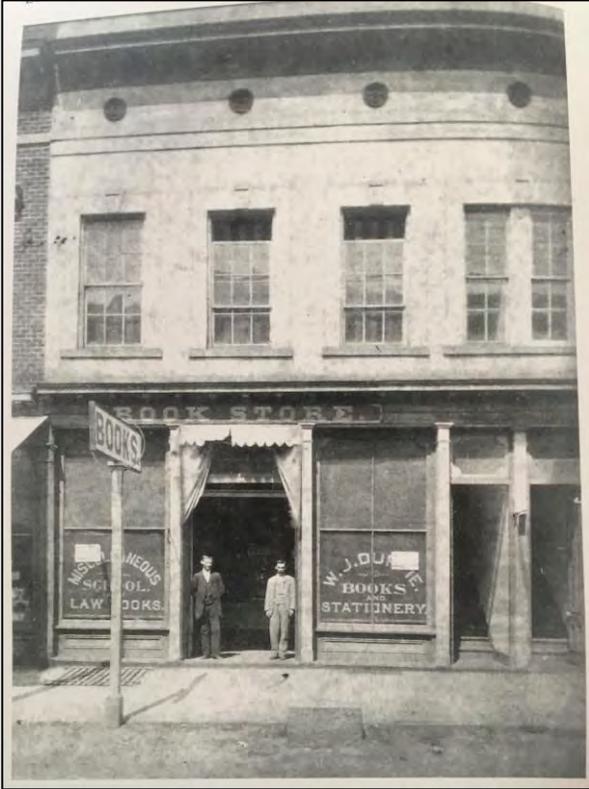
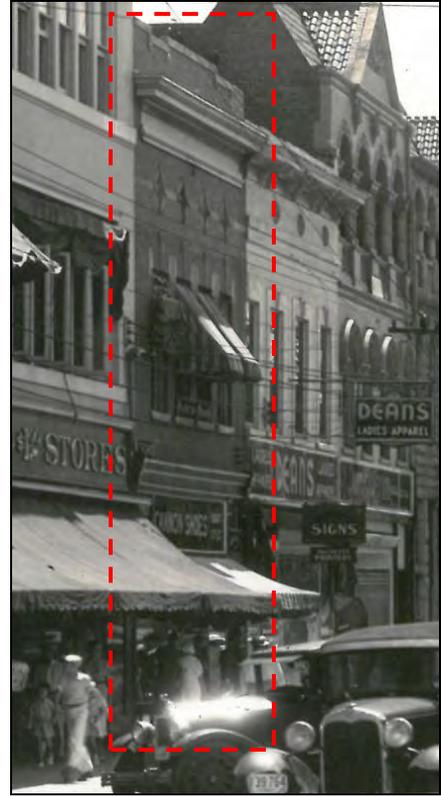
1544 Main Street, 1870s façade (left) with original shared window and stair; 1930s façade (right) with reconfigured windows and details

This two story brick building was constructed c. 1872 and was originally used as a book store. The original design of the building, as seen in historic photographs, included a tall storefront area with a central double door topped by a transom and flanked by large windows with regularly spaced cast iron columns along the front. Above the storefront was a band that included the Book Store signage topped by a simple bracketed cornice. The second floor included three 6/6 double hung windows topped with brick and cast stone jack arches; above the windows was a simple banding and decorative metal medallions, centered above each window, and a heavy wooden cornice at the top of the building. The original design of the building also included a staircase to the right of the storefront with window above shared with the building next door for access to the second floor.

A renovation of the building in the 1930s and 40s, around the time that the building became a shoe store, involved completely reconfiguring the building façade. The shared staircase was eliminated, cutting off access to the second story, and the storefront was redesigned to include three display cases with chamfered corners, metal accents, and pigmented structural glass at their bases. The central island display case split the entry way so that it included two recessed doorways for access into the building. The second story was reconfigured to include four evenly spaced windows rather than the original 3½, but appear to have retained the same detailing as the original design such as the jack arches and decorative metal medallions centered over each window. The cornice also appears to have been altered at this time.

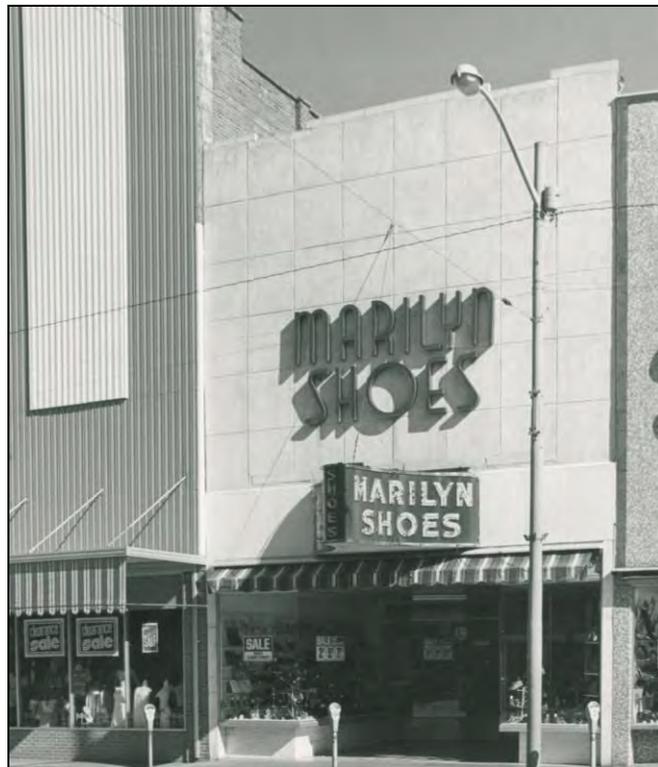
1544 Main Street, c. 1976, slipcover façade and rectangular display cases

In the 1950s or 60s the building underwent another renovation that included installing a slipcover façade which resulted in obscuring the windows and decorative medallions and removing the cornice. The storefront was eventually redesigned without the island display case for a central recessed entry flanked by rectangular display cases. Today, the display cases have been removed but the recessed entry remains which allows for outdoor seating for the current occupant, Drake's Duck-In. The owners are undertaking a full building renovation which will include the restoration of the storefront and a redesign of interior spaces, including installing a stair for access to the

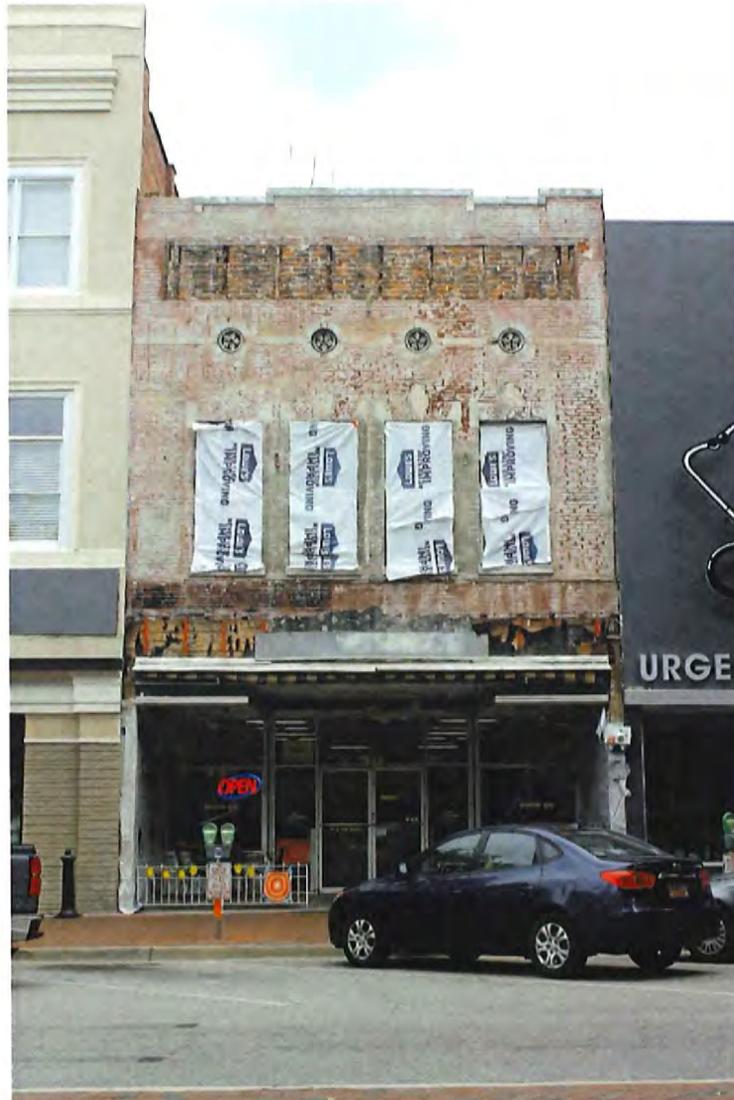
Photo 1 – Drake's Duck-In
1544 Main St. Columbia, SC
West façade
8/3/2017

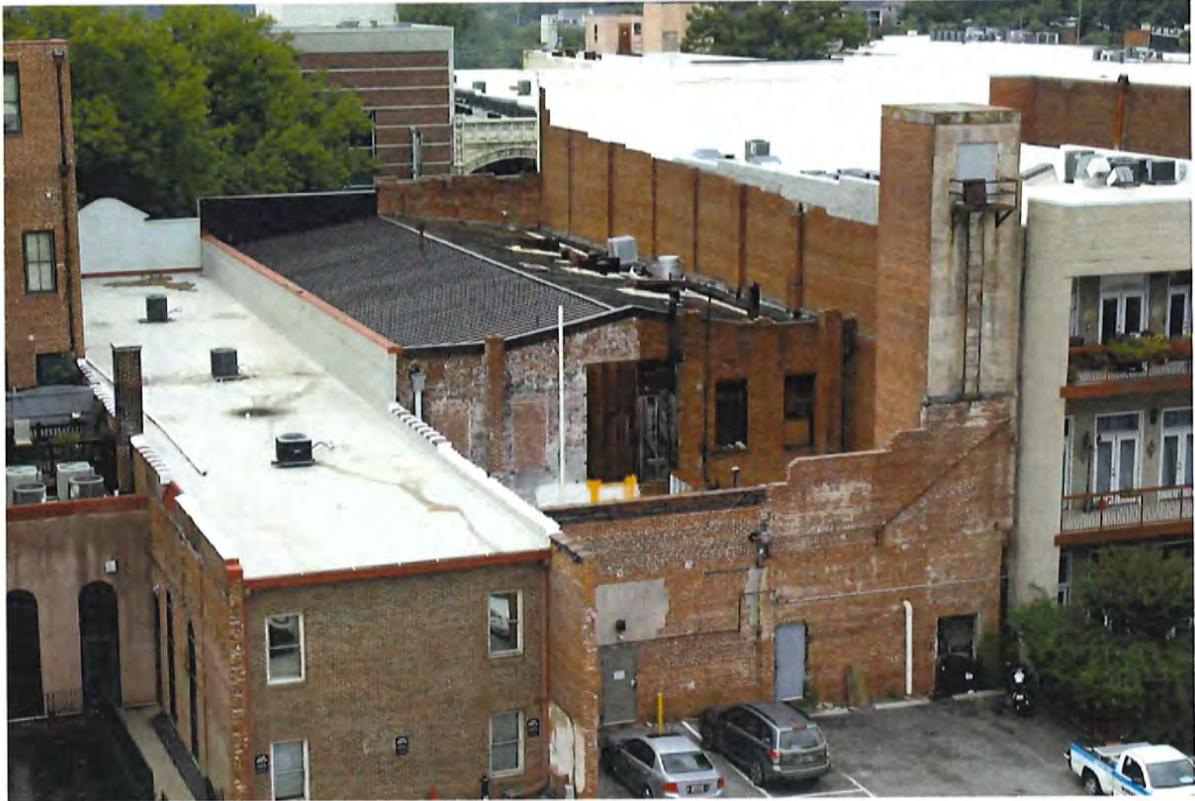
Photo 2 – Drake's Duck-In
1544 Main St. Columbia, SC
East elevation, aerial view
8/3/2017

The second level of the east elevation has a door on the south end of the elevation that has been covered from the interior to prevent usage since it does not lead to anything. The exterior of the door is in poor condition.

The door will be replaced with a matching door if the existing is unable to be repaired due to its condition. This door will lead to a deck over the first level of building.

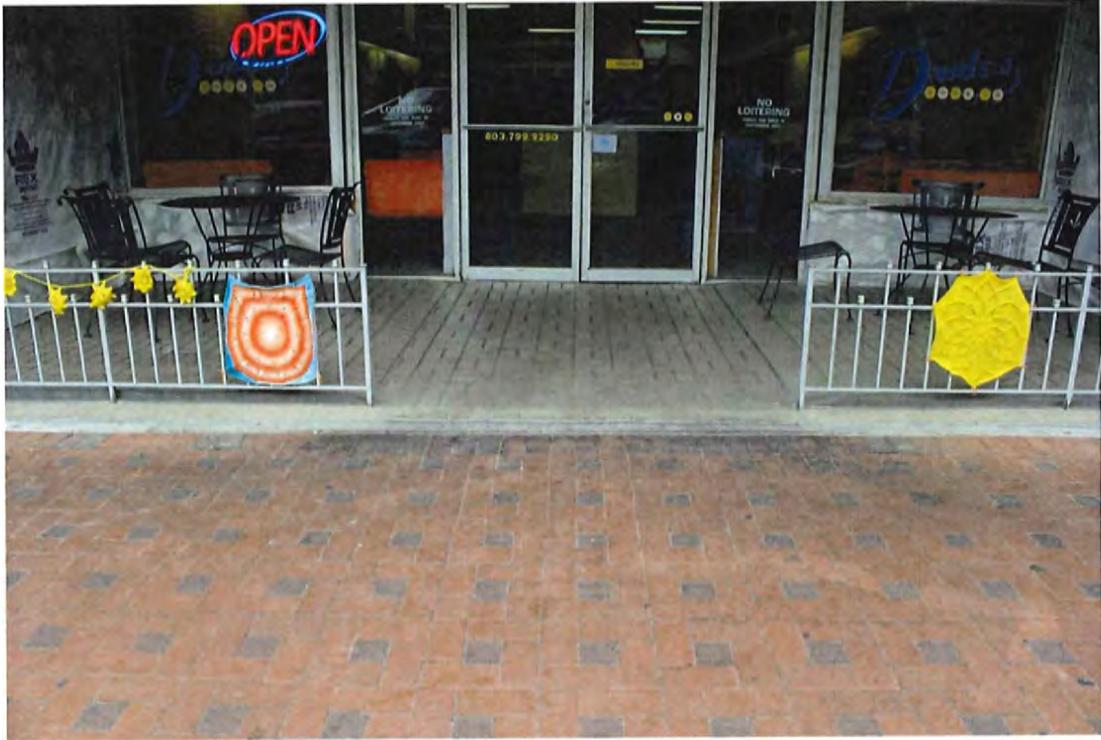
Photo 3 – Drake's Duck-In
1544 Main St. Columbia, SC
Storefront detail
8/3/2017

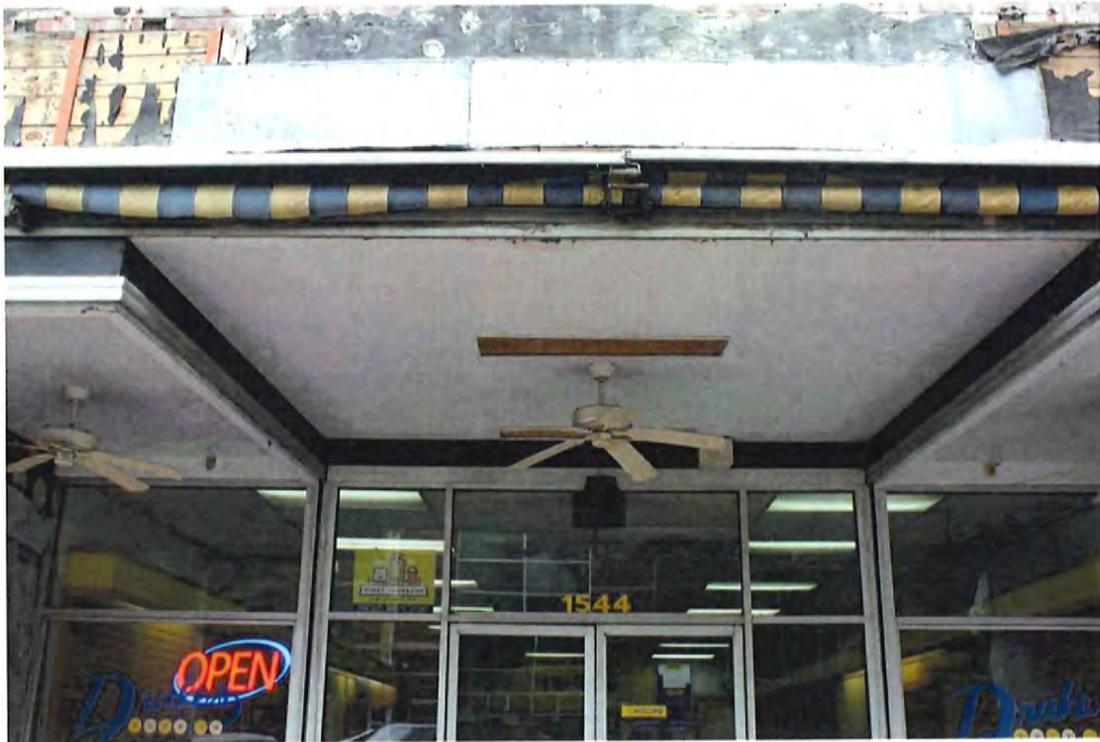
Photo 4 – Drake's Duck-In
1544 Main St. Columbia, SC
Storefront detail, former display window framing
8/3/2017

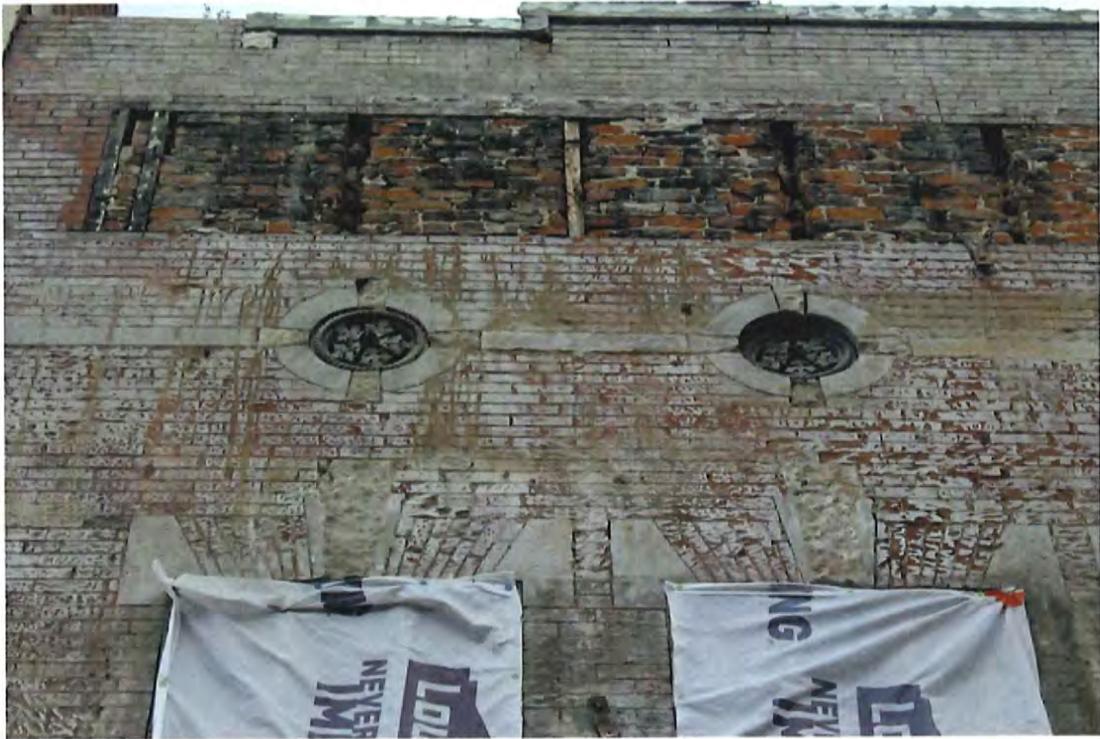
Photo 6 – Drake's Duck-In
1544 Main St. Columbia, SC
Medallion detail, north elevation
8/3/2017

All distinctive features that remain on the building's facade, such as the window details and decorative medallions, will be preserved.

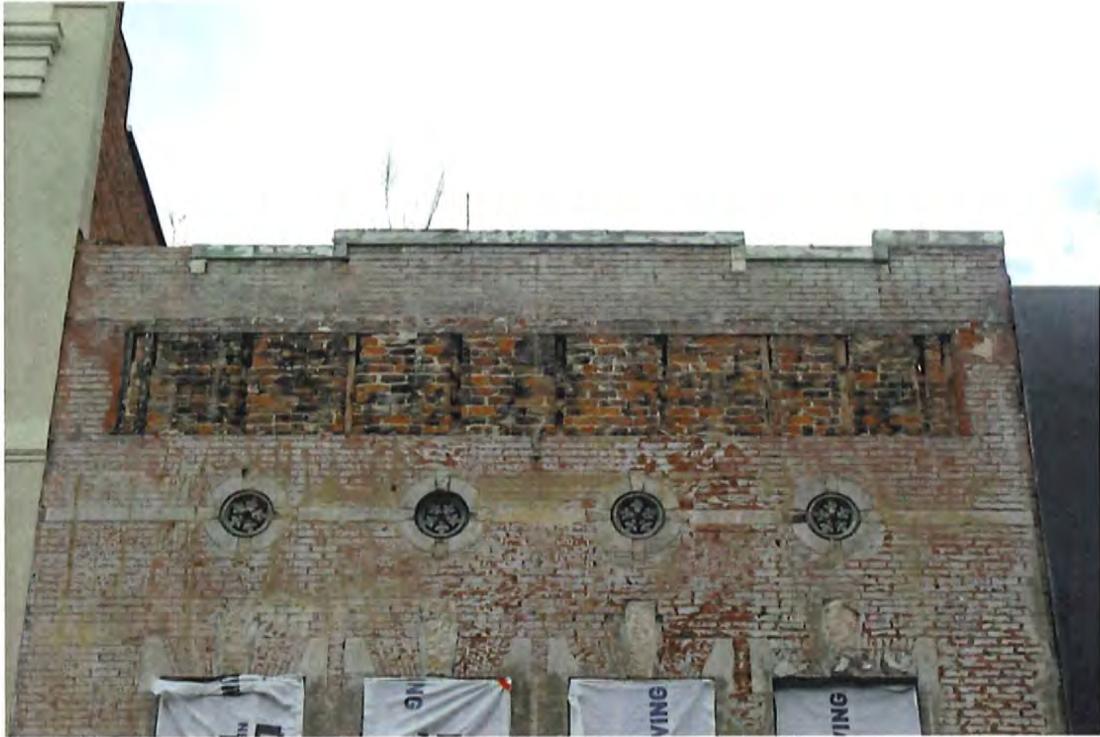
Photo 7 – Drake's Duck-In
1544 Main St. Columbia, SC
Second level detail, west façade
8/3/2017

Historic details of the 1940s façade remain on the second floor and will be retained and repaired. Areas of coping at the parapet wall will require repair and replacement and will match the original detail and material. Missing features include cornices and windows. The cornice above the storefront and at the top of the building will use historic photographs to match the 1930s/40s design. Details of the cornices have not yet been provided to staff; staff is happy to review these designs for compatibility with the historic photos should the Commission wish to defer this to staff. Windows will be wooden 6/6 double hung windows to match the details and pane configuration as

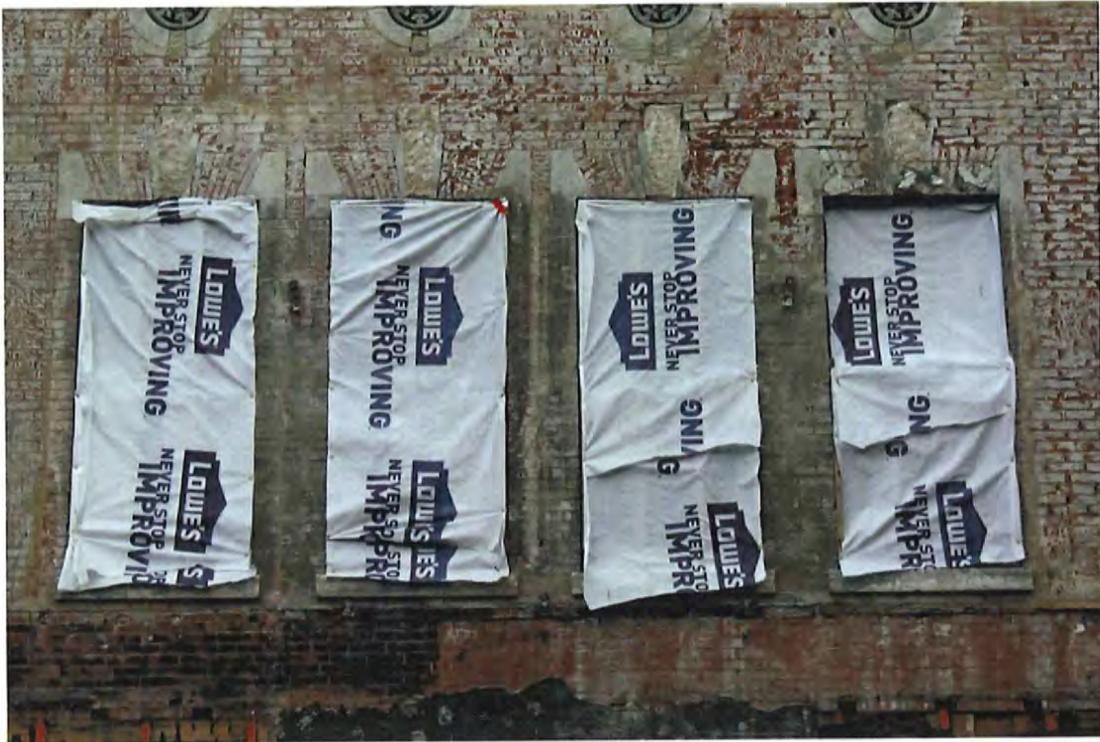
Photo 8 – Drake's Duck-In
1544 Main St. Columbia, SC
Window detail, west façade
8/3/2017

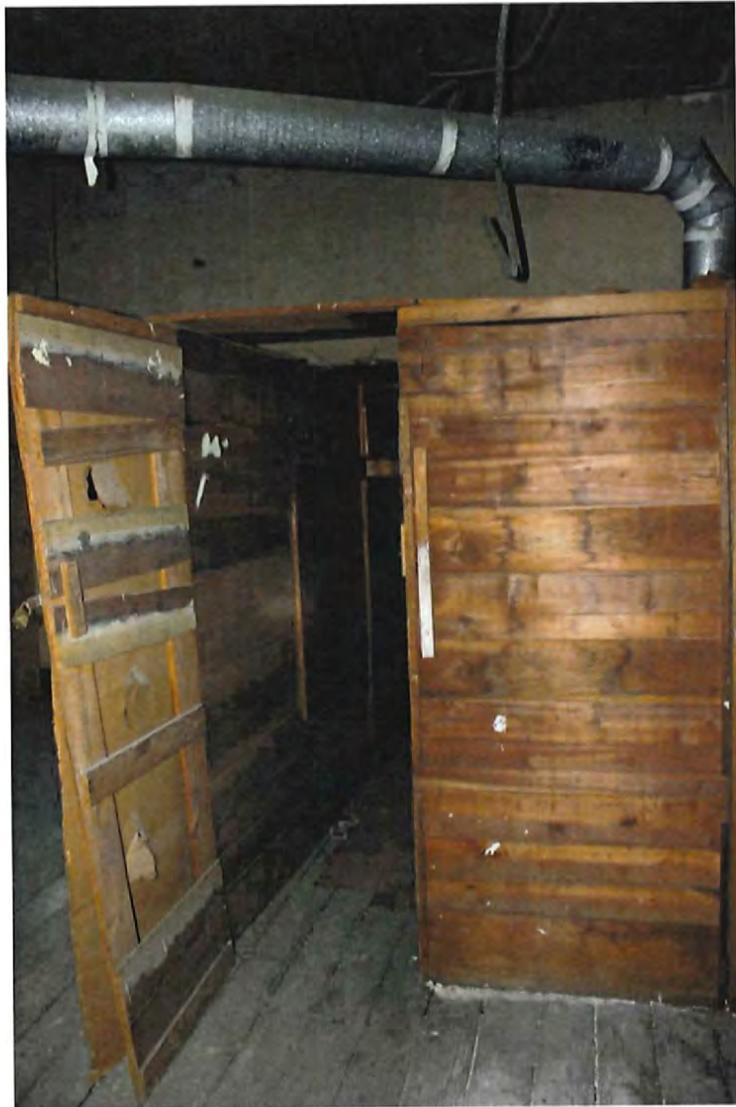
Photo 9 – Drake's Duck-In
1544 Main St. Columbia, SC
Second level interior, rear room partition
1/27/2017

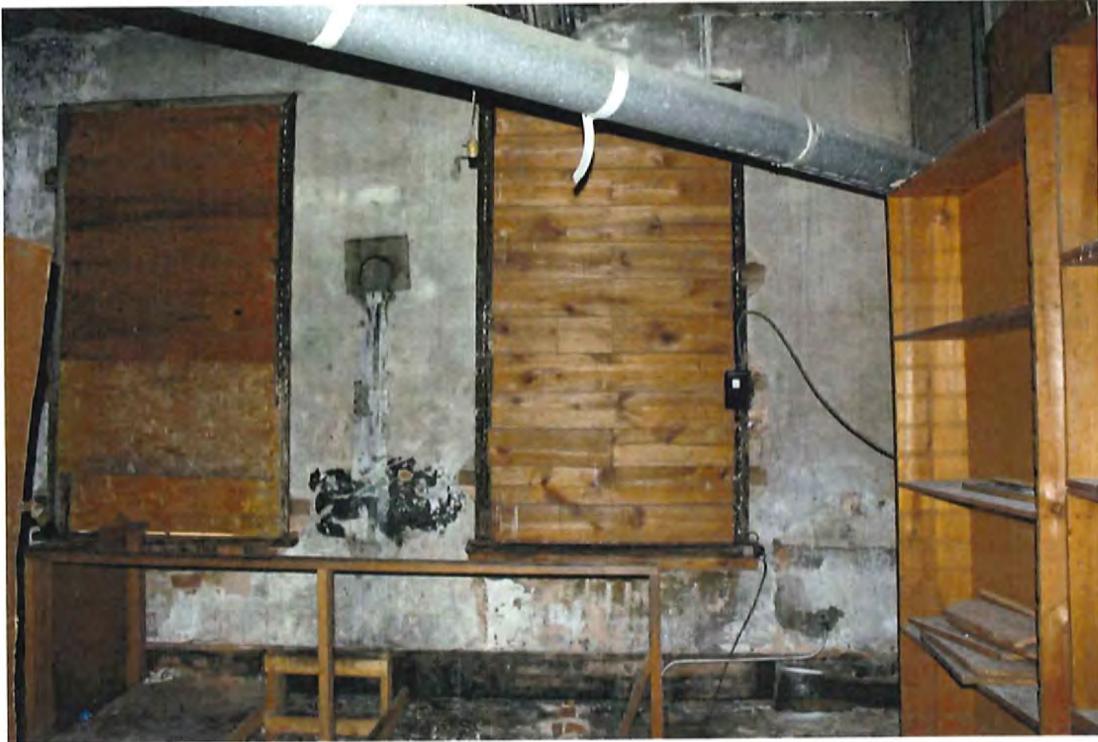
Photo 10 – Drake's Duck-In
1544 Main St. Columbia, SC
Two windows, east elevation interior
8/3/2017

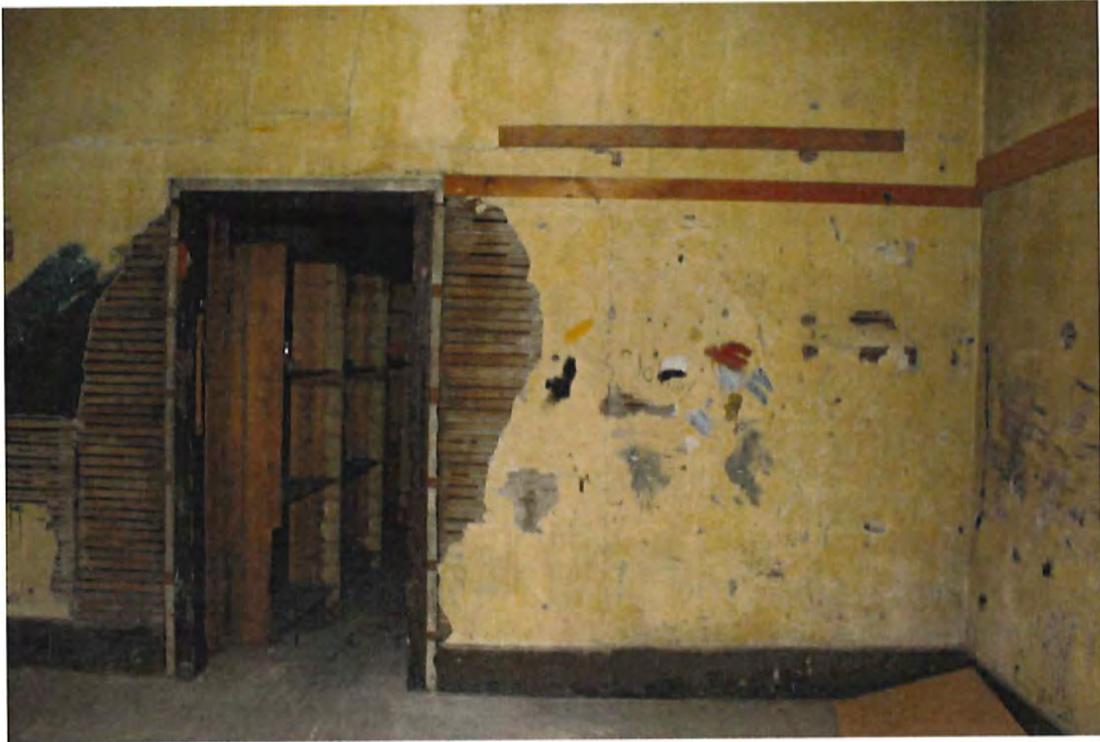
Photo 11 – Drake's Duck-In
1544 Main St. Columbia, SC
Plaster and lath walls, second level
1/27/2017

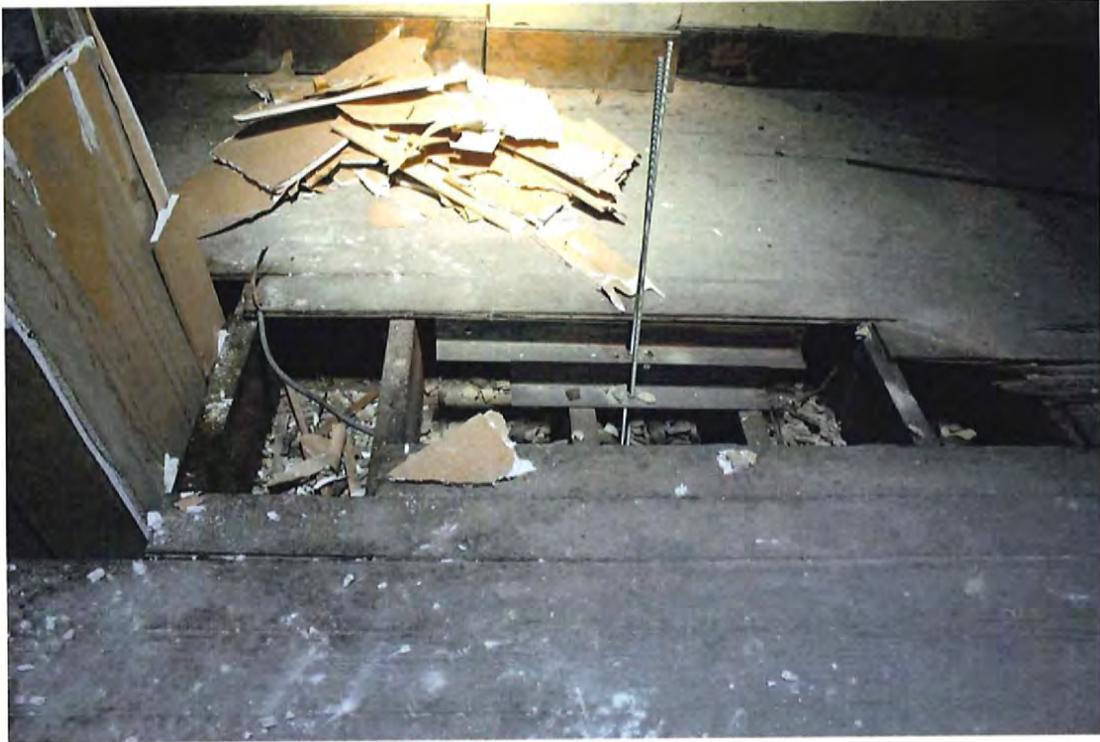
Photo 13 – Drake's Duck-In
1544 Main St. Columbia, SC
Second level flooring
1/27/2017

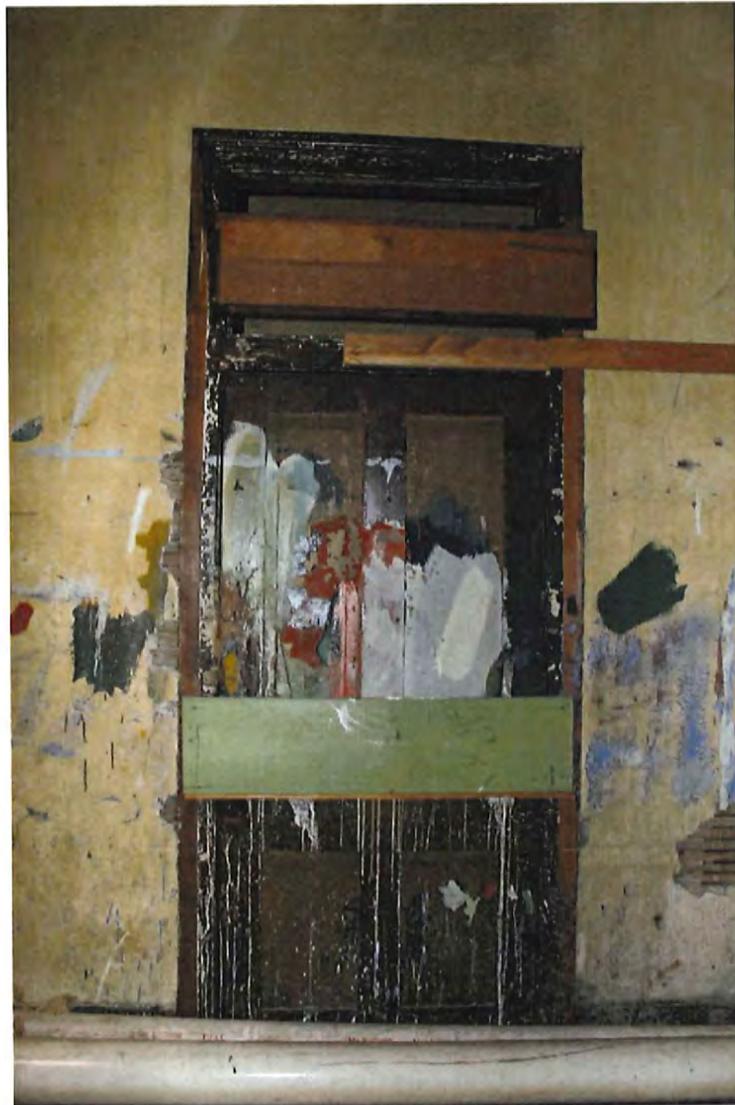
Photo 15 – Drake's Duck In
1544 Main St. Columbia, SC
Original door and transom
1/27/2017

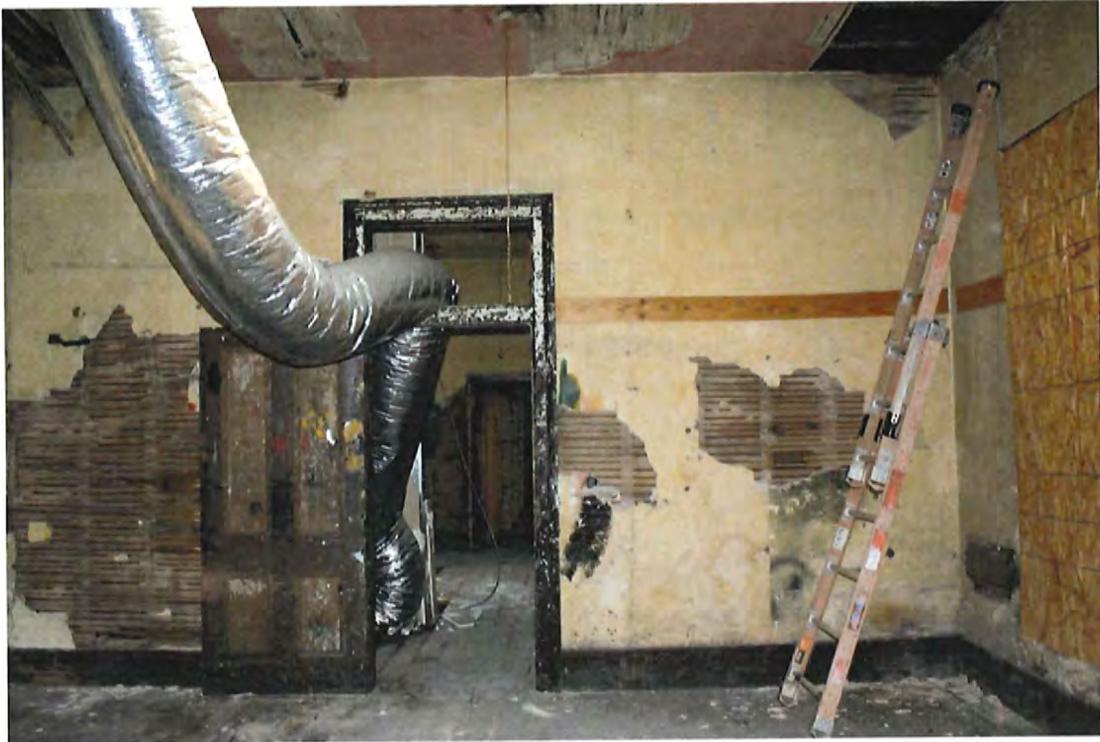
Photo 17 – Drake's Duck-In
1544 Main St. Columbia, SC
Current HVAC equipment
1/27/2017

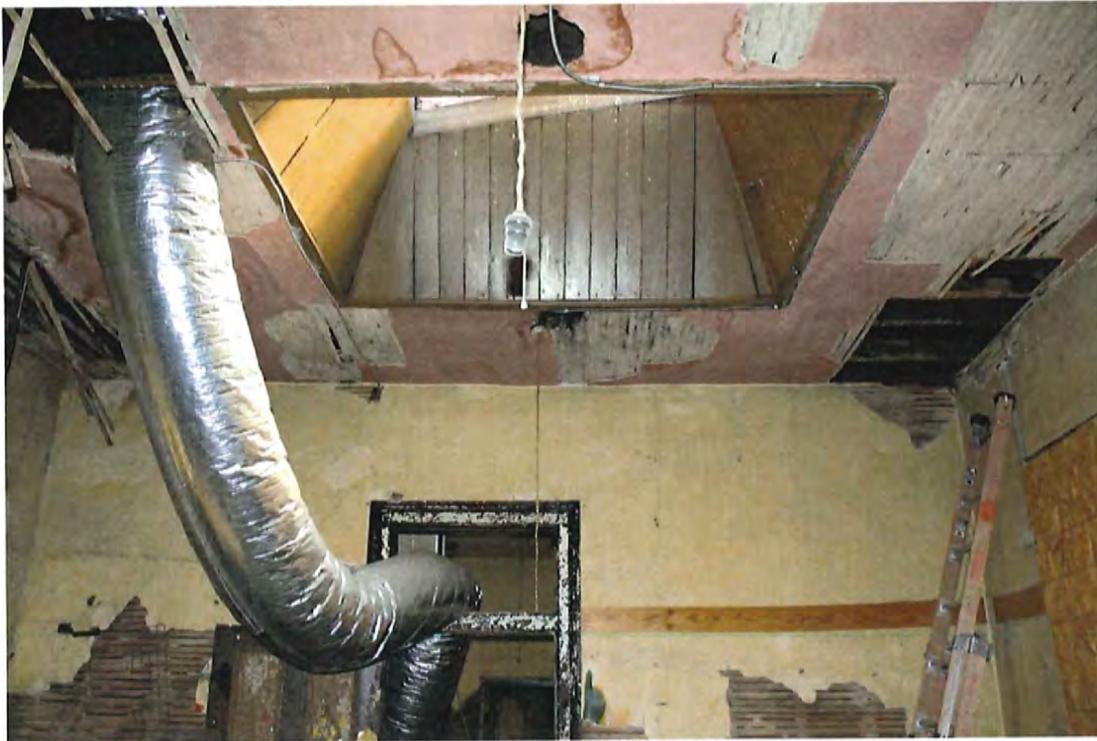
Photo 18 – Drake's Duck-In
1544 Main St. Columbia, SC
Skylight in ceiling
1/27/2017

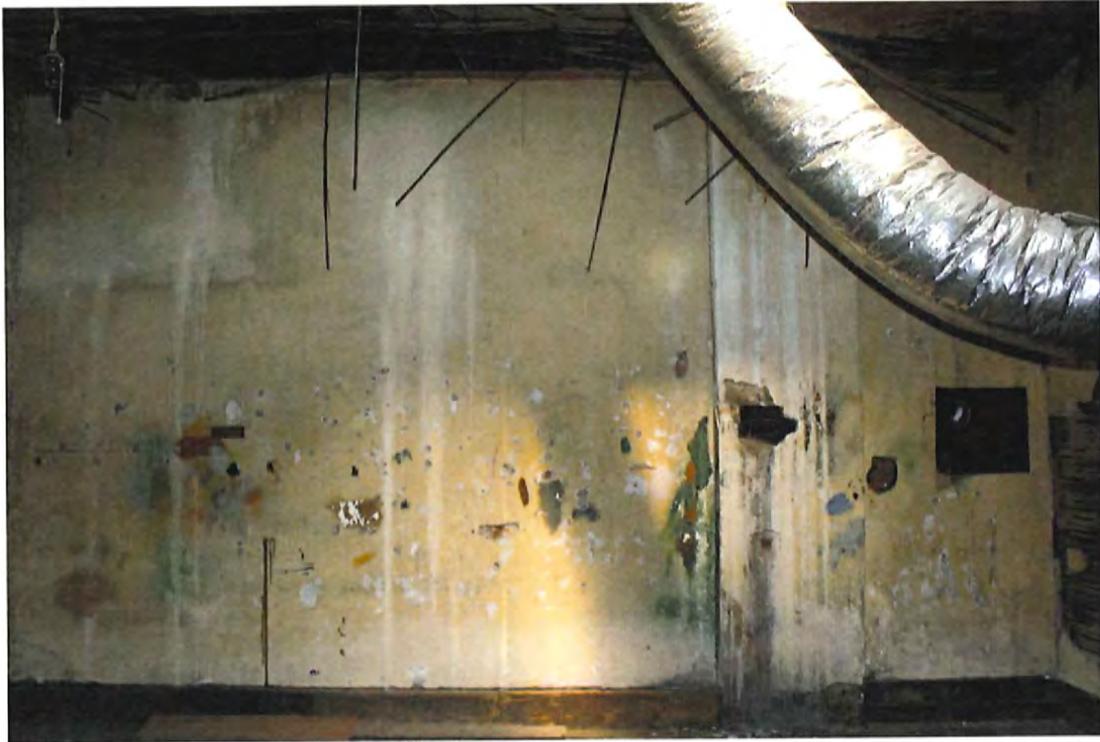
Photo 19 – Drake's Duck-In
1544 Main St. Columbia, SC
Intact plaster
1/27/2017

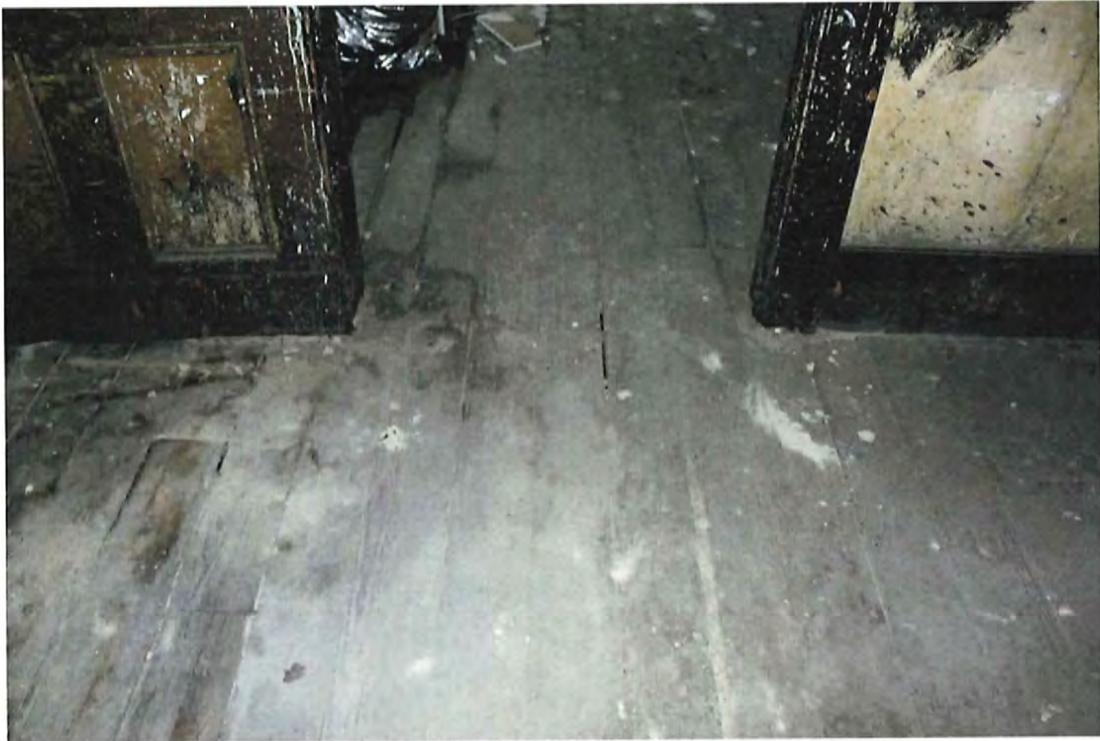
Photo 20 – Drake's Duck-In
1544 Main St. Columbia, SC
Second level flooring
1/27/2017

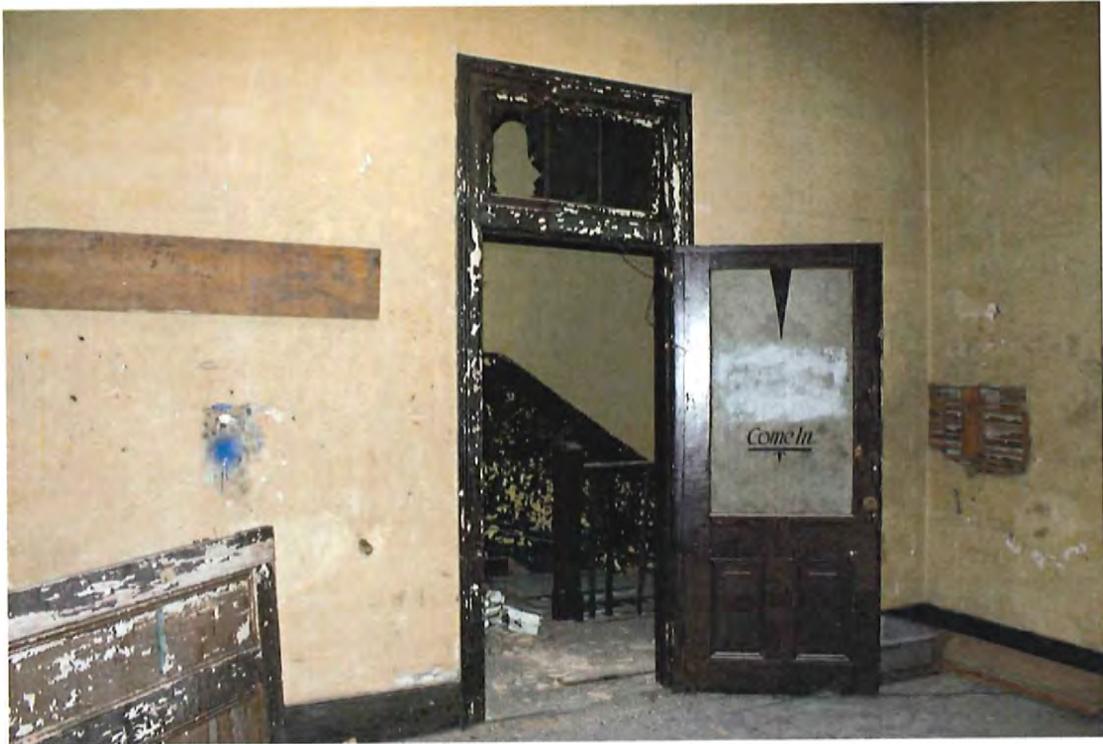
Photo 21 – Drake's Duck-In
1544 Main St. Columbia, SC
Early door and former stair
1/27/2017

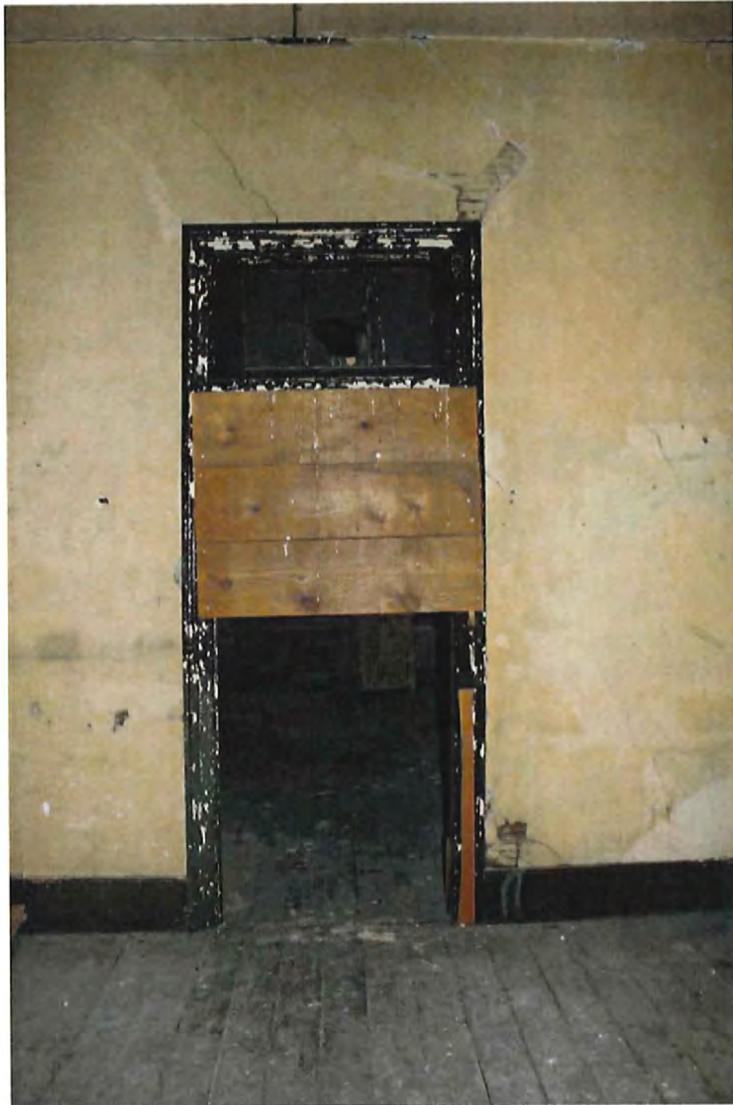
Photo 22 – Drake’s Duck-In
1544 Main St. Columbia, SC
Second level doorway and transom
1/27/2017

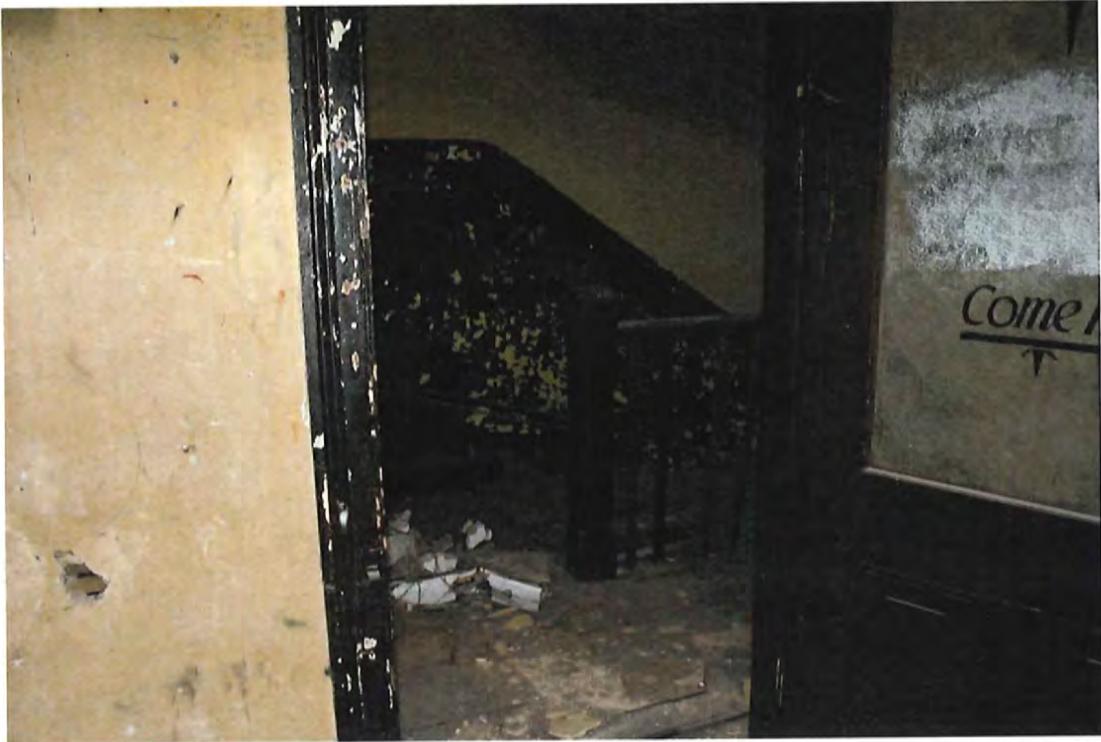
Photo 23 – Drake's Duck-In
1544 Main St. Columbia, SC
Former stair, south wall
1/27/2017

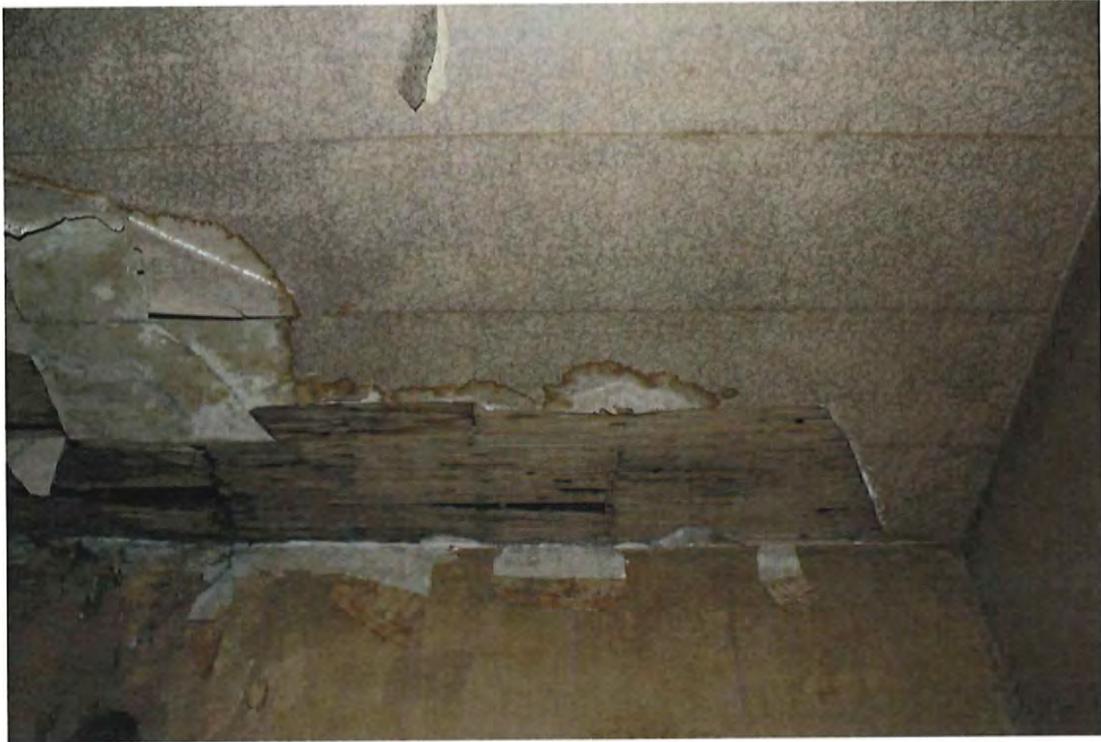
Photo 24 – Drake' Duck-In
1544 Main St. Columbia, SC
Ceiling condition
1/27/2017

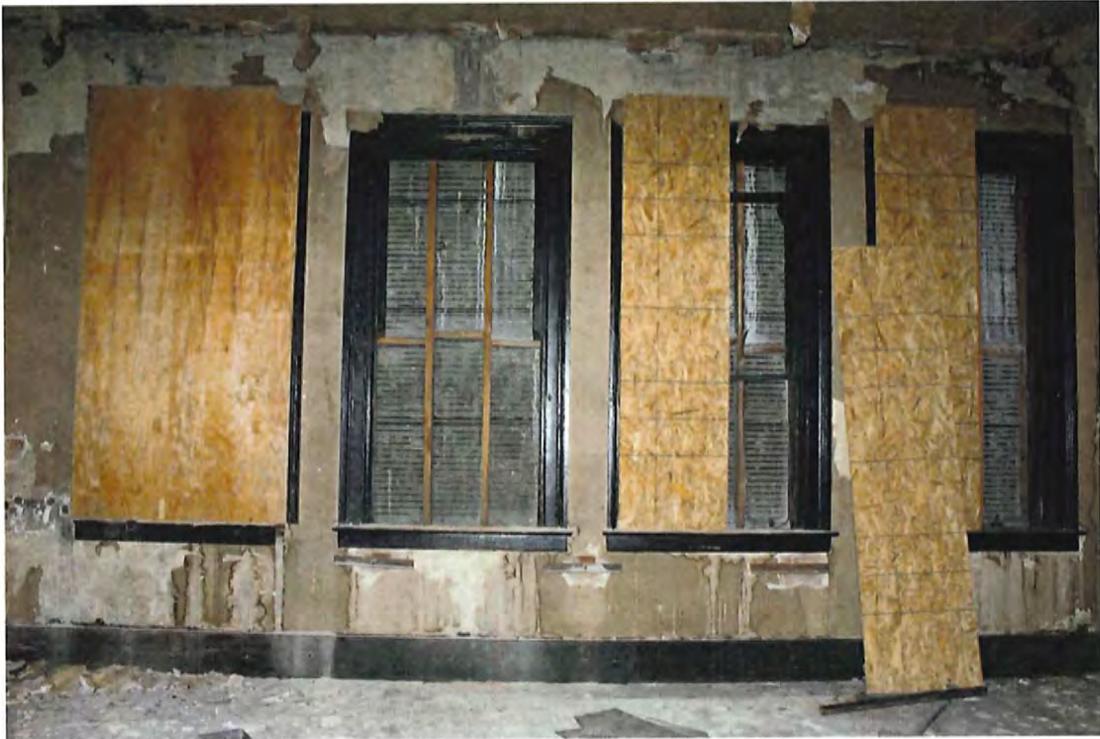
Photo 25 – Drake's Duck-In
1544 Main St. Columbia, SC
Interior of west façade windows
1/27/2017

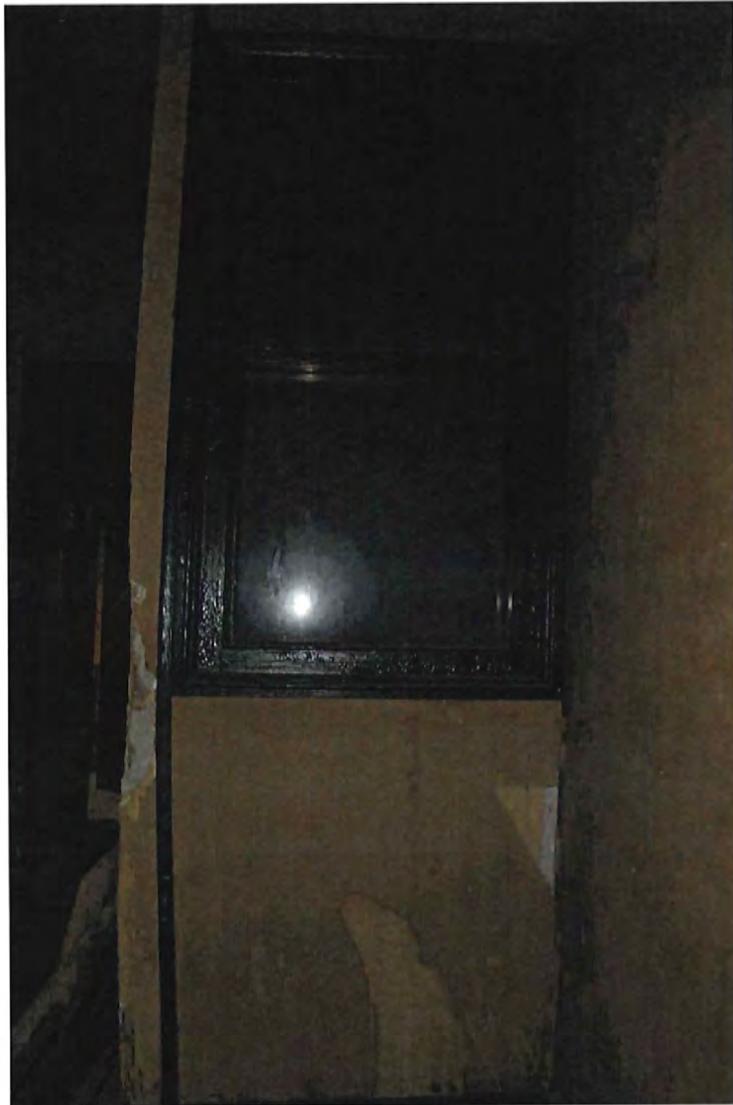
Photo 26 – Drake's Duck-In
1544 Main St. Columbia, SC
Original window above staircase
1/27/2017
