DESIGN/DEVELOPMENT REVIEW COMMISSION
DESIGN REVIEW DISTRICT
CONSENT AGENDA
EVALUATION SHEET
Case # 4

ADDRESS: 1544 Main Street

NATURE OF REQUEST: Request for Certificate of Design Approval for exterior changes and preliminary certification for the Bailey Bill

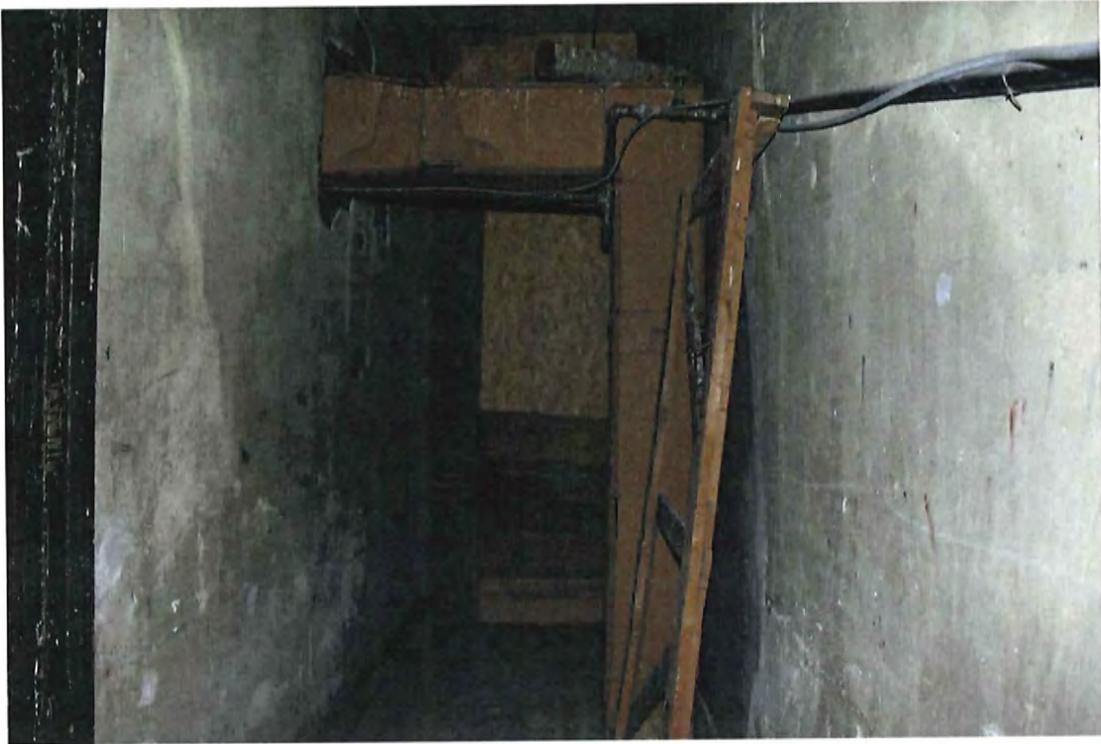
Photo 28 – Drake's Duck-In
1544 Main St. Columbia, Sc
Duct in southeast corner of second floor
1/27/2017

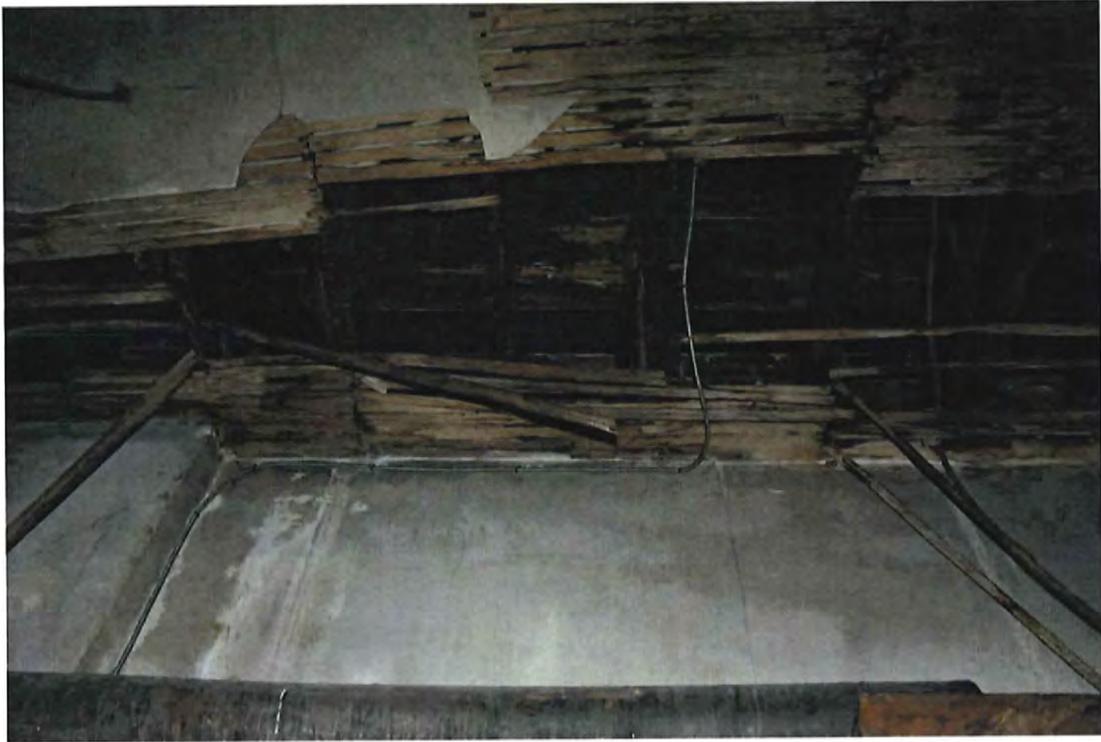
Photo 29 – Drake's Duck-In
1544 Main St. Columbia, SC
Deteriorated ceiling, second level
1/27/2017

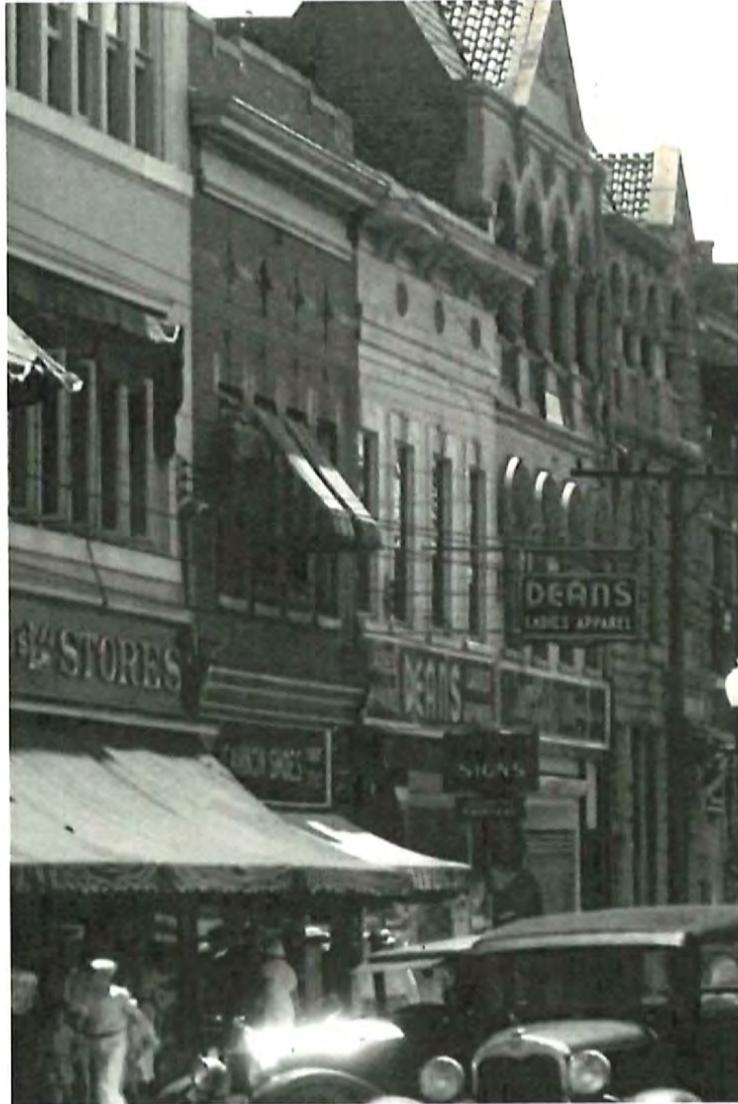
Photo 31 – Drake's Duck-In
1544 Main St. Columbia, SC
Cannon Shoe Store
1939

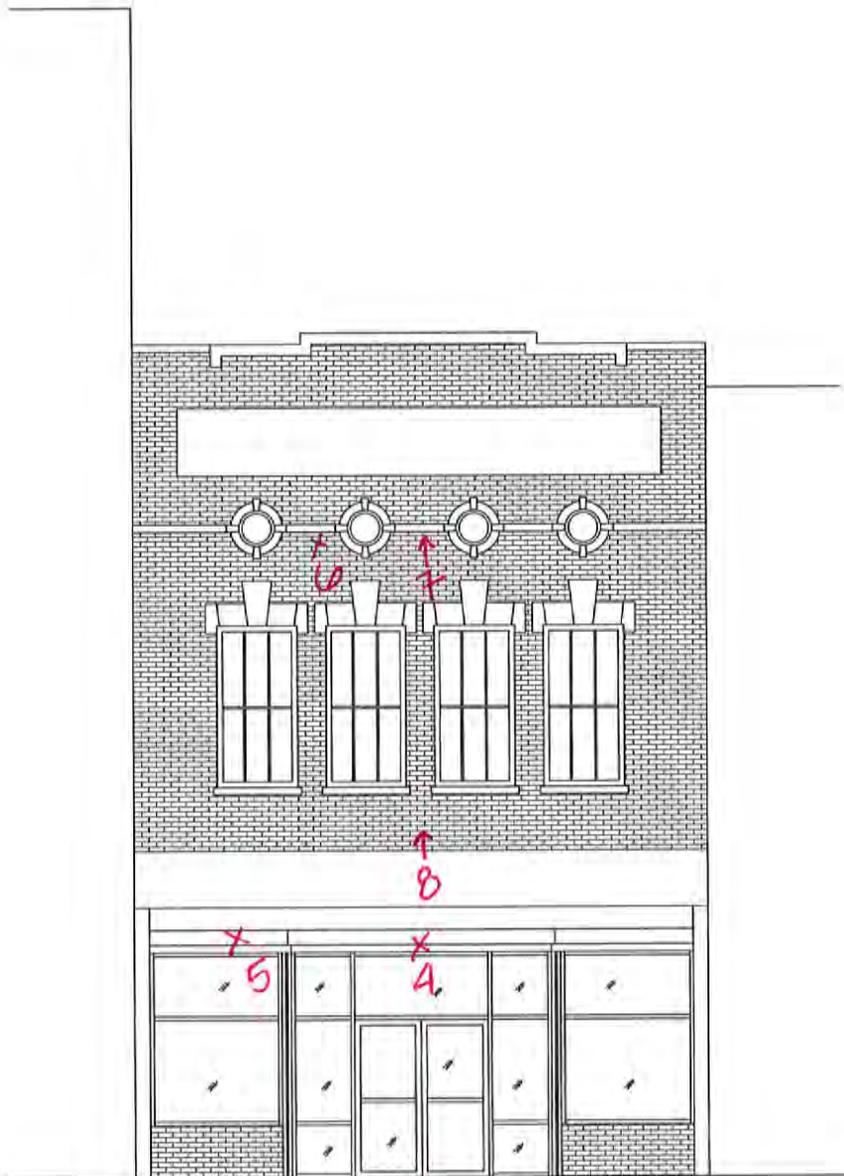
3 EXTERIOR ELEVATION (EXISTING)
3/16" = 1'-0"

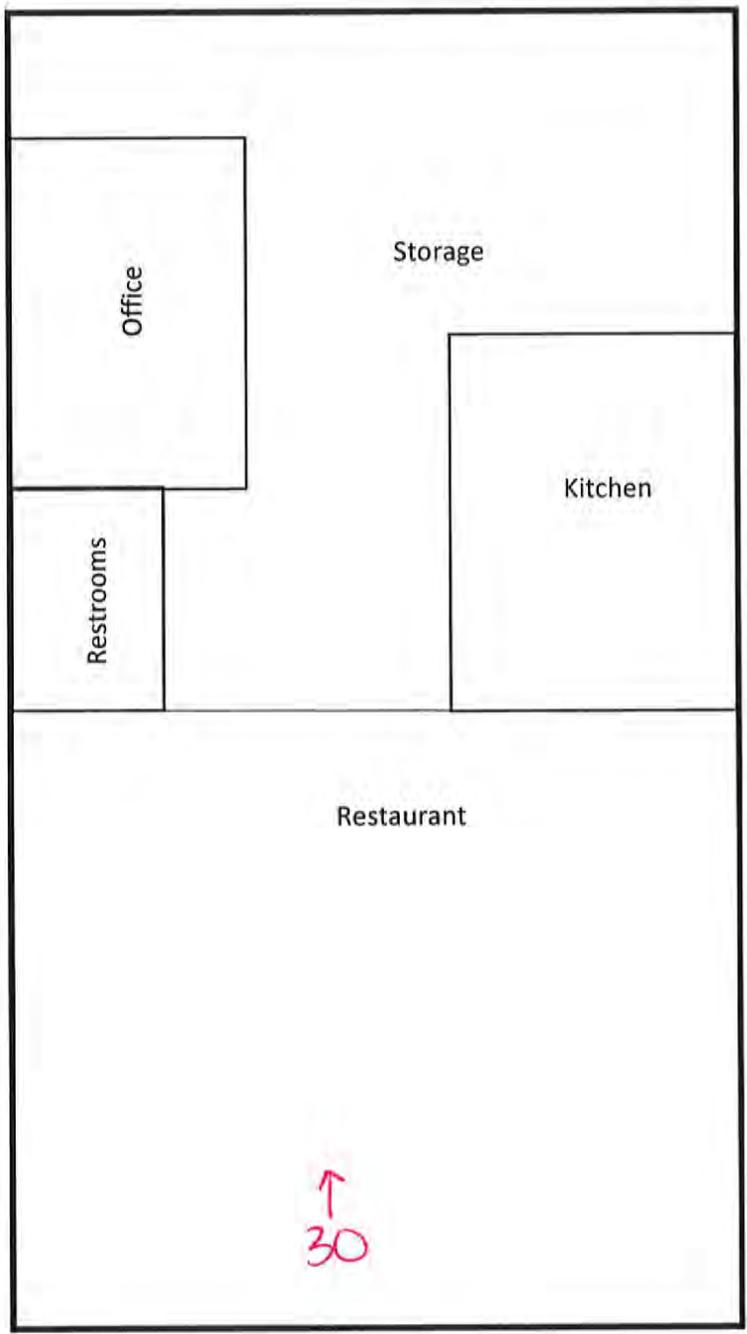
D1.1 First Level Existing Floor Plan

Photo Map

*Not Drawn to Scale

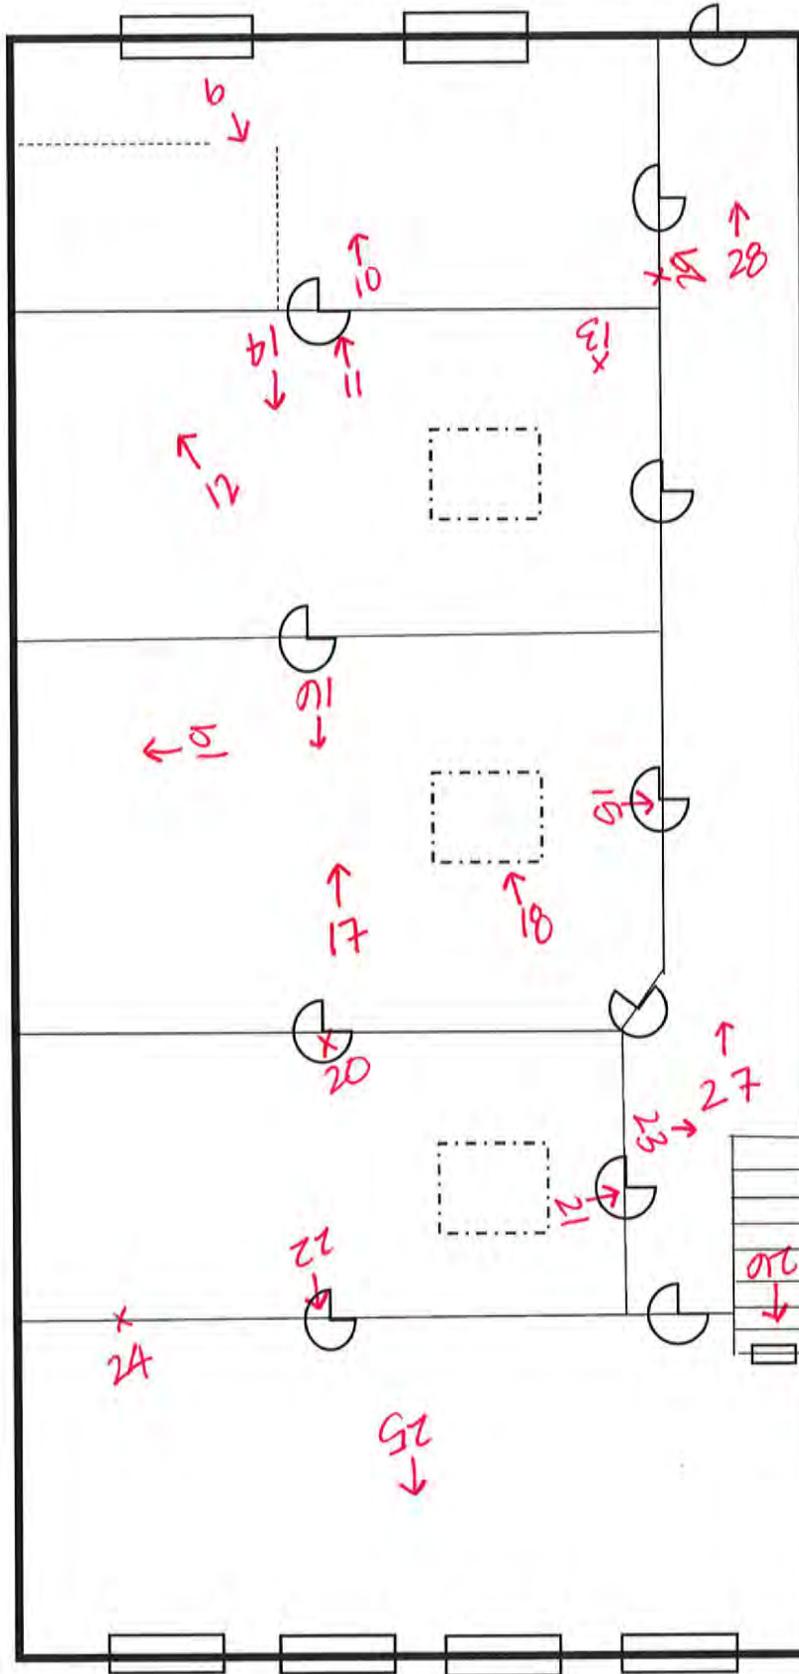
D1.2 Second Level Existing Floor

Plan Photo Map

*Not Drawn to Scale

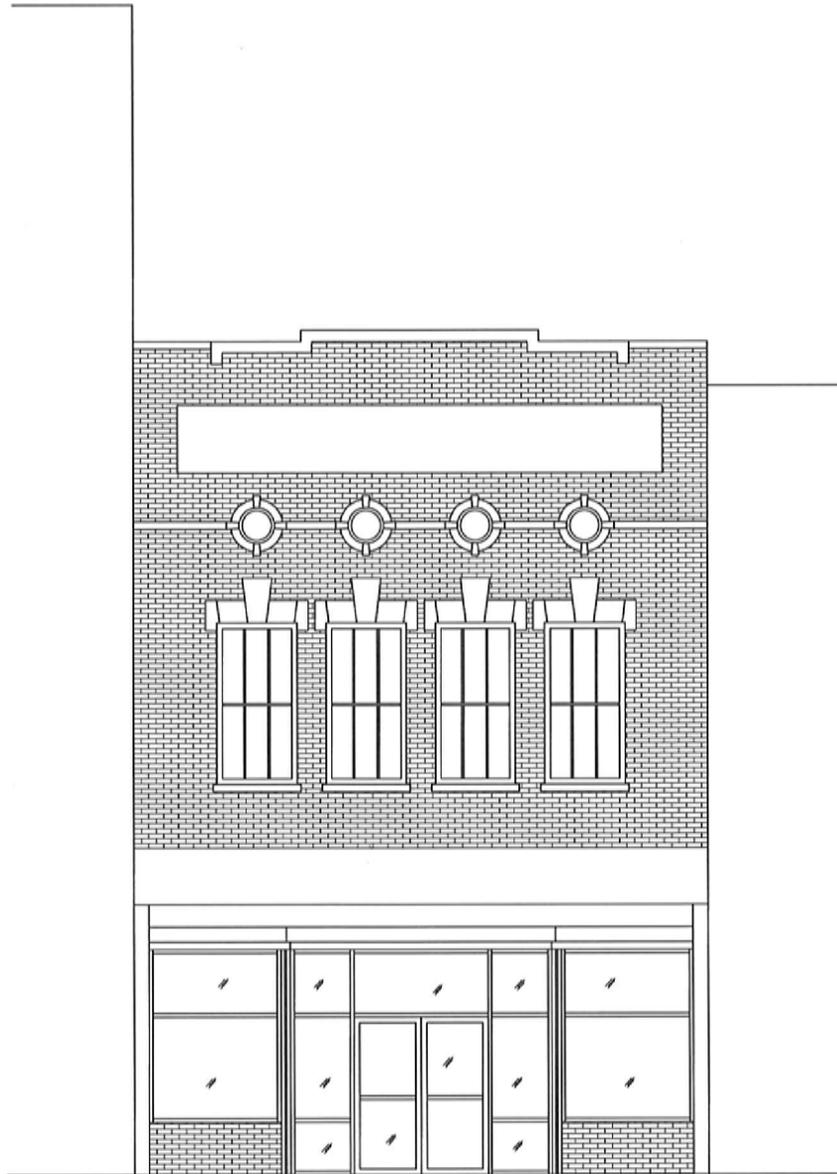
3 EXTERIOR ELEVATION (EXISTING)
3/16" = 1'-0"

D1.0 Existing Facade

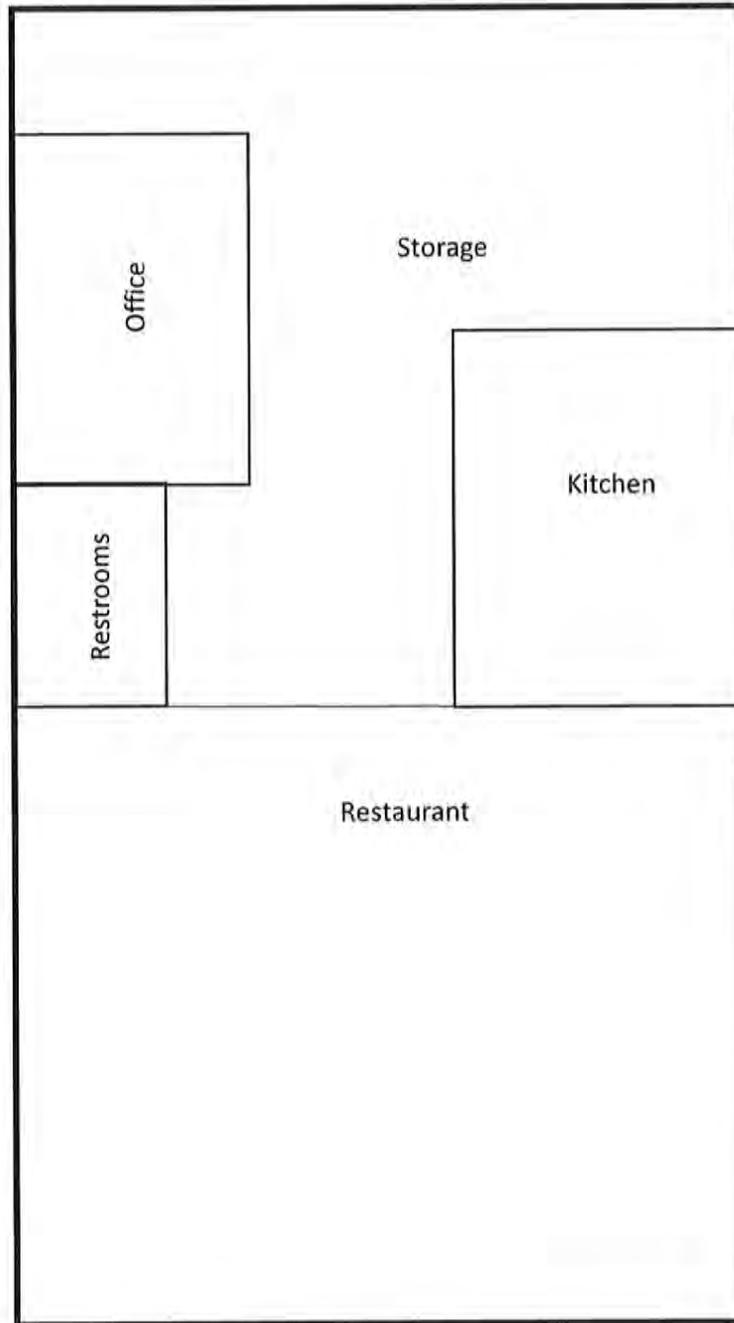
D1.1 First Level Existing Floor Plan

*Not Drawn to Scale

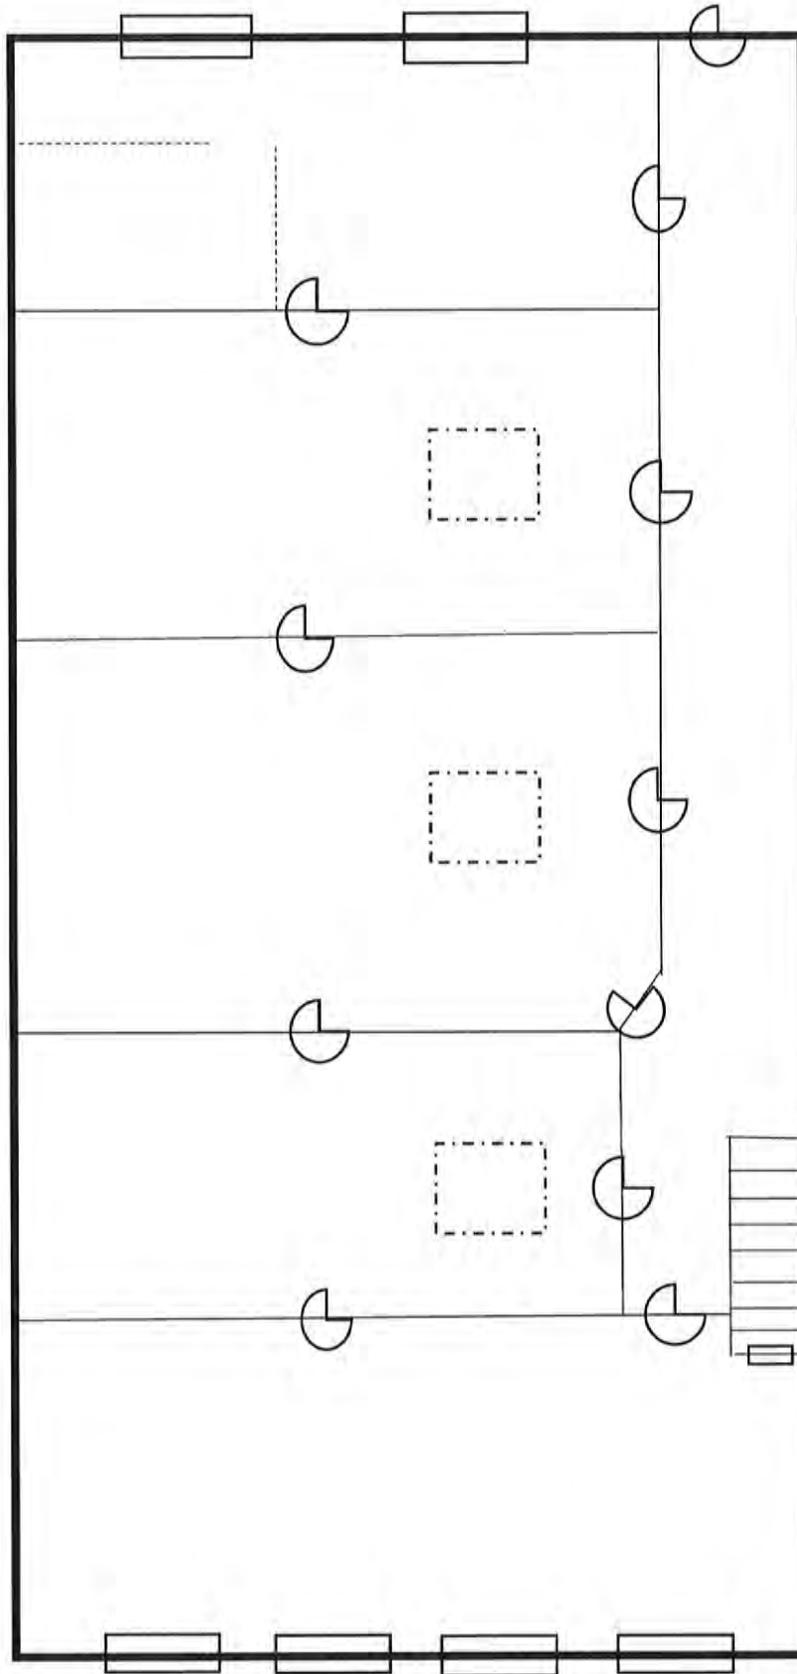
D1.2 Second Level Existing Floor

*Not Drawn to Scale
