## D/DRC Case

929 Gervais Street

West Gervais Street Historic Commercial District

**DESIGN/DEVELOPMENT REVIEW COMMISSION  
BAILEY BILL APPLICATION  
CONSENT AGENDA  
EVALUATION SHEET  
Case #1**

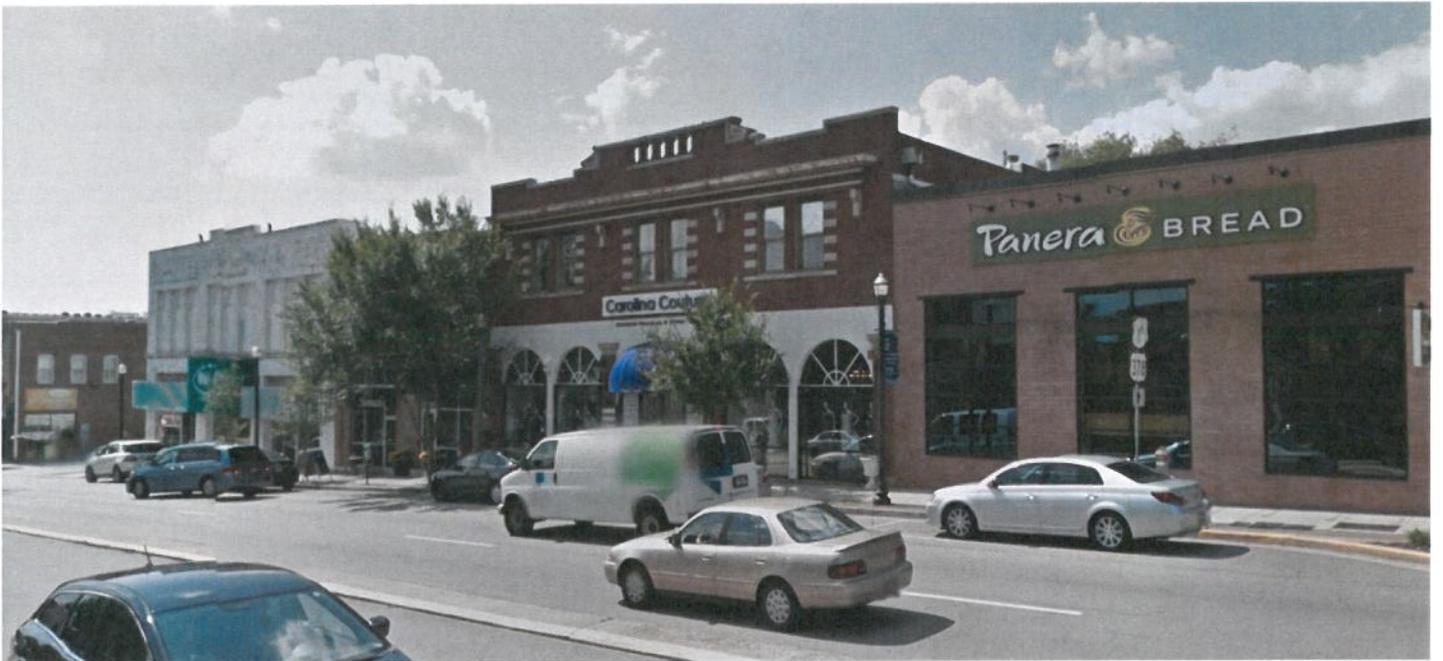
1. Southeast view

<p>Architectural feature <u>Storefront / facade</u>          Approximate date of feature <u>1990's</u>          Describe feature and its condition  <u>Existing storefront and facade have non-original modifications</u></p> <p>Photograph No. <u>1,2,5</u> Drawing No. _____</p>	<p>Describe work and impact on feature  <u>Pending tenant req's, exterior modifications may be req'd - to be in keeping with the Vicks Design Guidelines and DDRC review and approval</u></p>
<p>Architectural feature <u>Accessibility (Plumbing, floor)</u>          Approximate date of feature _____          Describe feature and its condition  <u>Existing 1st floor plumbing and flooring do not meet current accessibility req's</u></p> <p>Photograph No. <u>6</u> Drawing No. _____</p>	<p>Describe work and impact on feature  <u>Pending tenant req's, plumbing layout and floor elevations to be modified and replaced to meet current IBC/ANSI/ADA req's</u></p>

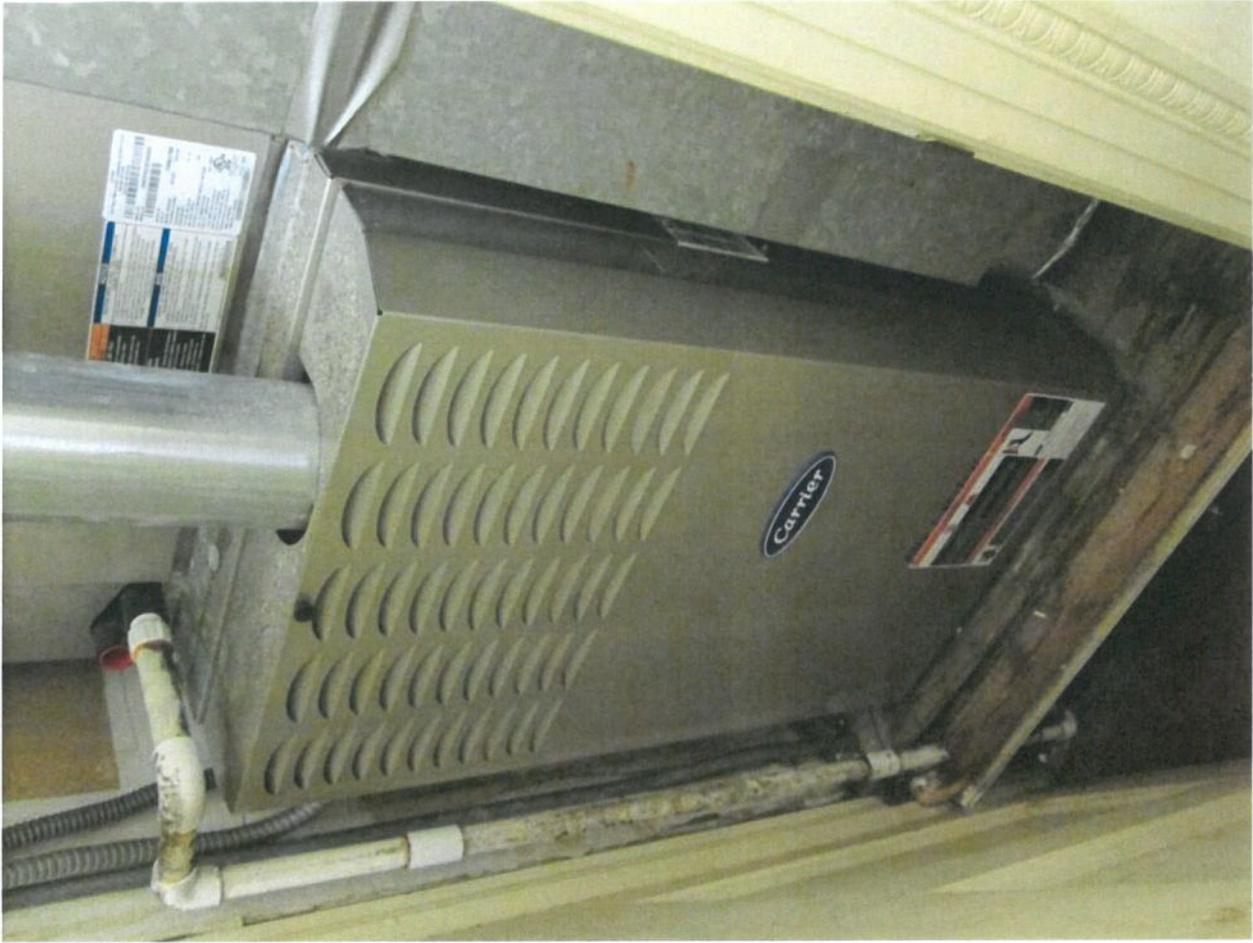
4. HVAC

<p>Architectural feature <u>HVAC</u> Approximate date of feature <u>1990's</u> Describe feature and its condition <u>Existing HVAC units in disrepair</u></p> <p>Photograph No. <u>4</u> Drawing No. _____</p>	<p>Describe work and impact on feature <u>Replace existing HVAC unit(s) with new units to meet future tenant req's and to meet IMC and IECC req's.</u> <u>*Cost estimate approx \$25,000</u></p>

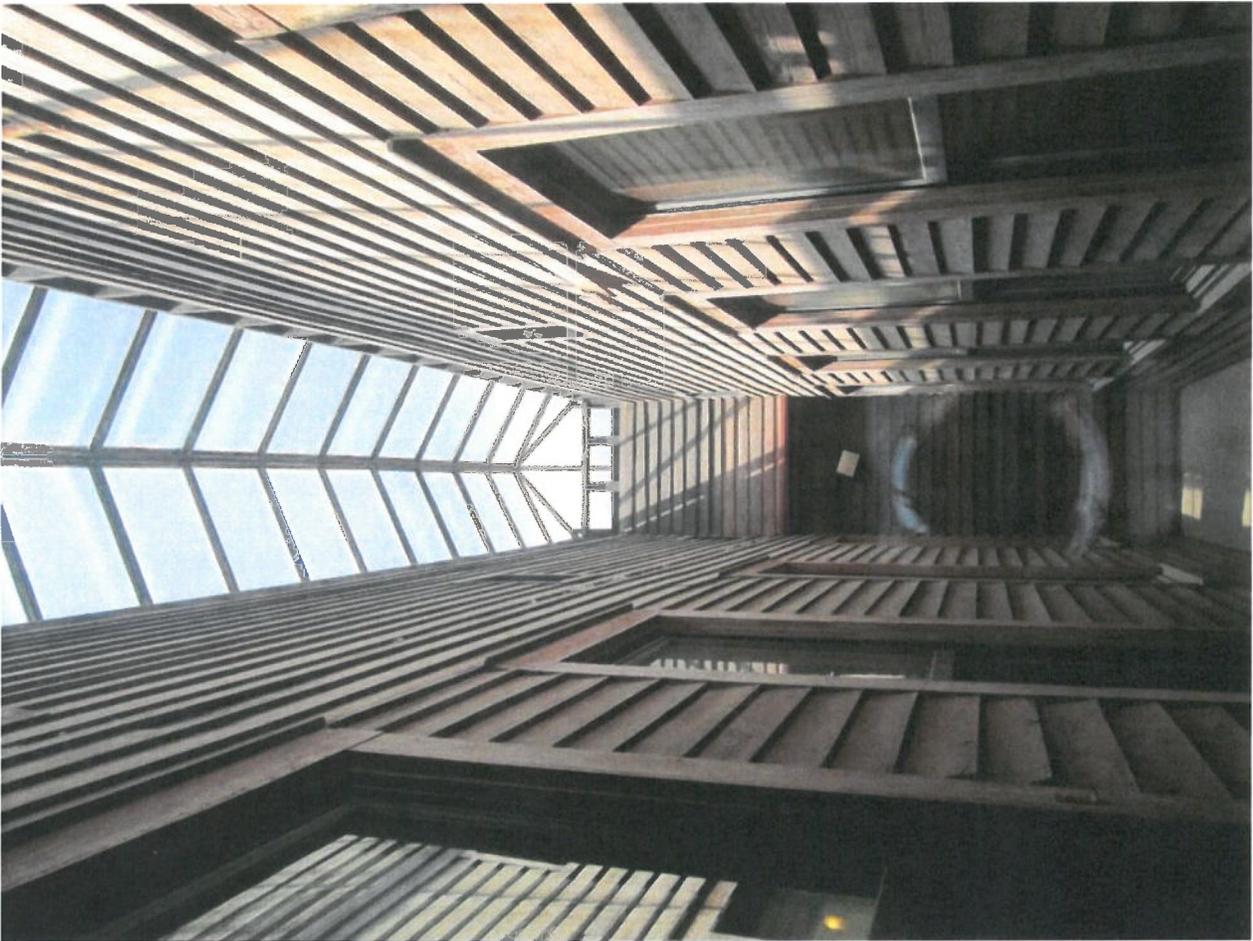
3. Skylights

<p>Architectural feature <u>Roof</u> Approximate date of feature <u>unknown</u> Describe feature and its condition <u>Existing roof has existing leaks, leading to water and mold damage</u></p> <p>Photograph No. _____ Drawing No. _____</p>	<p>Describe work and impact on feature <u>Repair roof to water-tight condition</u></p>
<p>Architectural feature <u>Skylights</u> Approximate date of feature <u>1970s</u> Describe feature and its condition <u>Existing, but not original, skylights are in poor condition and create unusable 2nd floor space</u></p> <p>Photograph No. <u>3</u> Drawing No. _____</p>	<p>Describe work and impact on feature <u>Remove skylights and repair roof structure and roof membrane. Replace all water damaged materials</u></p>
<p>Architectural feature <u>General</u> Approximate date of feature _____ Describe feature and its condition <u>Moisture readings are elevated due to roof and skylight disrepair.</u></p> <p>Photograph No. _____ Drawing No. _____</p>	<p>Describe work and impact on feature <u>After roof repair and skylight removal, mold remediation is req'd to return the bldg to optimal moisture readings</u></p>
