DESIGN/DEVELOPMENT REVIEW COMMISSION
BAILEY BILL APPLICATION
CONSENT AGENDA
EVALUATION SHEET
Case #3

ADDRESS: 1328 Richland Street

NATURE OF REQUEST: Request for preliminary certification for Bailey Bill

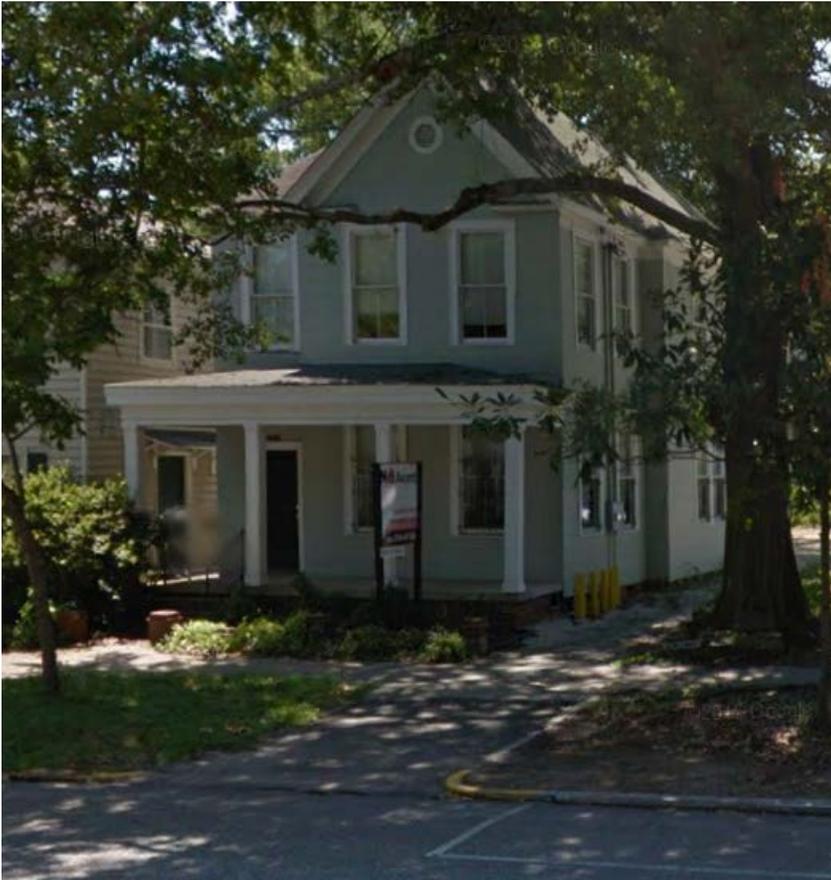
Facade

This is an early 20th century, two-story, originally wood-sided building in the Landmark District. Although very simple, it is typical of others in the area and is a contributing structure to the district. The new owners are taking care of long delayed maintenance and plan to rehabilitate its 2/2 windows, etc., some of which are in poor condition. The asbestos siding, a later alteration, will remain for the moment although the new owners intend to fix any that is in poor repair as well as any trim. The HVAC units will also be replaced. The applicants have been advised that staff will need to review any material for its condition before it is removed for replacement.

- Architectural Feature: Windows
 - the existing window sashes around the perimeter of the building are rotten and in need of replacement. Each window sash will be removed and replaced, any existing window sill and trim that has been damaged will be removed and replaced, and any exterior door trim will be repaired
 - Estimated cost of project \$10,278.00
 - photo attached of existing damaged windows

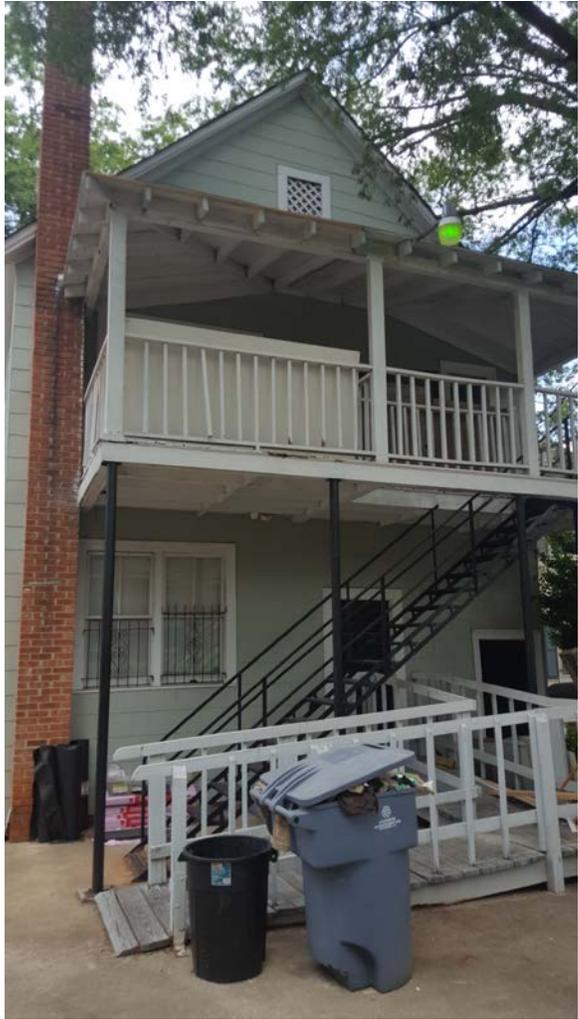
Back porch

Any original windows will be rehabilitated. The back porches (both floors) are in poor repair and need some work. Historic materials will be maintained where present or new materials will be fabricated where needed.

Windows will be rehabilitated and the back porch, which was probably a later addition to the house, has suffered some damage and will be repaired.

- Architectural Feature: Rear porch
 - the rear porch has aged and is in need of repair, all damaged, rotten wood will be replaced. The handrails will be replaced and code compliant. The original design will not be changed and most materials will be salvaged except for the T&G porch floor.
 - Estimated cost of project \$4,300.00
 - photo attached of existing rear porch
